Residential Building Report

Pre-Purchase Inspection - Residential Building Report- (Except ACT)

Residential Pest Report

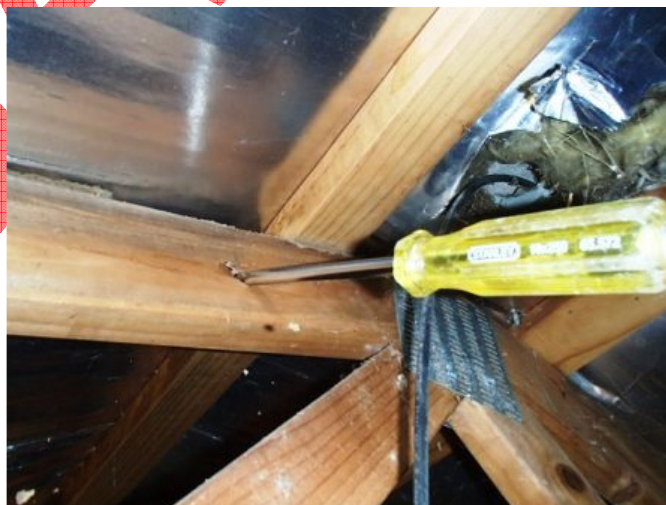
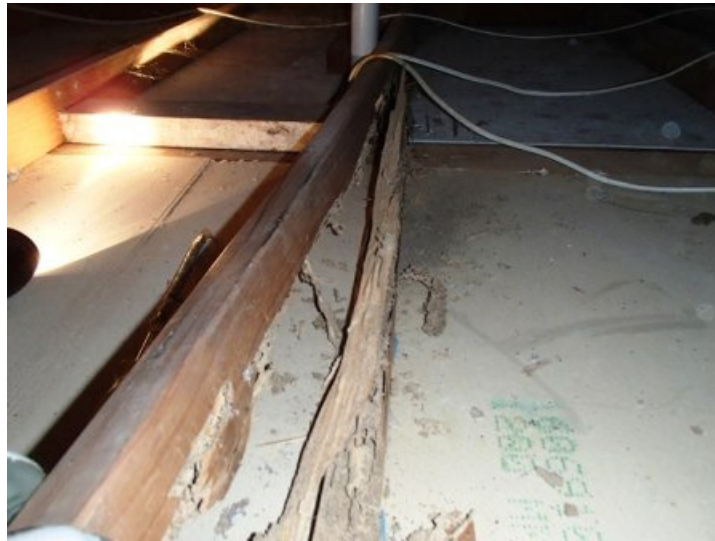
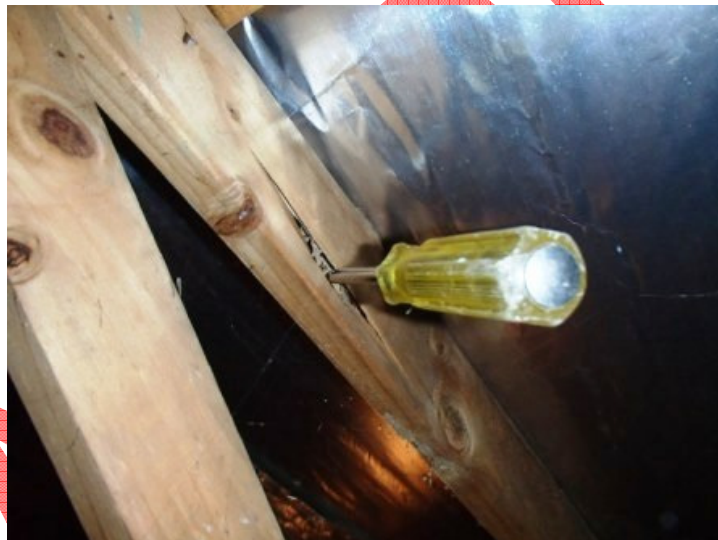
- Possible termite damage to the wall and floor framing timber due to termite mudding to the ground and 1st floor walls, floor beams, roof trusses and wall top plates in the roof void

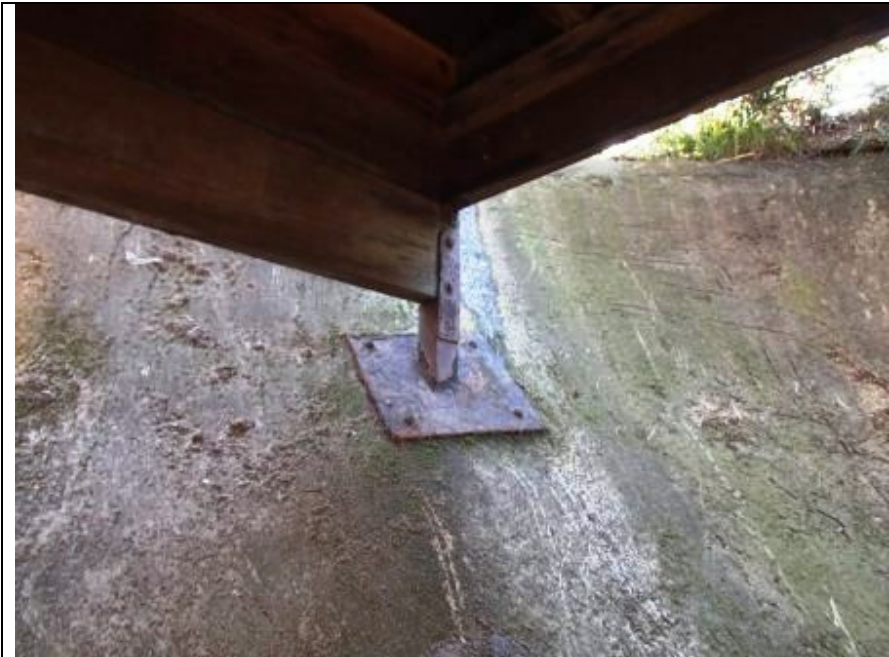
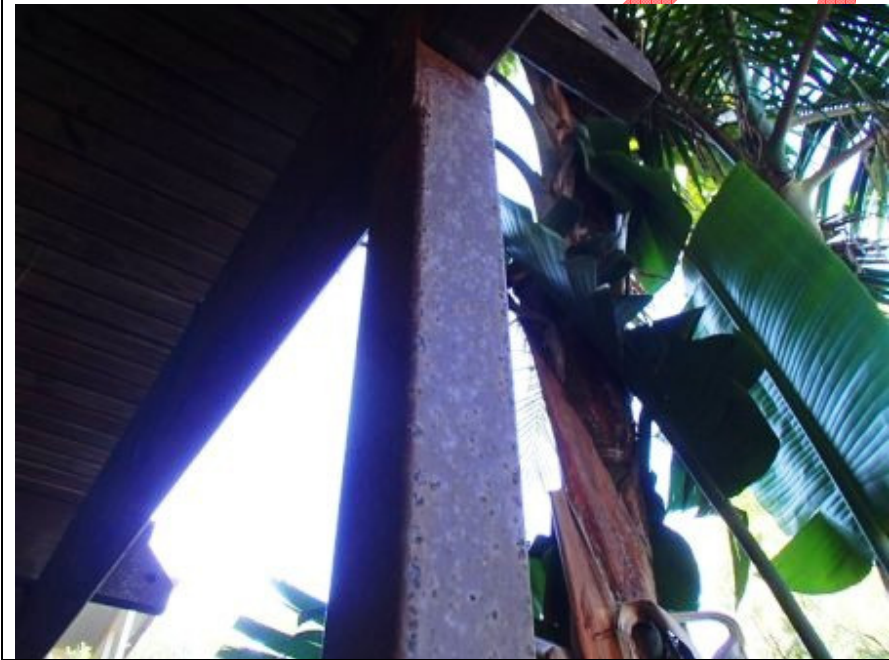
The external timbers to the weatherboards, windows, fascia boards, rafter ends, balcony timbers and carport timbers of the property have aged and weathered in areas. These timbers should be painted immediately to prevent decay.

\$5,000.00

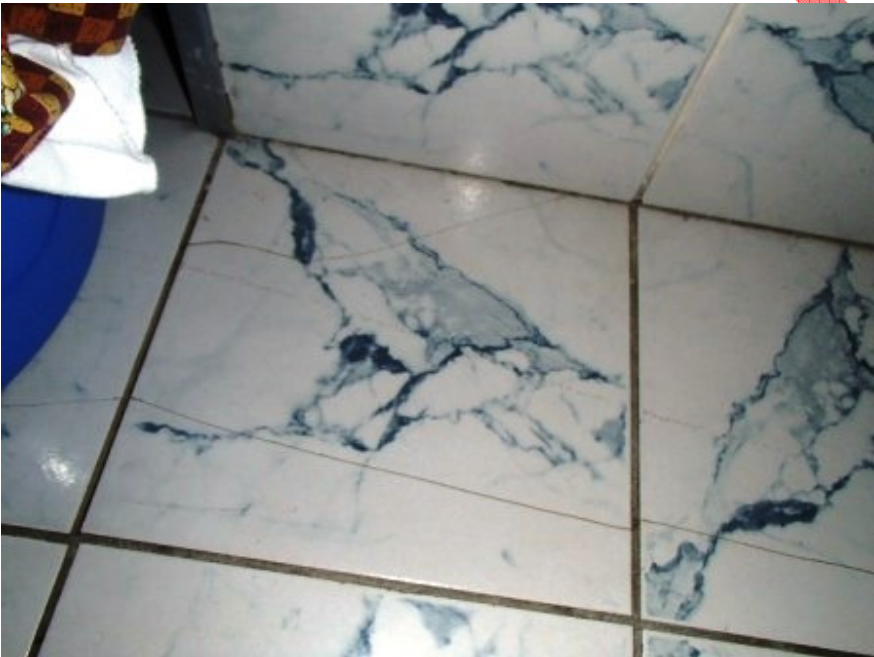
Minor cracks were noted to the bathroom 1 and ensuite internal walls. These cracks have been possibly caused by termite damage to the wall framing timbers.

<p>The wall lining to the bathroom 1 is bowed in a number of areas which is possible due to termite damage to the wall framing timbers, movement and loss of adhesion to glue between the wall lining and the wall studs. Replacement of this wall lining is essential.</p>	
<p>The front door to top floor requires easing and adjustment in order for it to operate correctly.</p>	\$100.00
<p>A number of tiles to the ground floor kitchen, bathroom 2 and ensuite floor tiles have become drummy and cracked.</p> <p>These tiles have become cracked and drummy possibly due to termite damage to the floor framing timbers, movement and loss of adhesion with their bedding materials. Replacement of these tiles will be required by a ceramic tiler.</p>

<p>An invasive inspection should be carried out as concealed termite damage to the wall and floor framing timbers is highly likely due to termite mudding and damage to the ground and 1st floor.. Without the removal of wall linings, it is not possible to determine the extent or existence of termite damage. A builder should be contracted by the purchaser or vendor to undertake the removal of the wall lining, subject to the vendor's approval in writing.</p>  	Discuss with the inspector

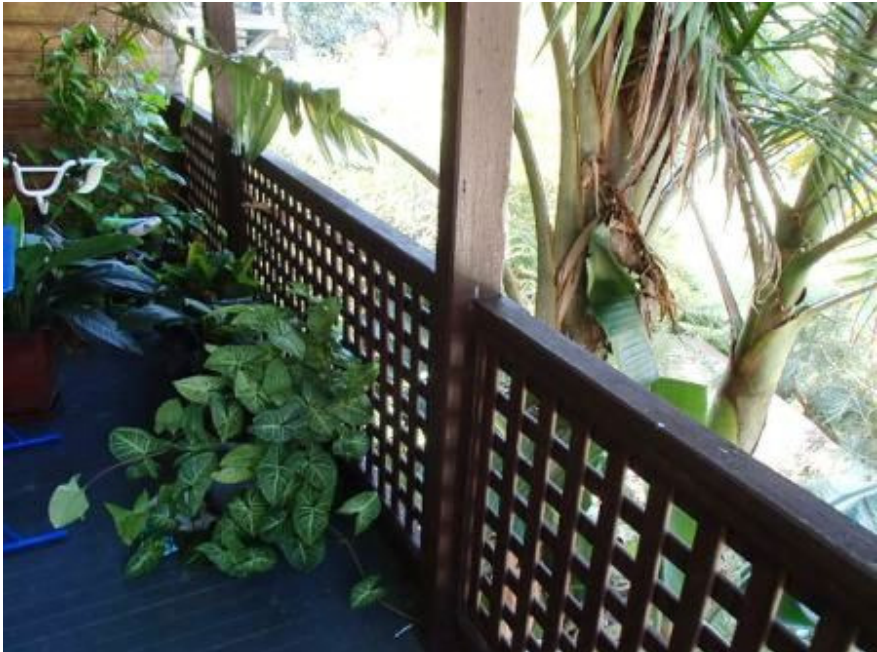
Defect description, type, location and the significance of defect.	Estimated cost of repairs
<p>The handrails to the balcony are too low in height and do not comply with the Building Code of Australia, which states that the minimum height of the handrail must be no less than a minimum height of 1 metre. The handrail must be replaced to prevent an accident.</p>

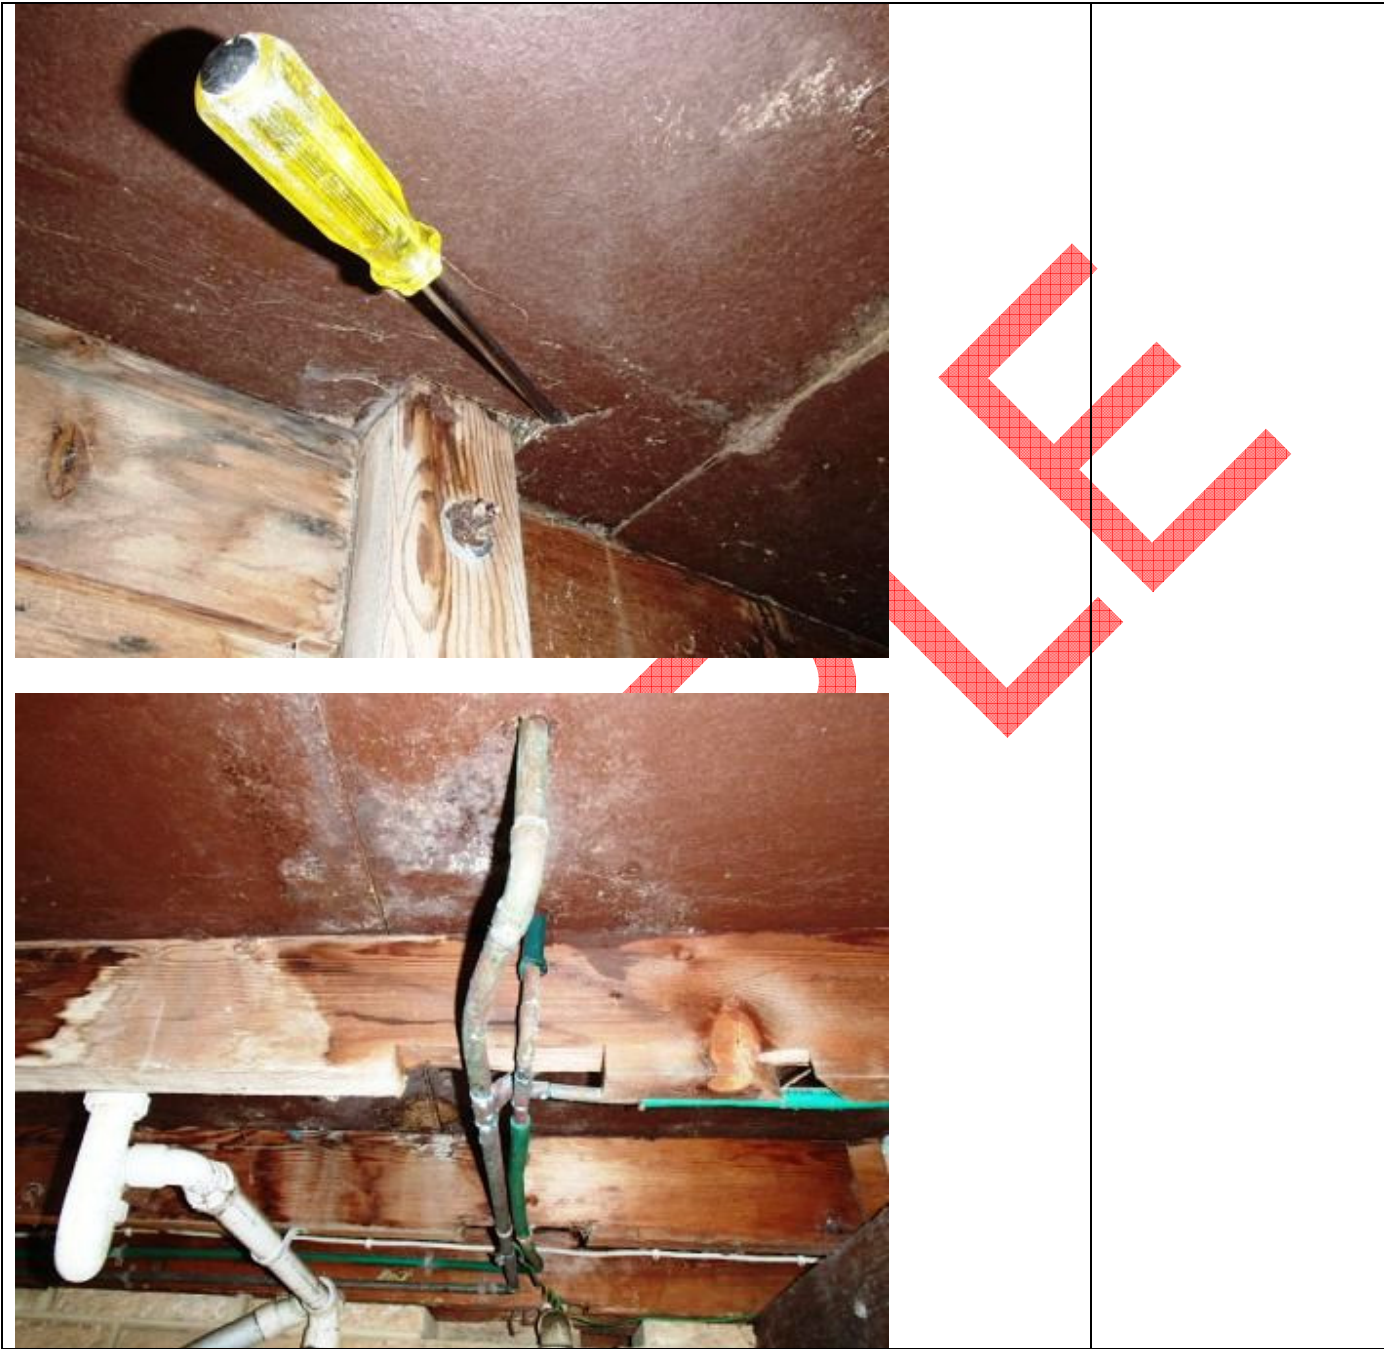
<p>\$2,000.00</p>
<p>Fungal decay was identified in the right side balcony although its extent and significance could not be determined. A timber specialist or engineer needs to be instructed to advise on the full extent of the problem, including any remedial work and potential safety issues.</p>	<p>Seek a structural engineer</p>
<p>Replace the water damaged flooring below the 1st floor bathroom / laundry area of the home, this damage is due to a past leak.</p>	<p>\$6,000.00</p>

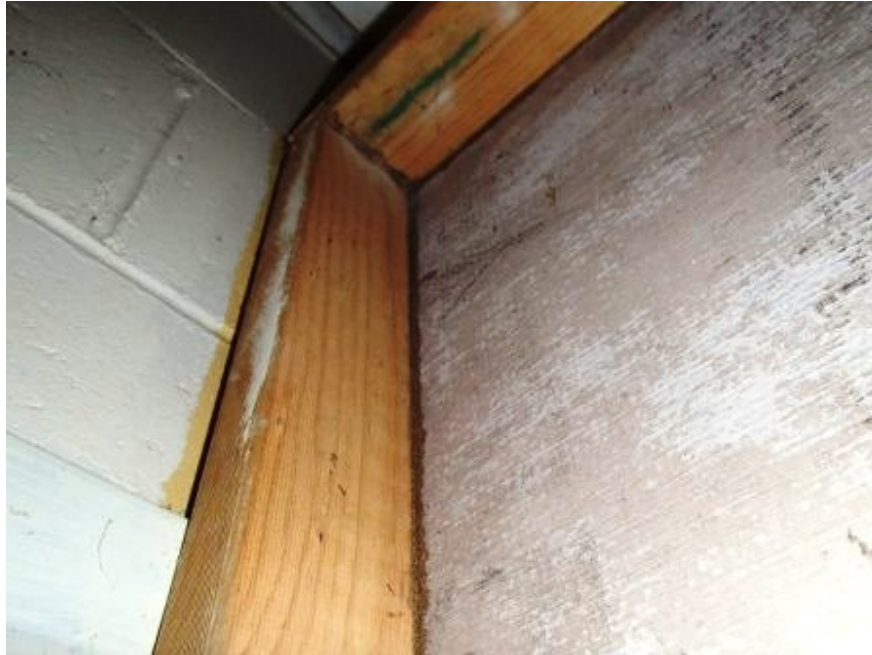
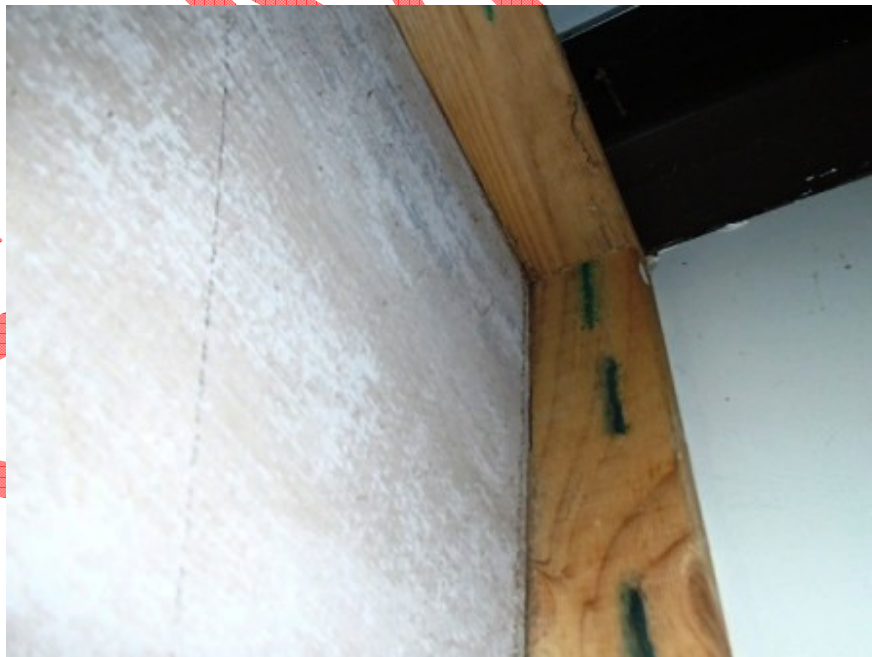
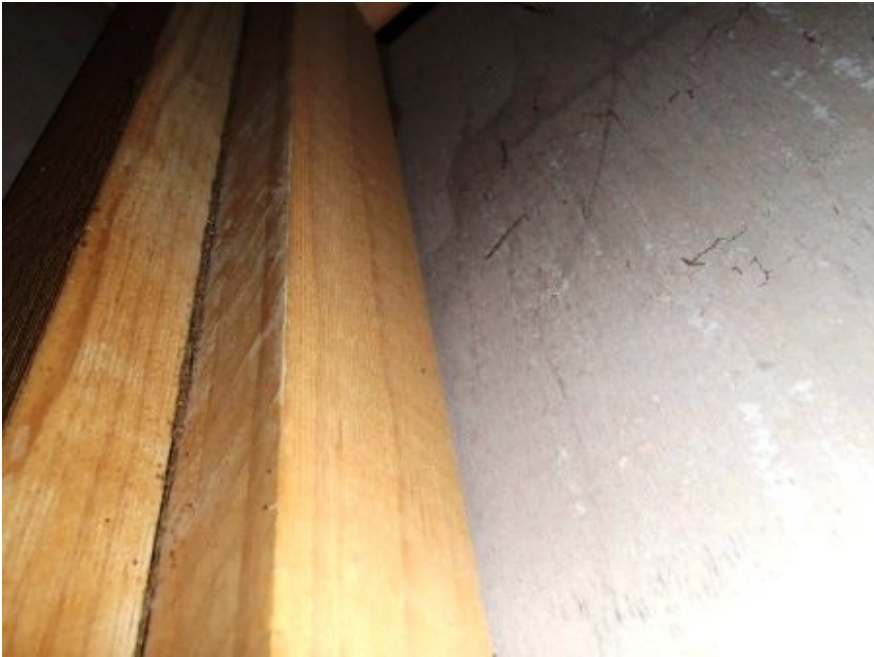
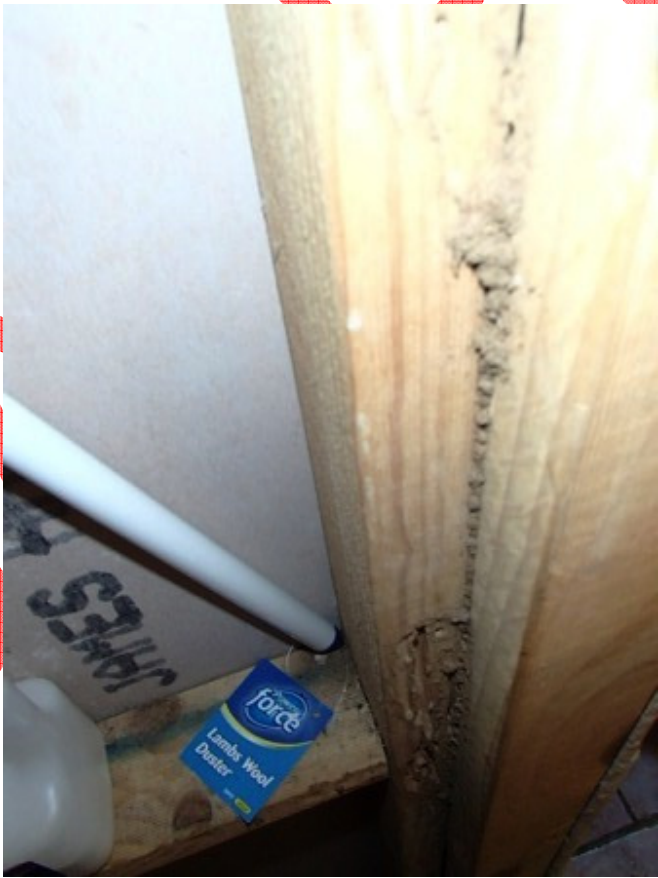
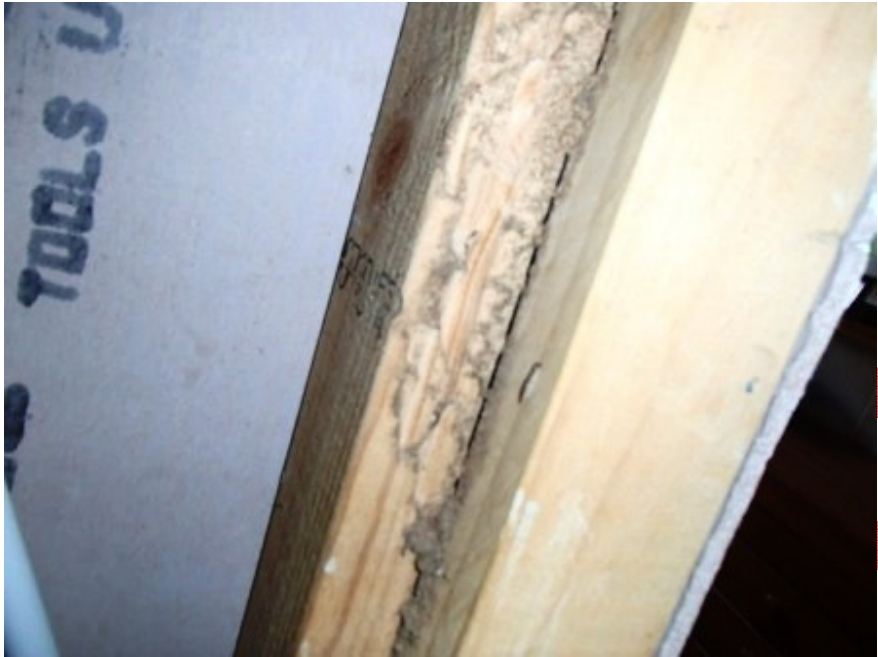
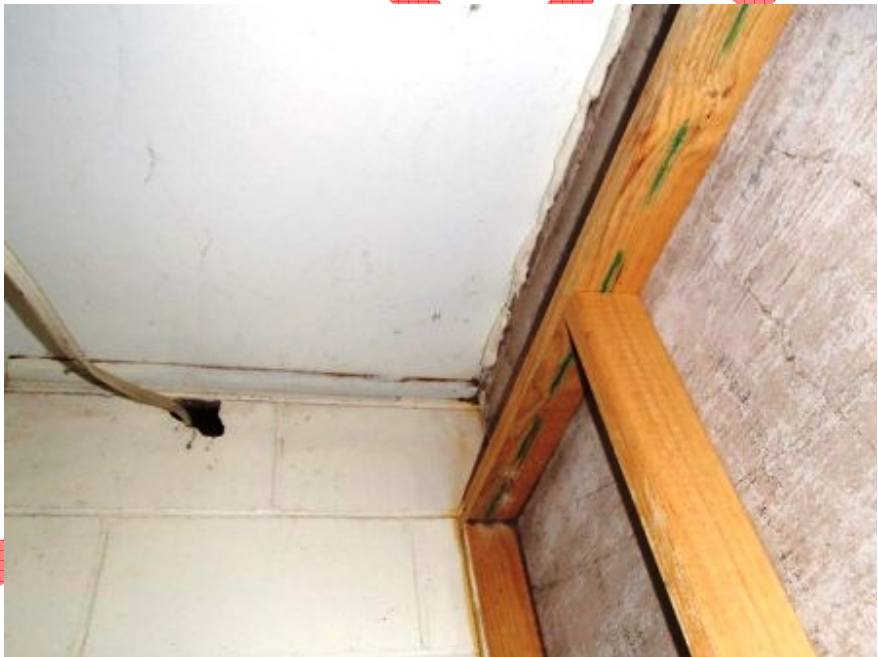
2.3 Visible evidence of subterranean termite workings and/or damage was found. Where workings and/or damage was found, it was in but not necessarily limited to the following areas: the ground floor laundry wall frame, kitchen linen cupboard wall frames, balcony beams to the rear and right sides, floor joist to the front left corner of the home and the upper front door area interior and exterior, roof trusses and wall top plates throughout the roof void area of the home.

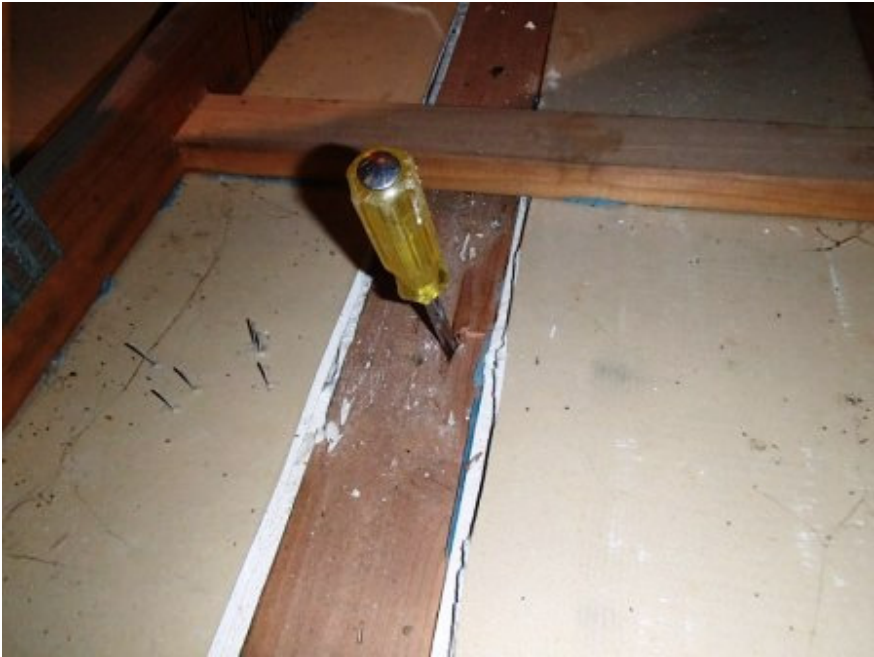
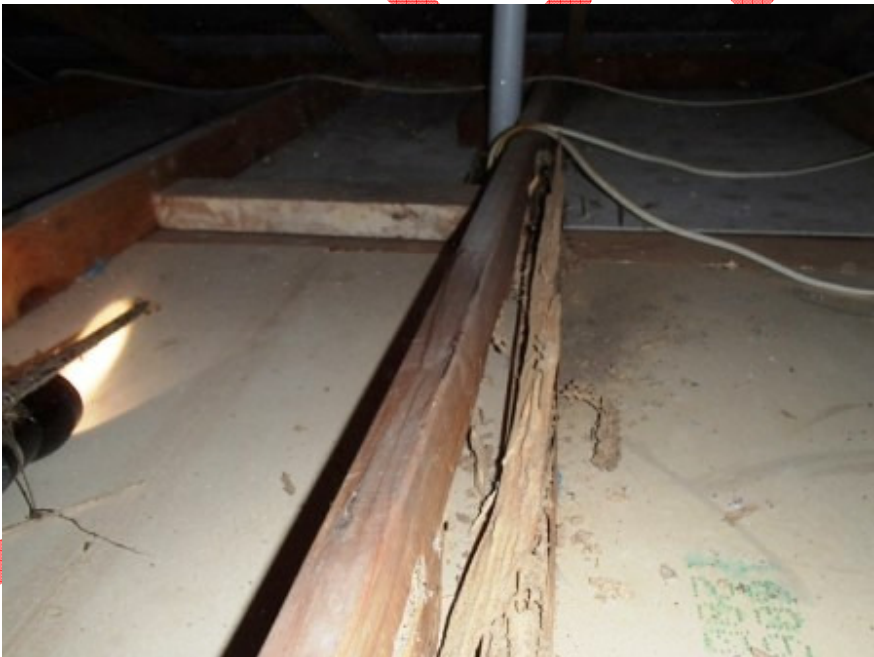
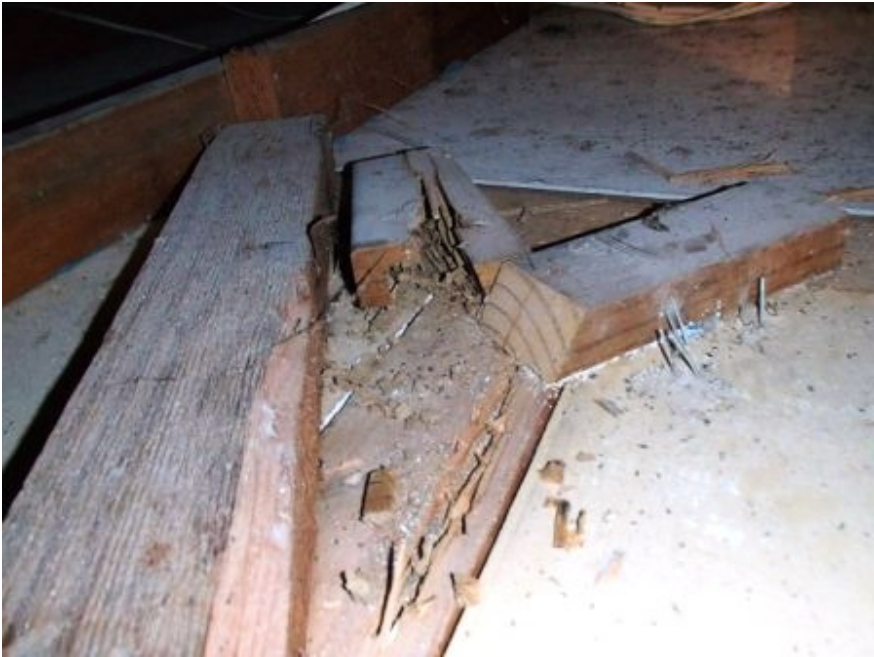
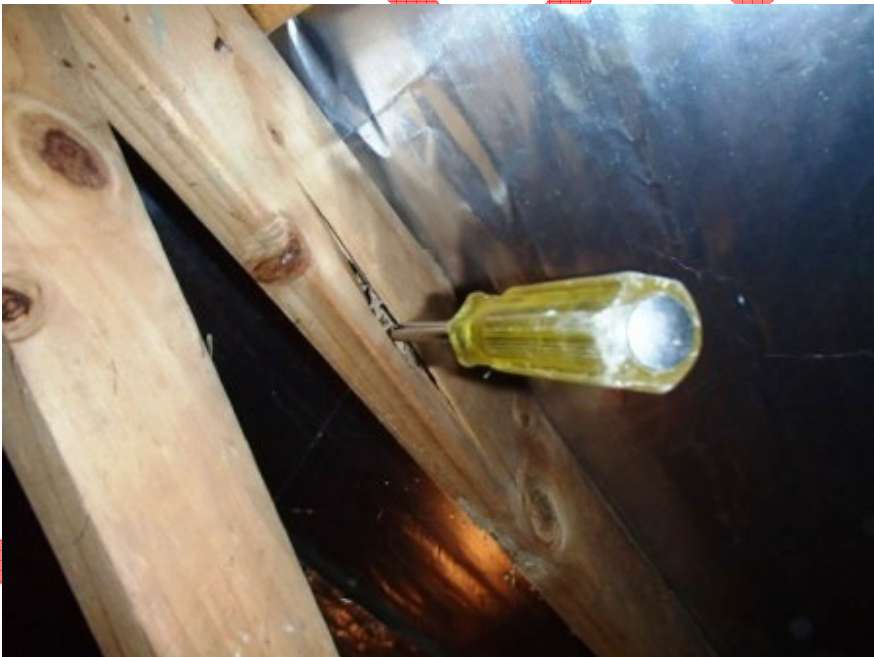
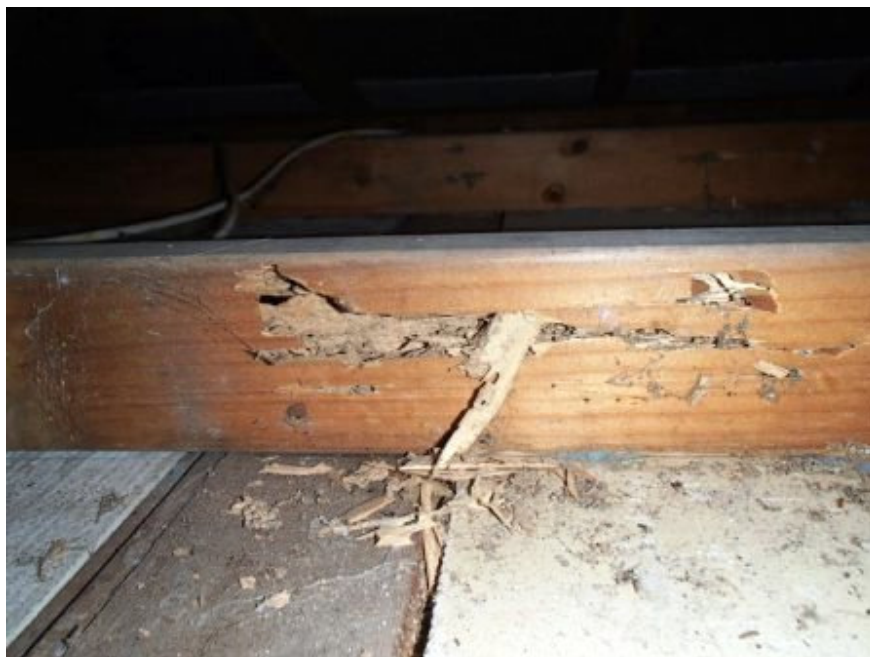
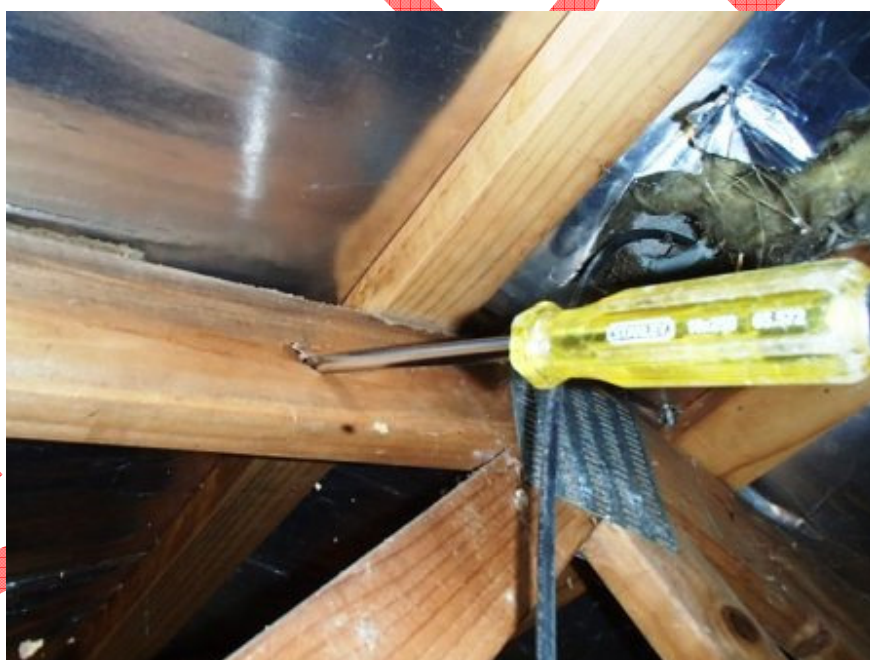
2.5 Where activity or damage is reported above, does it present a major safety hazard? Yes. If the answer is (Yes) the timber pest associated safety hazard is extensive and is located to the balcony timbers, roof void roof trusses and wall framing timbers.

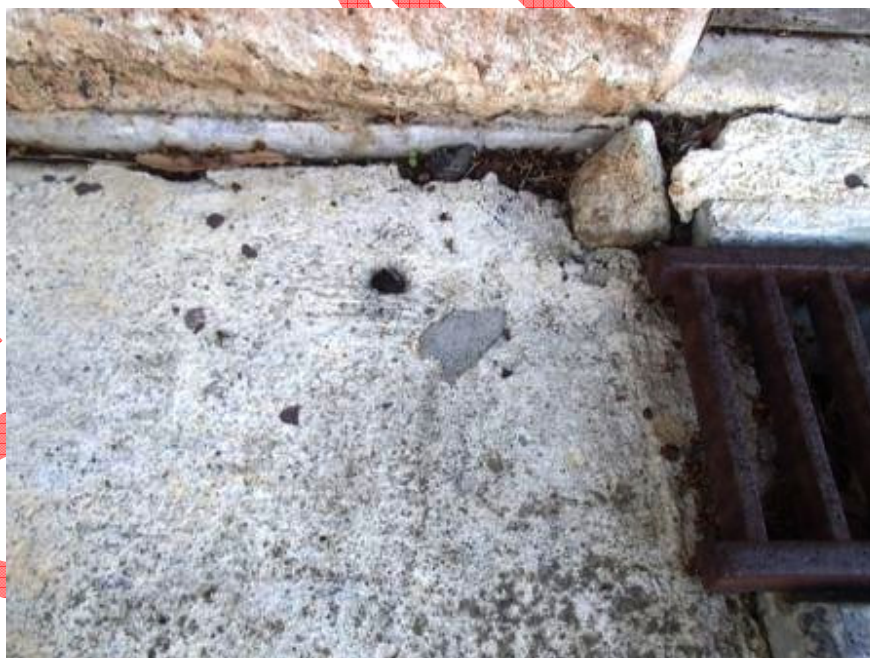
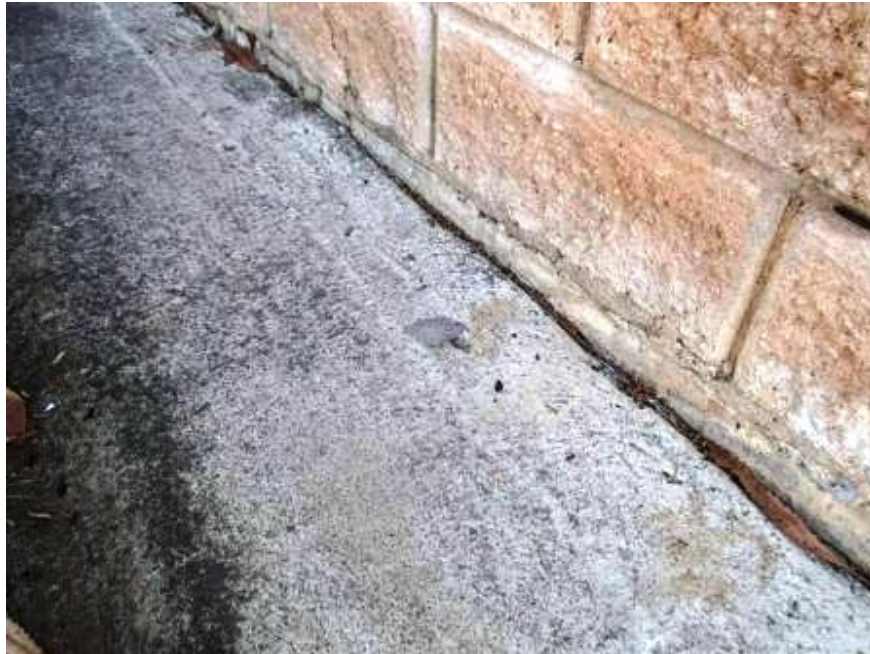
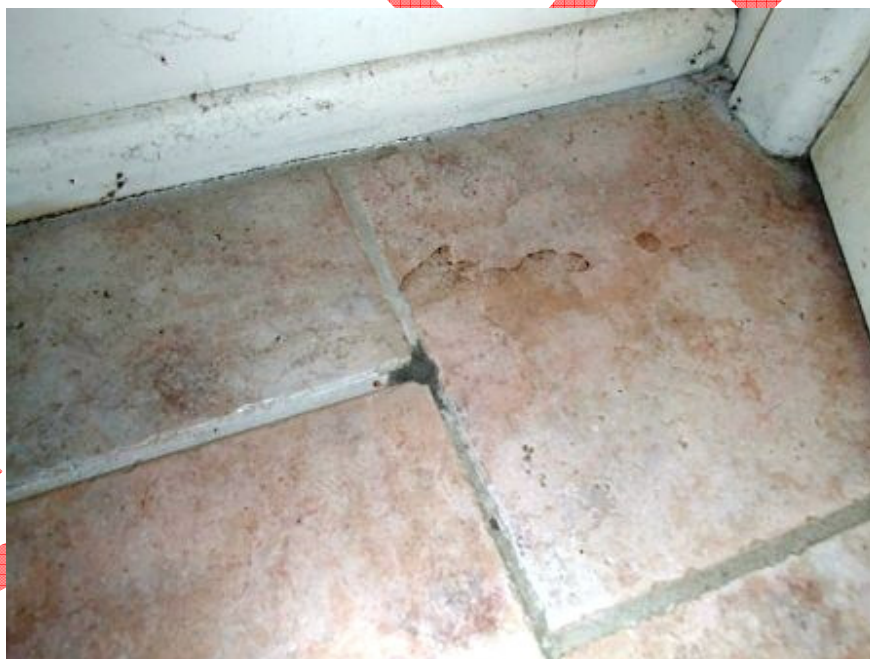
2.6 Drill holes were found that may be evidence of a possible previous termite treatment to the exterior paving and interior ground floor concrete floor.

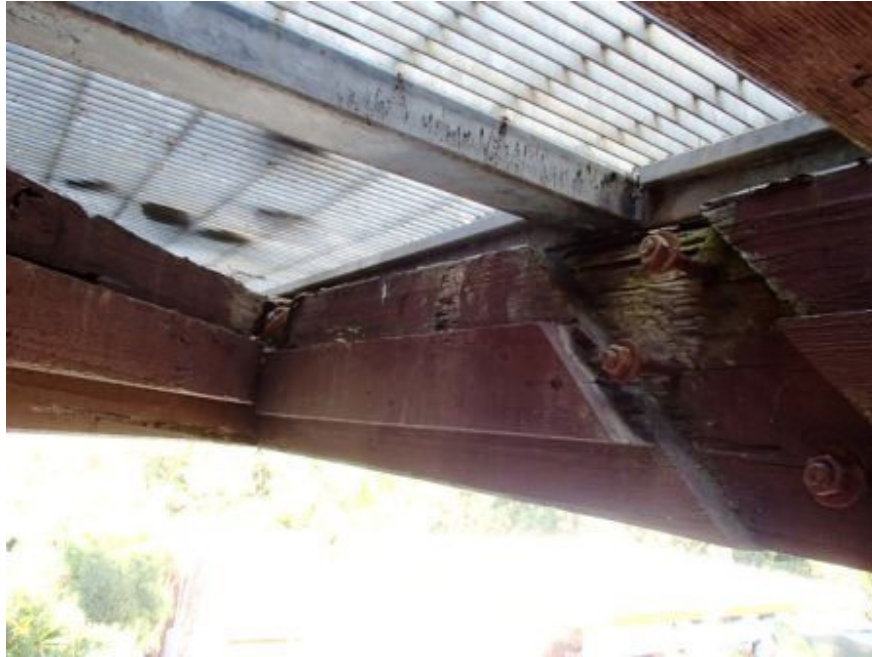
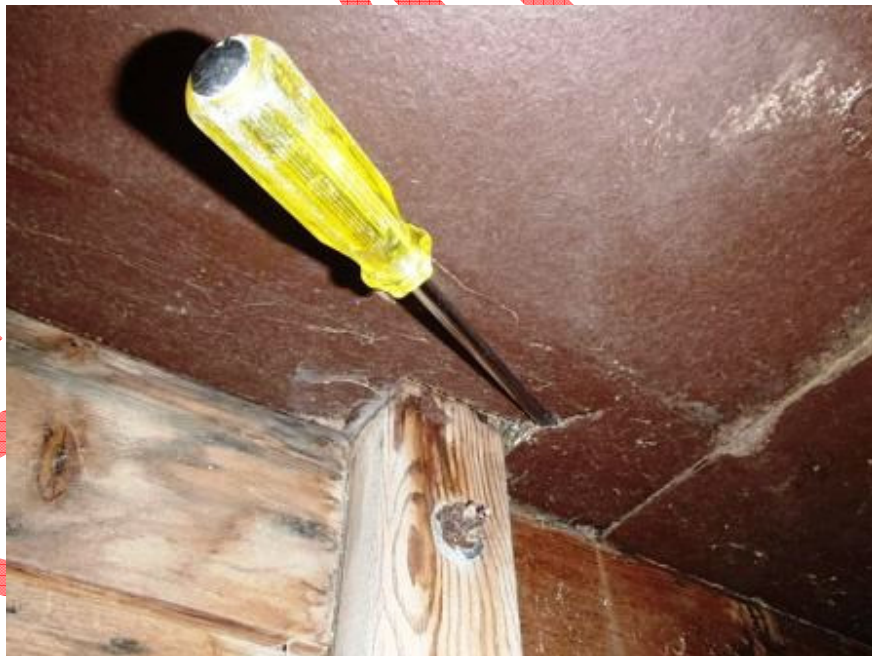
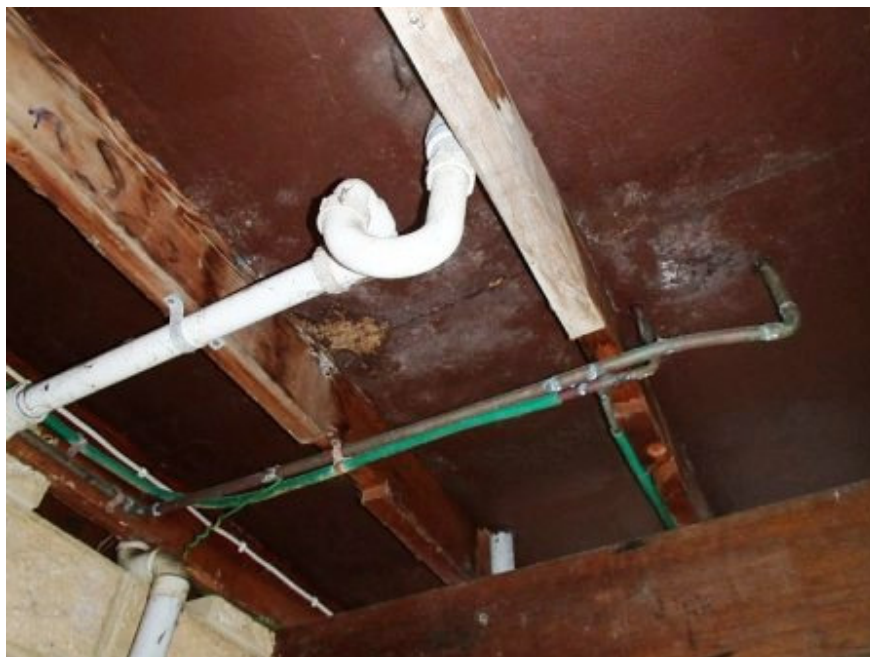
4.1 Was evidence of wood decay fungi (wood rot) found? Yes. to the balcony beams and flooring, bathroom 2 door jamb and kitchen cupboard.

4.2 Where damage is reported above, does its presence represent a major safety hazard? Yes. If the answer is (Yes) the timber pest associated safety hazard is extensive and is located to the balcony beams and flooring.

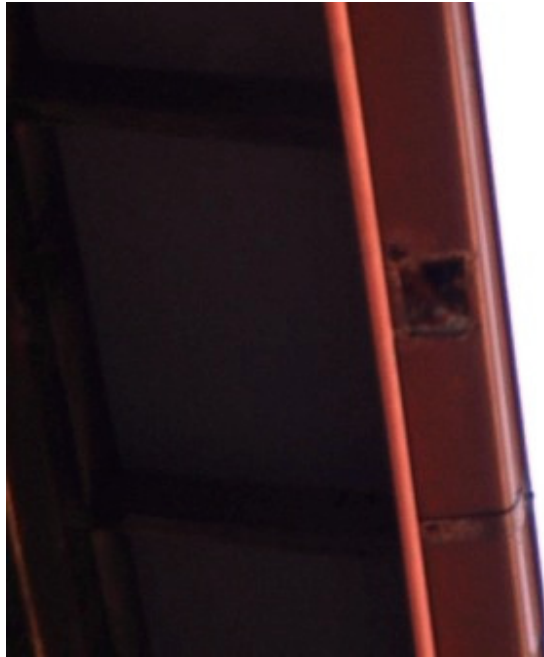
5.1 Water leaks, especially in or into the subfloor or against the external walls e.g. leaking taps, water tanks, leaking roofs or down pipes and or guttering, increases the likelihood of termite attack. Leaking showers or leaks from other 'wet areas' also increase the likelihood of concealed termite attack. These conditions are also conducive to borer activity and wood decay. At the time of the inspection, **leaks were found to be present in the rusted roof gutters.**

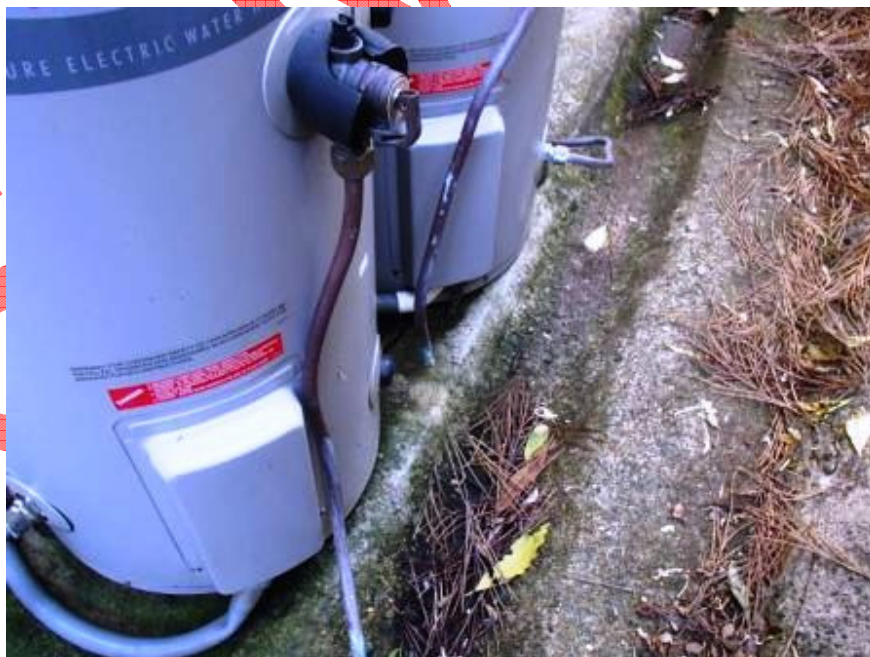
5.2 Hot water services or air conditioning units which release water alongside or near to building walls need to be connected to a drain. If this is not possible then their water outlet needs to be piped several meters away from the building, as the resulting wet area is highly conducive to termites. Is there a need for this work to be carried out? **Yes, to the hot water heater's x 2.**

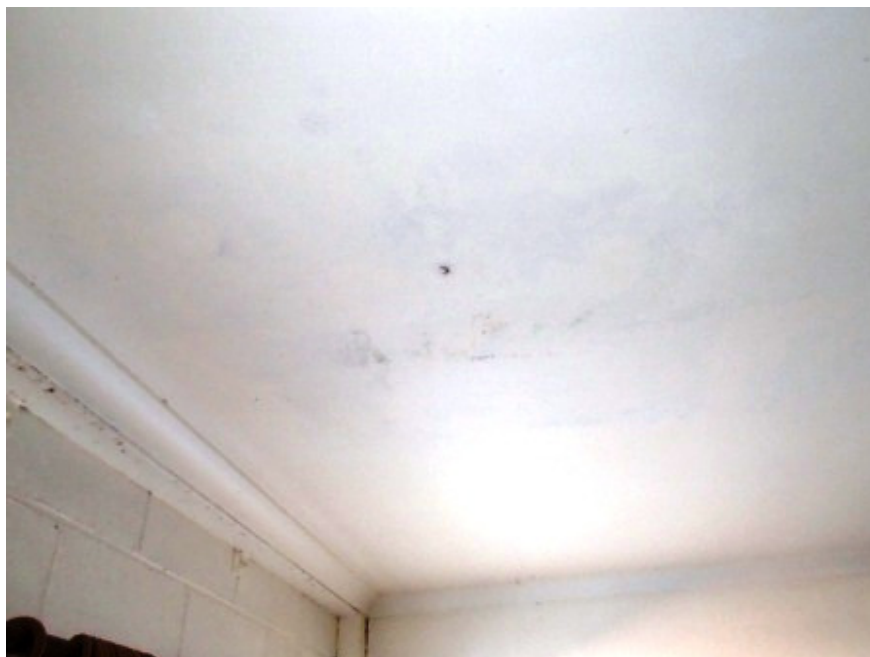
5.8 Mould on walls and ceilings etc; is an indicator of high moisture or very poor ventilation. If reported You need to have the reason investigated by a builder or a Industry Hygienist as its presence may indicate the presence of a water leak, wood decay or termites behind the wall or ceiling sheeting. Mould **was found in the following area(s): the ground floor lounge room ceiling lining.**

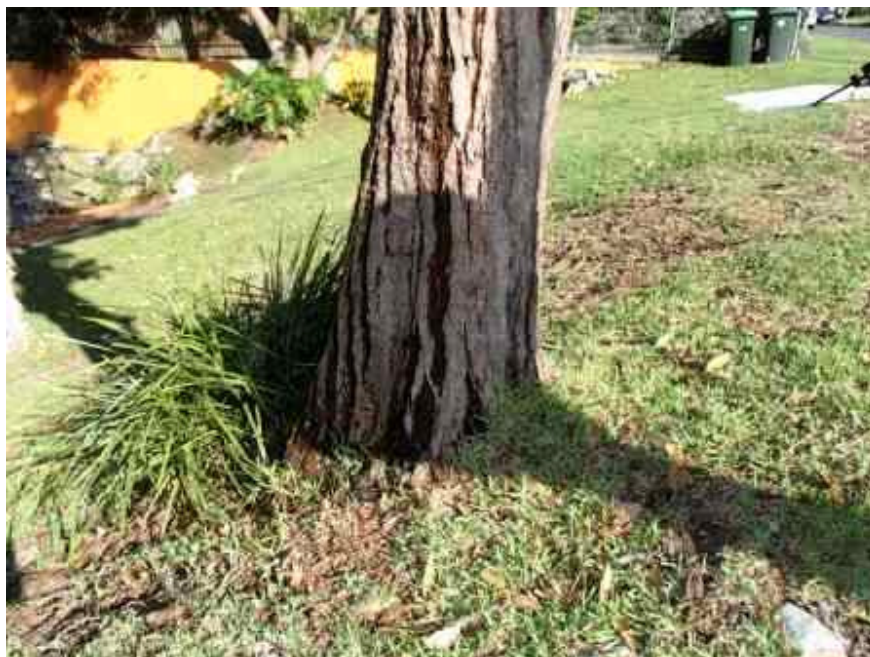
- Access should be provided to the roof void of the home as this area may show signs of timber pest activity.
- Large old growth trees with a girth greater than 100mm diameter are within 50 metres of the dwelling. It is very difficult, and generally impossible to locate termite nests since they are underground and evidence in trees is usually well concealed. We therefore strongly recommend that you arrange to have trees test drilled for evidence of termite nests.
