Residential Building Report

Pre-Purchase Inspection - Residential Building Report- (Except ACT)

Complies with Australian Standard AS 4349.1- 2007 Inspection of Buildings Part 1: Pre-Purchase inspections – Residential buildings – Appendix “C”

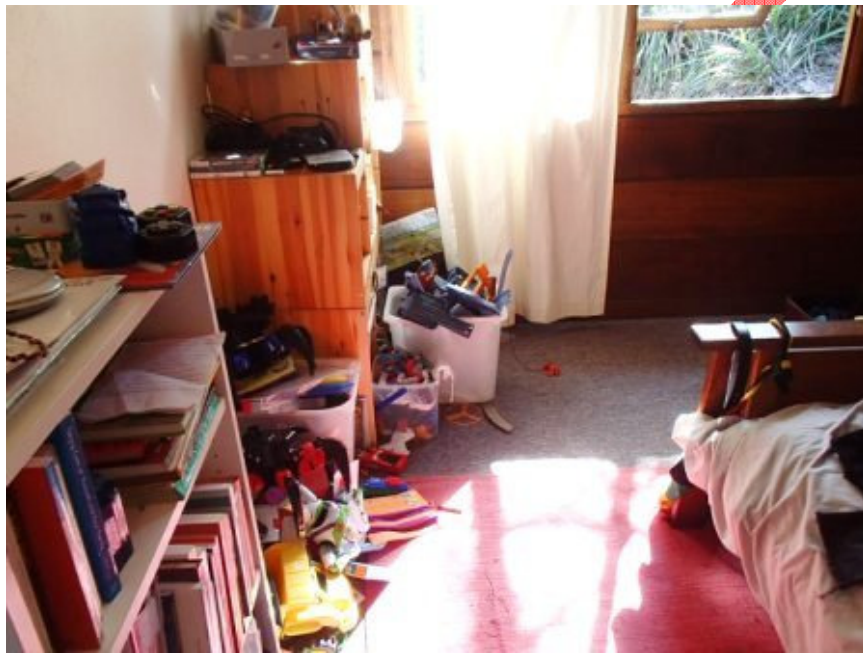
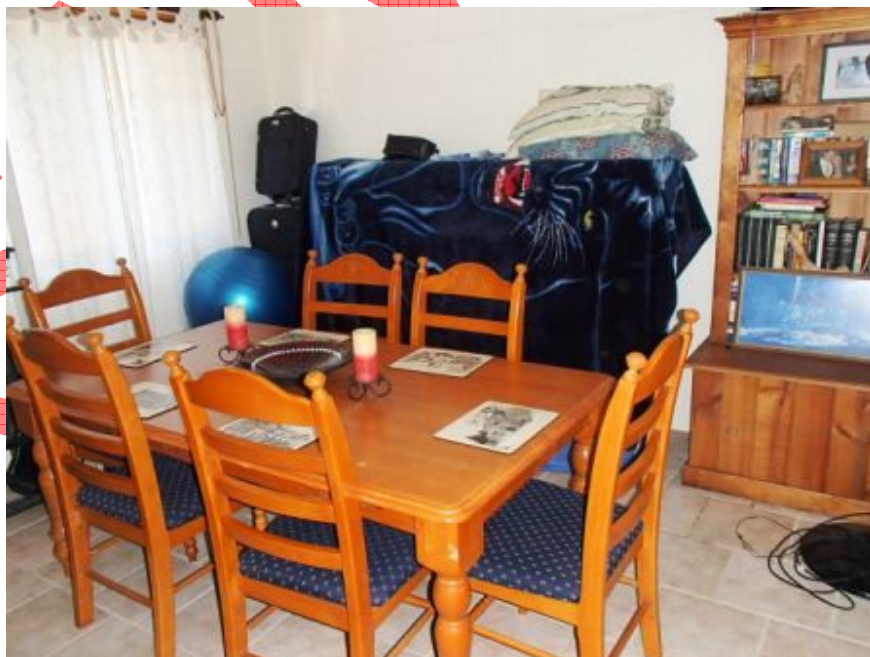
- **Interior due to stored goods, furniture and floor coverings**

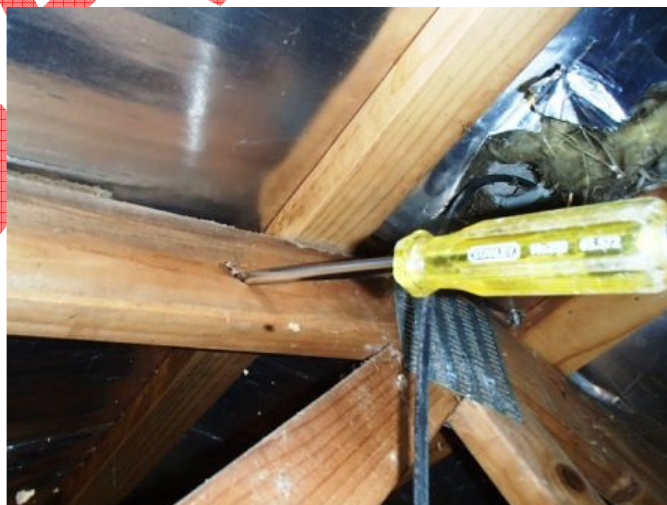
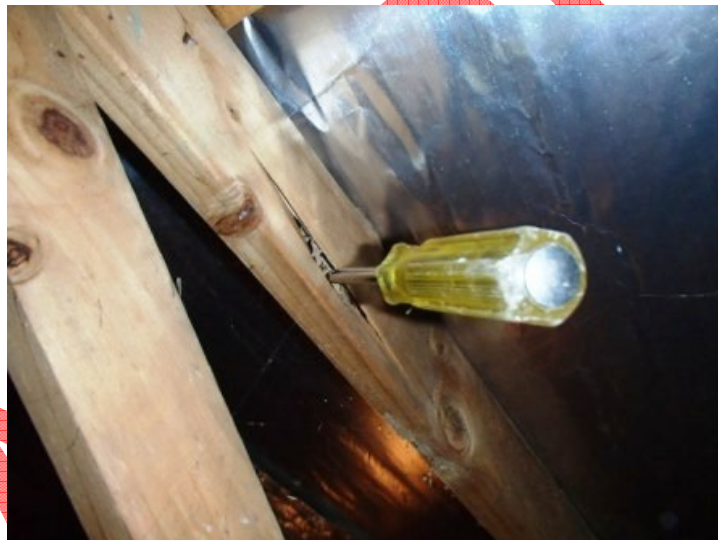
- Possible termite damage to the wall and floor framing timber due to termite mudding to the ground and 1st floor walls, floor beams, roof trusses and wall top plates in the roof void

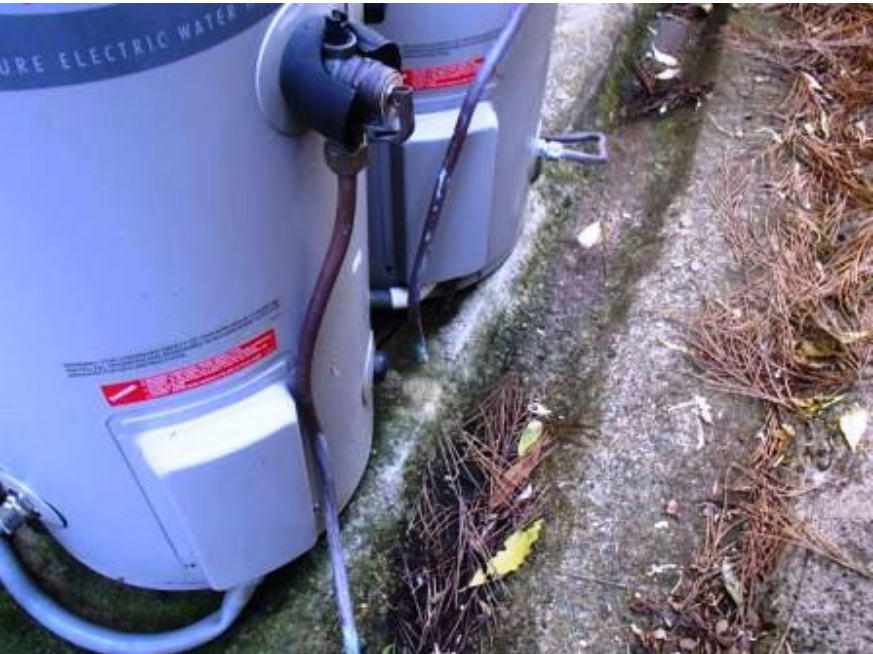
A plumber should be sought to connect the hot water heater overflow pipe to the stormwater drainage system.

Seek a plumber

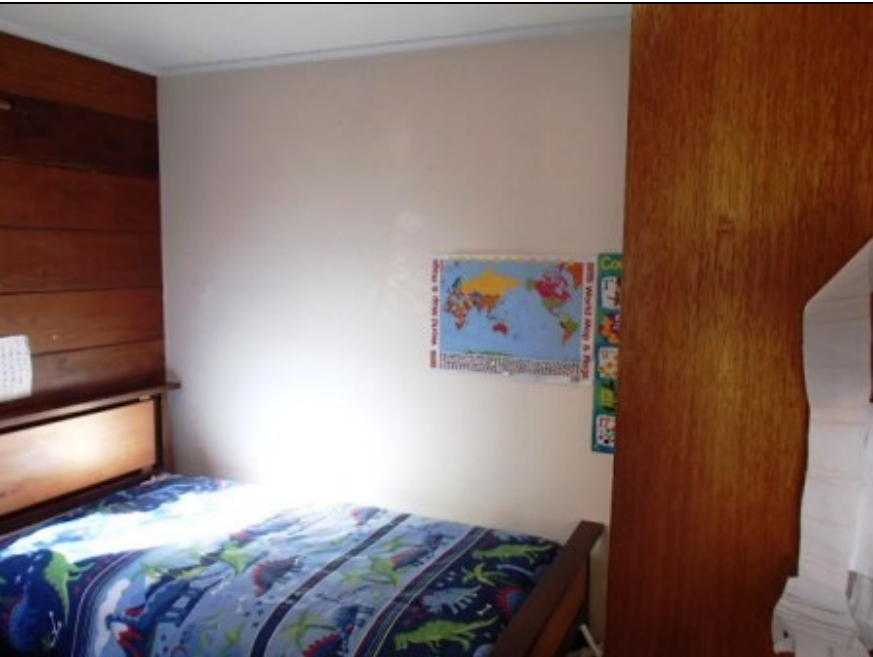
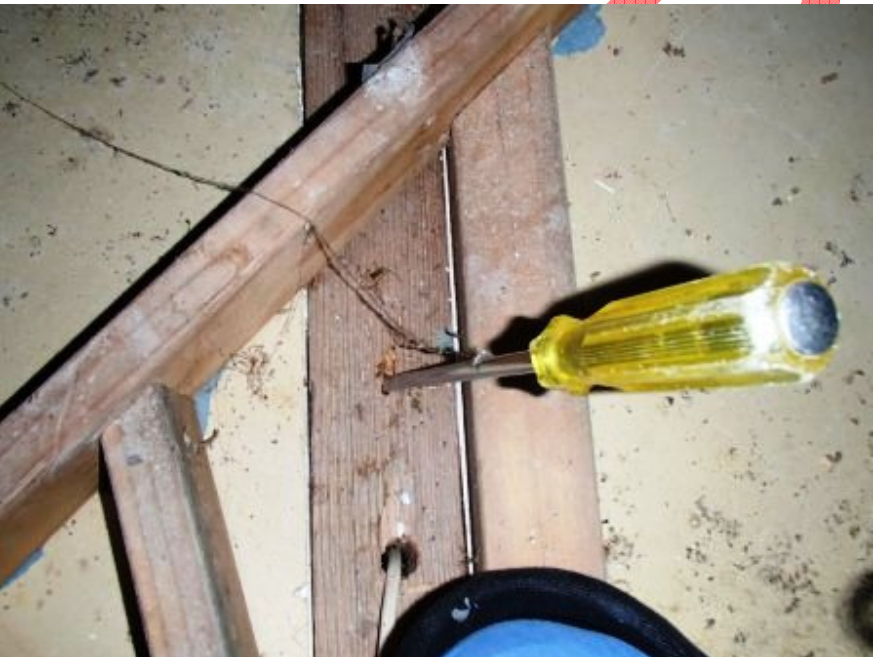
<p>An invasive inspection should be carried out as concealed termite damage to the wall and floor framing timbers is highly likely due to termite mudding and damage to the ground and 1st floor.. Without the removal of wall linings, it is not possible to determine the extent or existence of termite damage. A builder should be contracted by the purchaser or vendor to undertake the removal of the wall lining, subject to the vendor's approval in writing.</p>  	Discuss with the inspector

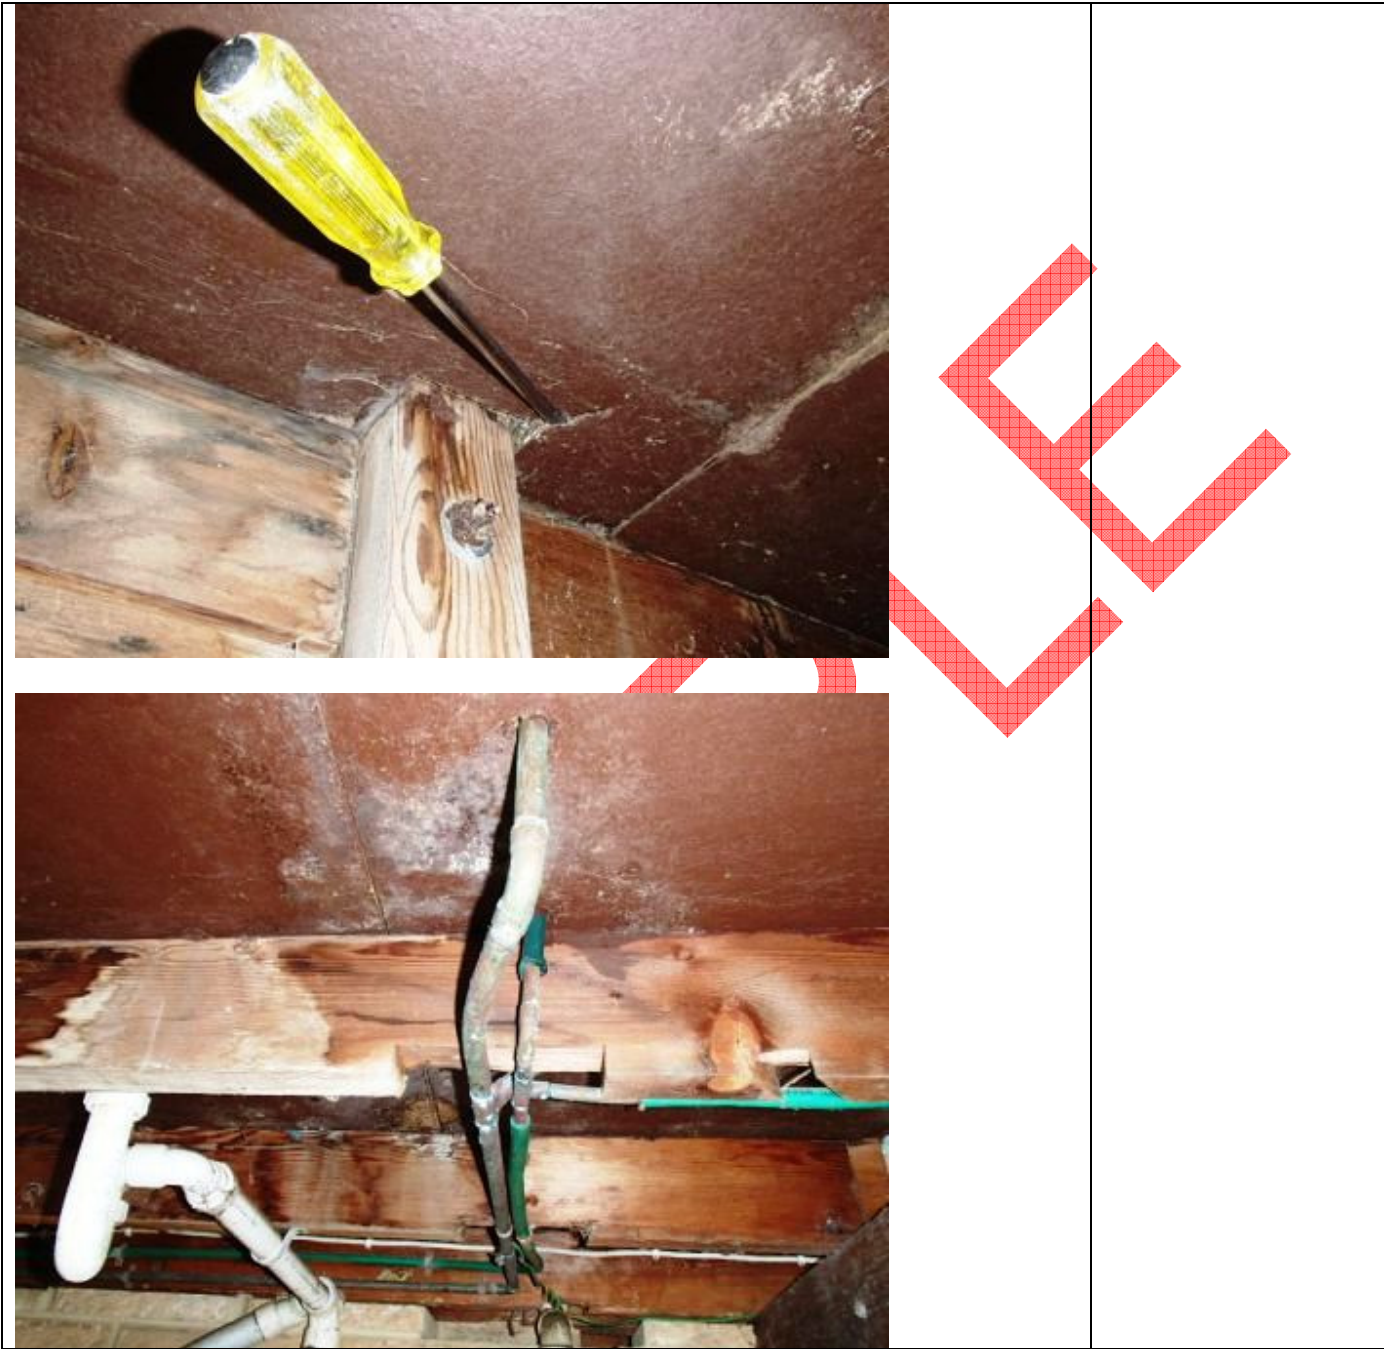
<p>\$2,000.00</p>
<p>Fungal decay was identified in the right side balcony although its extent and significance could not be determined. A timber specialist or engineer needs to be instructed to advise on the full extent of the problem, including any remedial work and potential safety issues.</p>	<p>Seek a structural engineer</p>
<p>Replace the water damaged flooring below the 1st floor bathroom / laundry area of the home, this damage is due to a past leak.</p>	<p>\$6,000.00</p>

Two verandah/balcony of timber construction are provided to the right side and rear of the property, "A timber specialist or engineer needs to be instructed to advise on any decay between the decking and frame and full extent of any problem, including any remedial work and potential safety issues."
