Residential Pest Report

Visual Timber Pest Inspection & Report in accordance with AS 4349.3 – 2010
(For use in all States & Northern Territory but not the Australian Capital Territory)

DWELLING

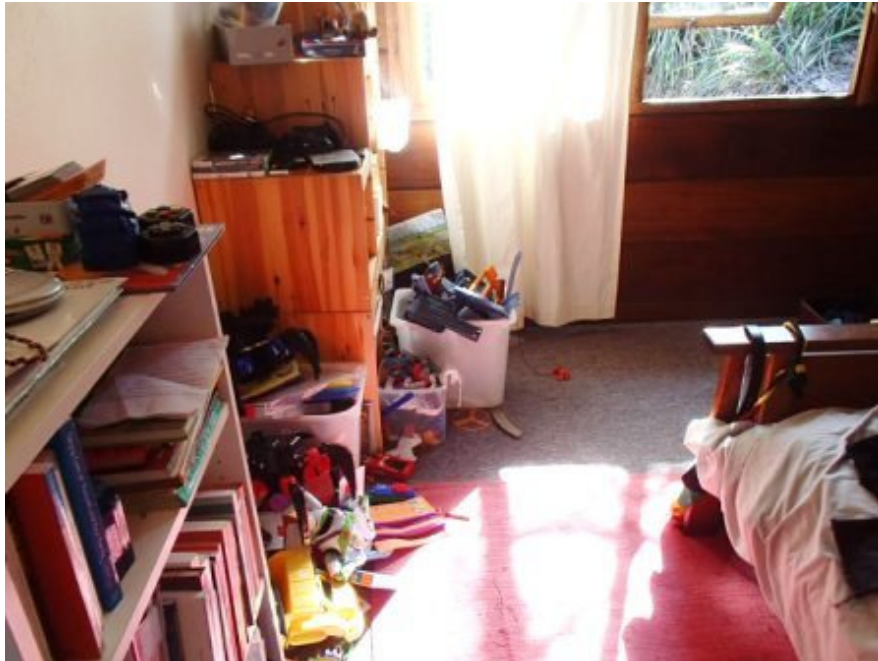
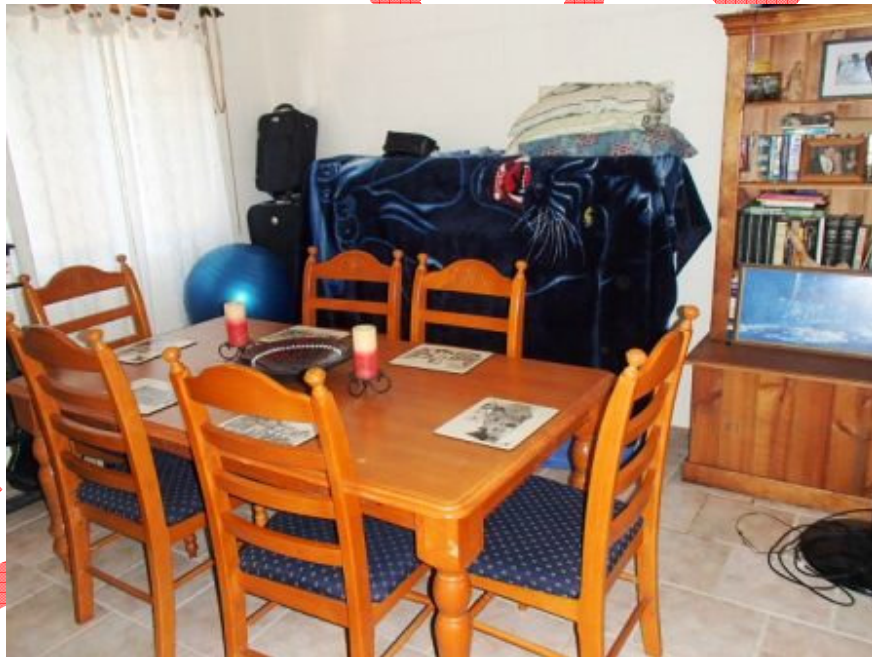
- Interior due to stored goods, furniture and floor coverings

- Sections of the exterior due to foliage, hot water heater and stored goods

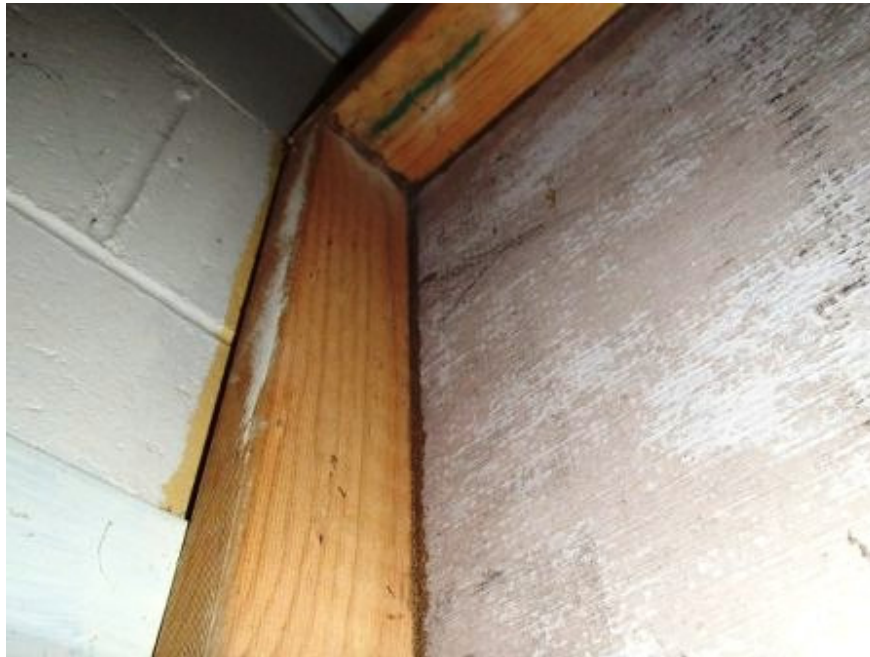
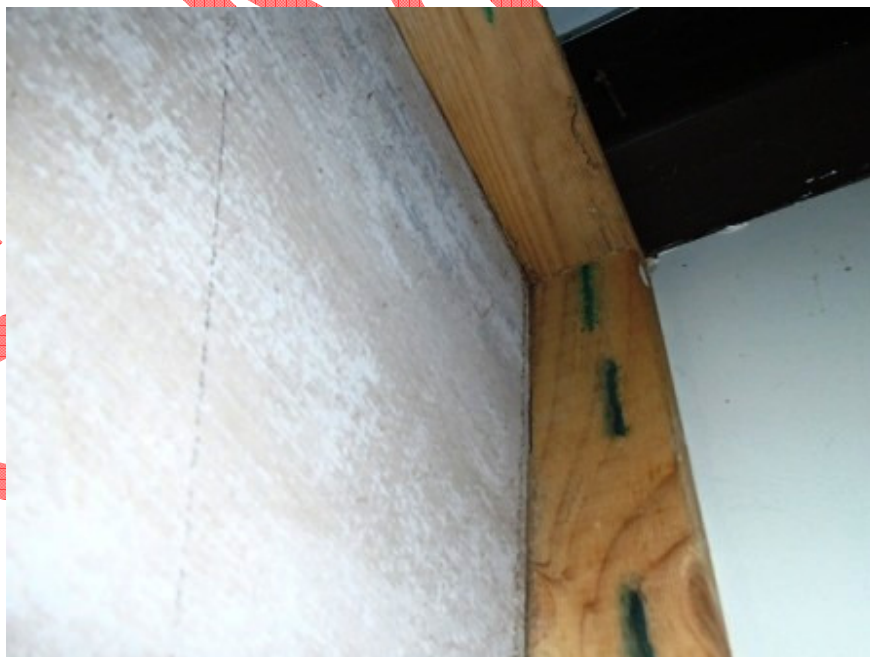
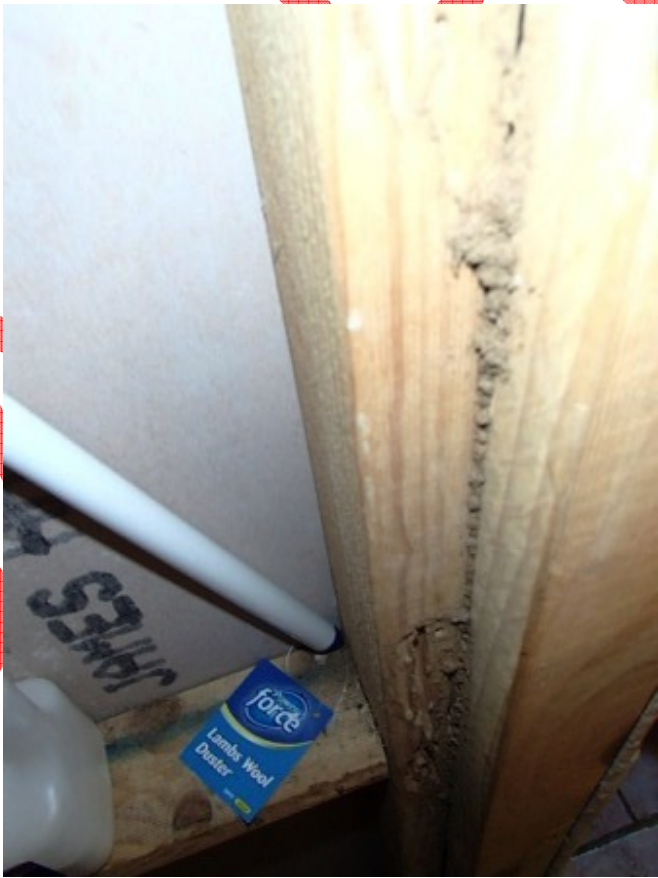
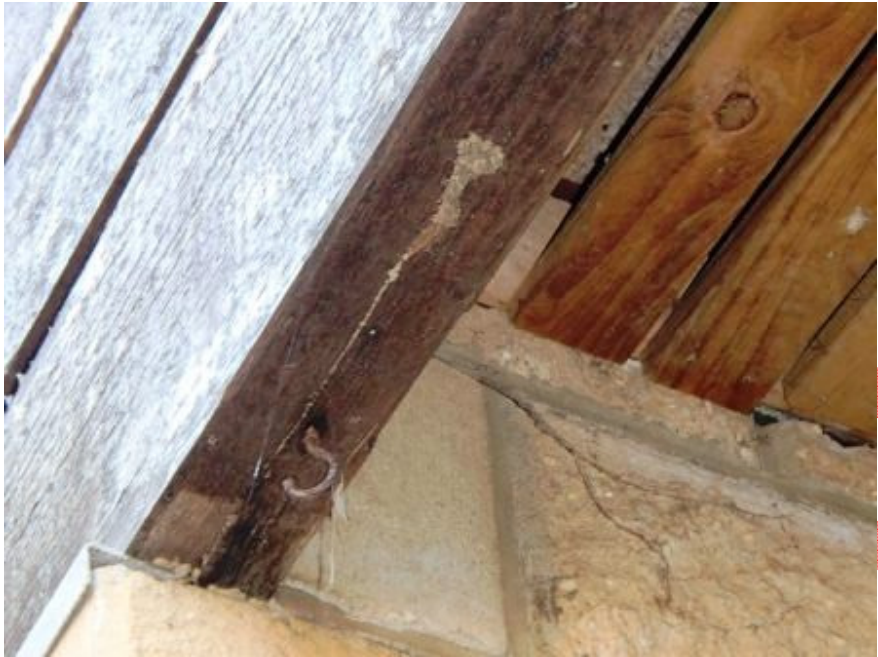
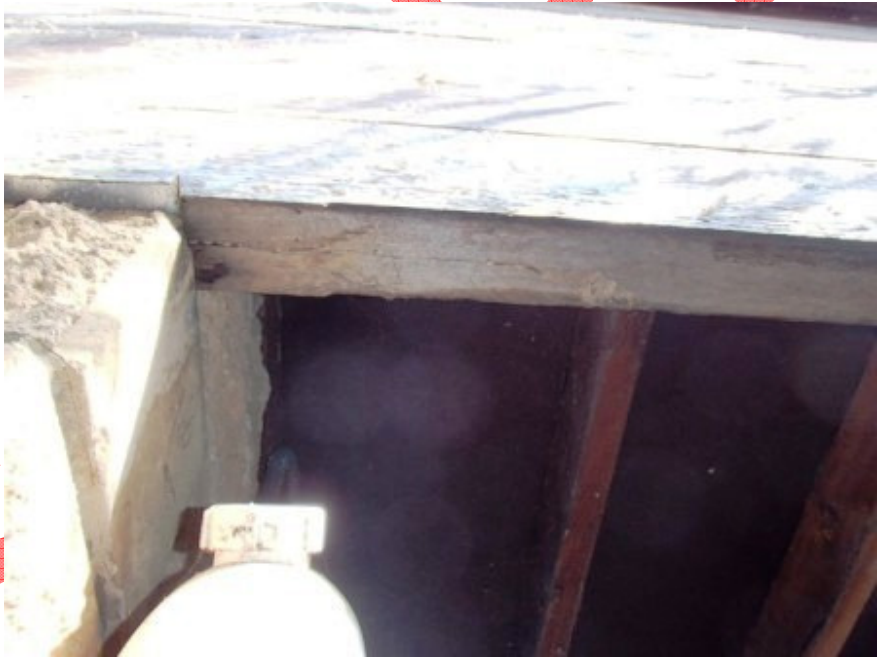
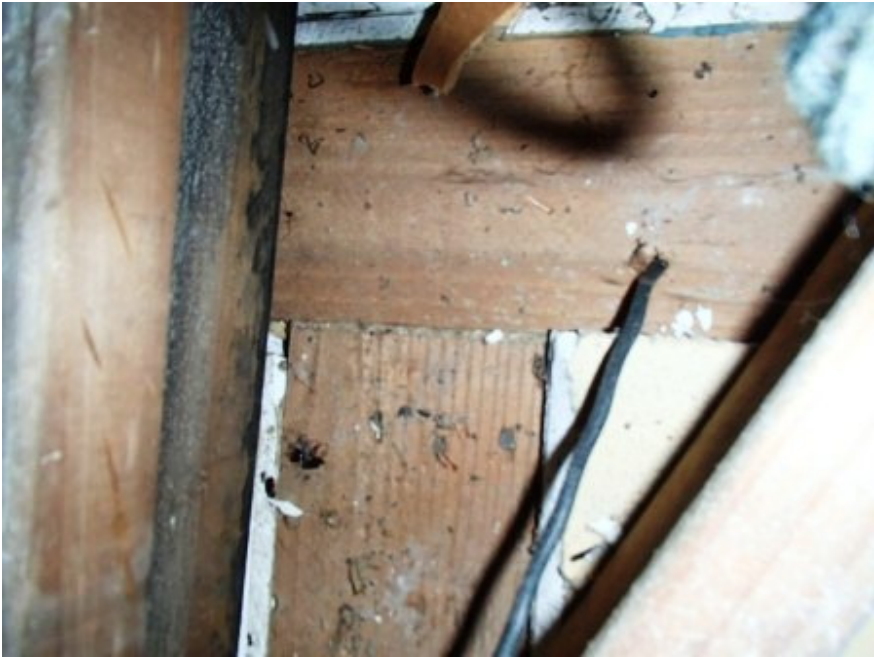
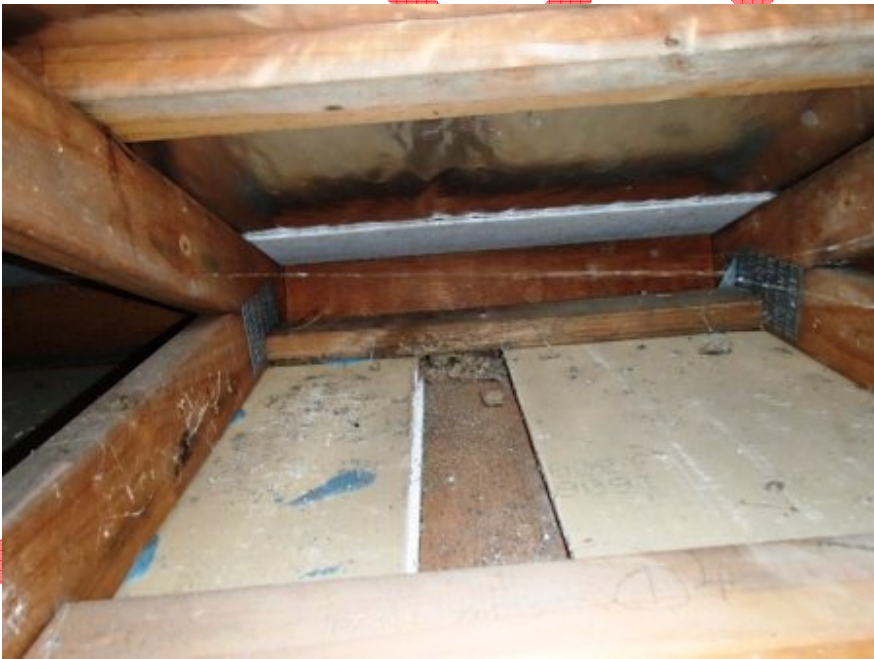
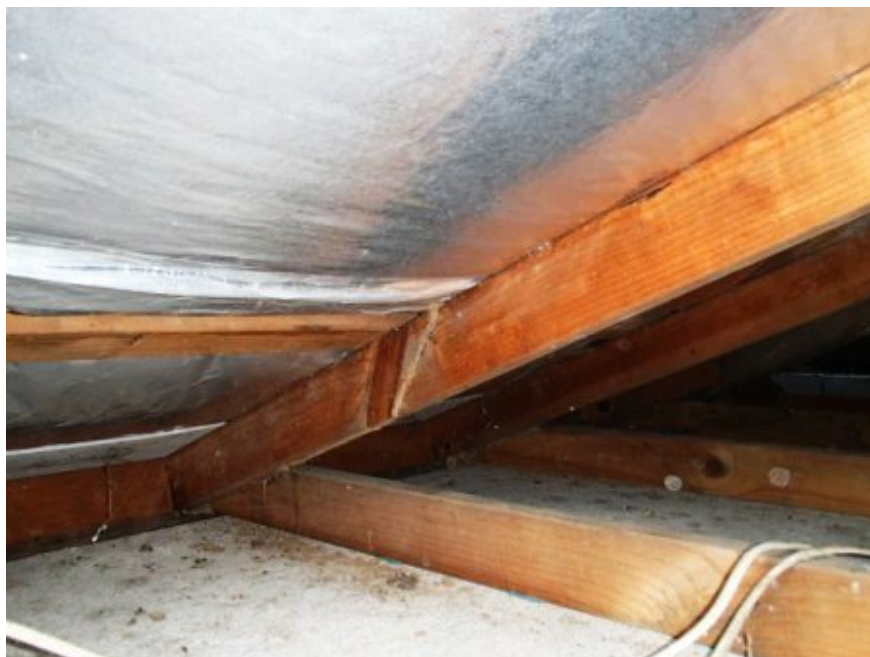
2.3 Visible evidence of subterranean termite workings and/or damage was found. Where workings and/or damage was found, it was in but not necessarily limited to the following areas: the ground floor laundry wall frame, kitchen linen cupboard wall frames, balcony beams to the rear and right sides, floor joist to the front left corner of the home and the upper front door area interior and exterior, roof trusses and wall top plates throughout the roof void area of the home.

2.4 Was any evidence of timber damage visible? Yes.

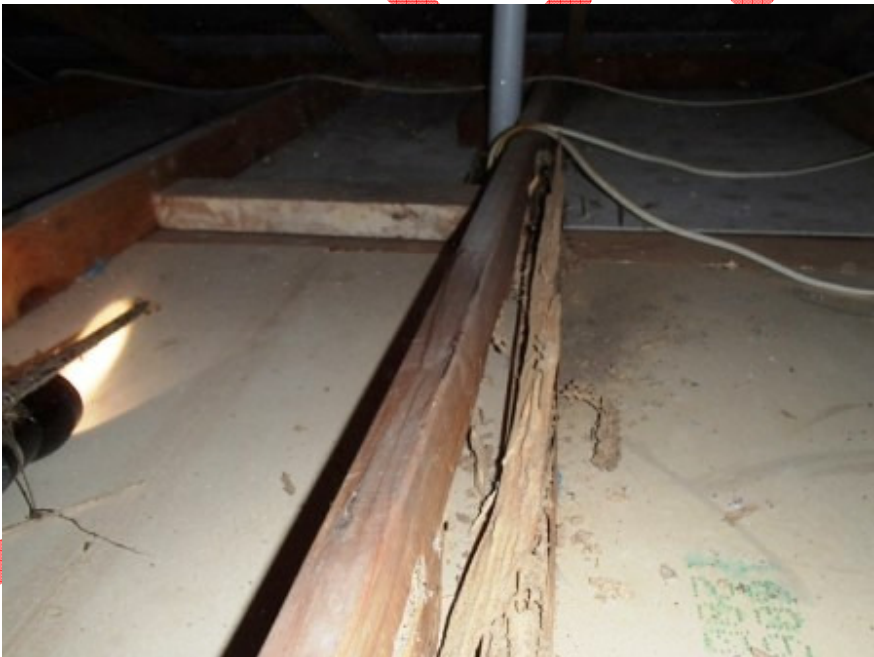
2.5 Where activity or damage is reported above, does it present a major safety hazard? Yes. If the answer is (Yes) the timber pest associated safety hazard is extensive and is located to the balcony timbers, roof void roof trusses and wall framing timbers.

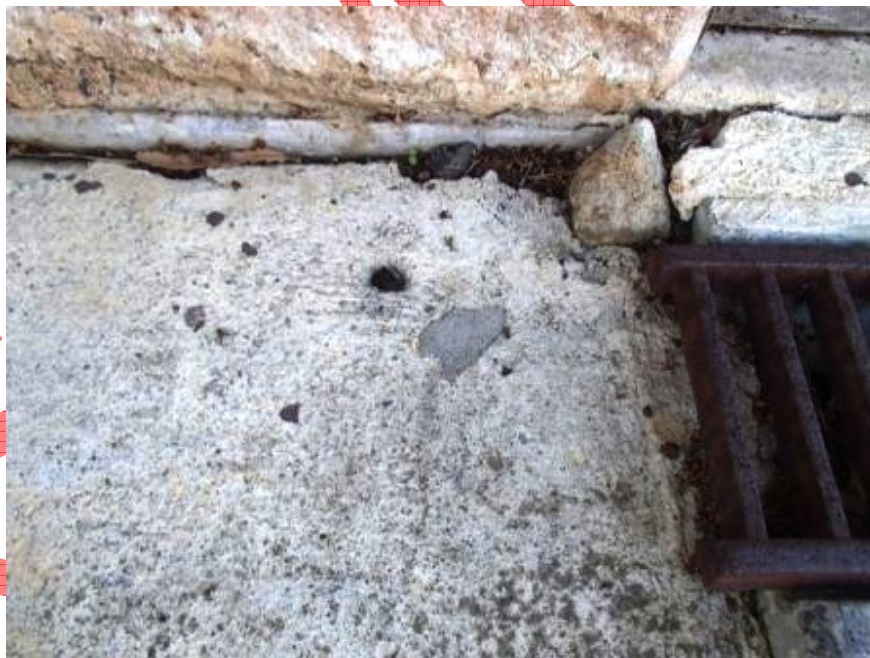
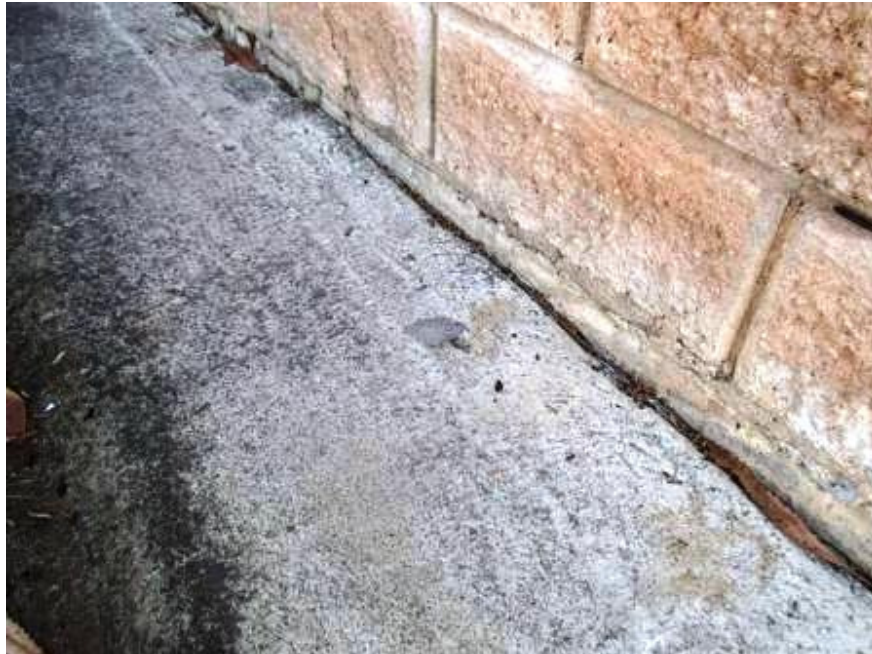
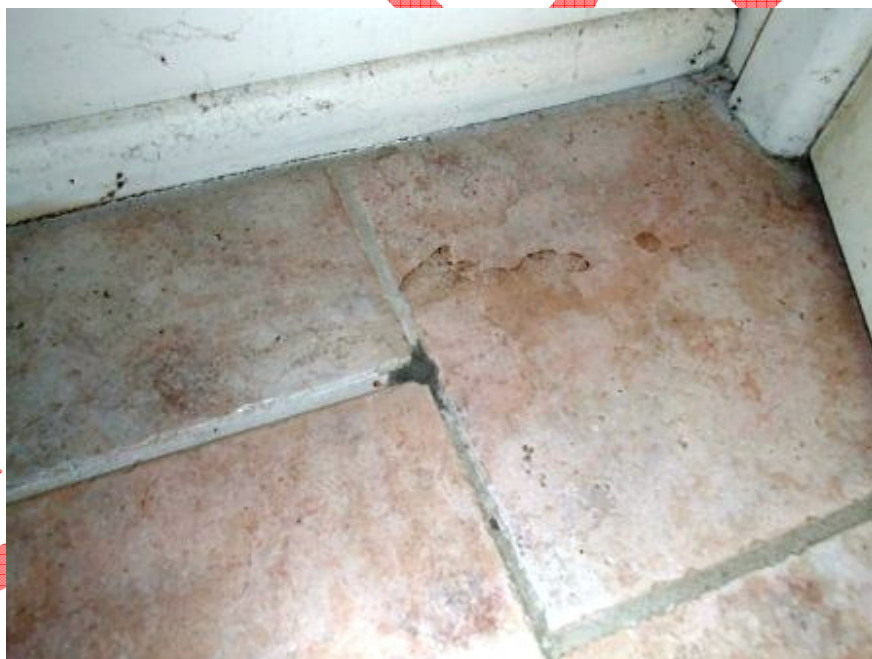
2.6 Drill holes were found that may be evidence of a possible previous termite treatment to the exterior paving and interior ground floor concrete floor.

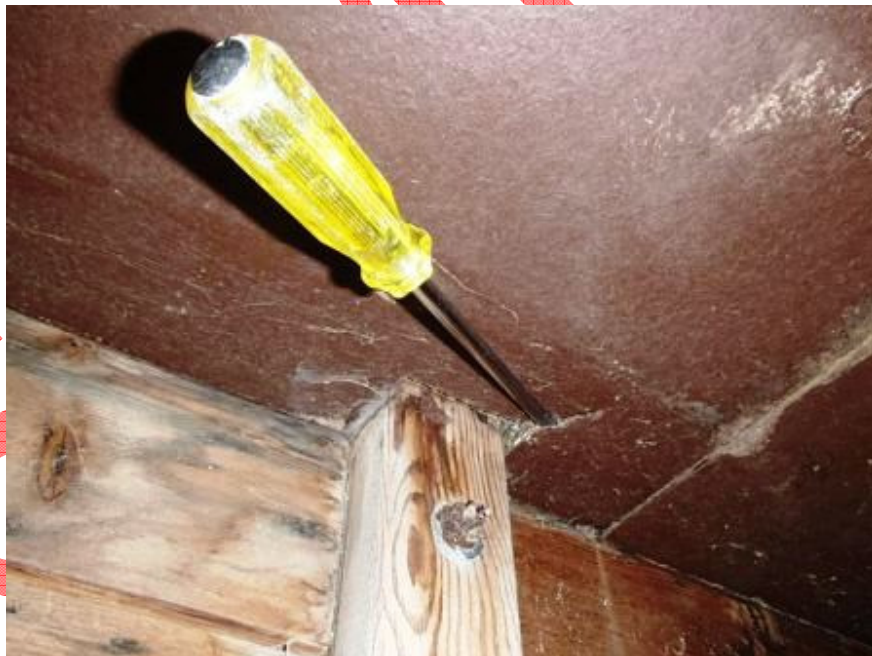
4.1 Was evidence of wood decay fungi (wood rot) found? Yes. to the balcony beams and flooring, bathroom 2 door jamb and kitchen cupboard.

4.2 Where damage is reported above, does its presence represent a major safety hazard? Yes. If the answer is (Yes) the timber pest associated safety hazard is extensive and is located to the balcony beams and flooring.

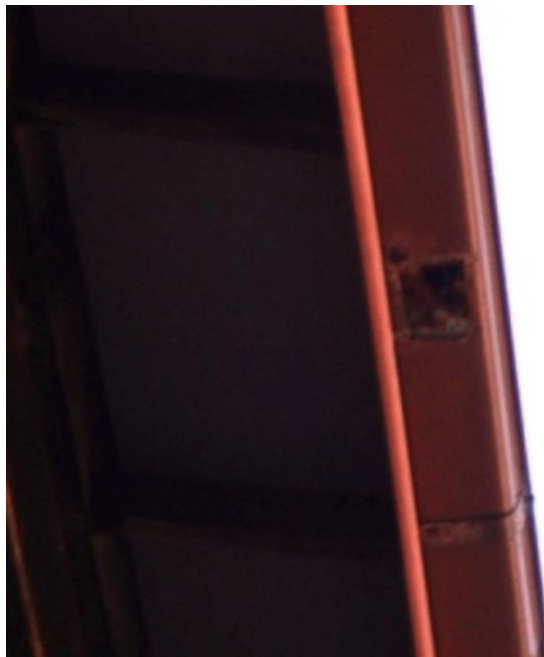
5.1 Water leaks, especially in or into the subfloor or against the external walls e.g. leaking taps, water tanks, leaking roofs or down pipes and or guttering, increases the likelihood of termite attack. Leaking showers or leaks from other 'wet areas' also increase the likelihood of concealed termite attack. These conditions are also conducive to borer activity and wood decay. At the time of the inspection, **leaks were found to be present in the rusted roof gutters.**

We claim no expertise in building and if any leaks were reported then you must have a plumber or other building expert determine the full extent of damage and the estimated cost of repairs.

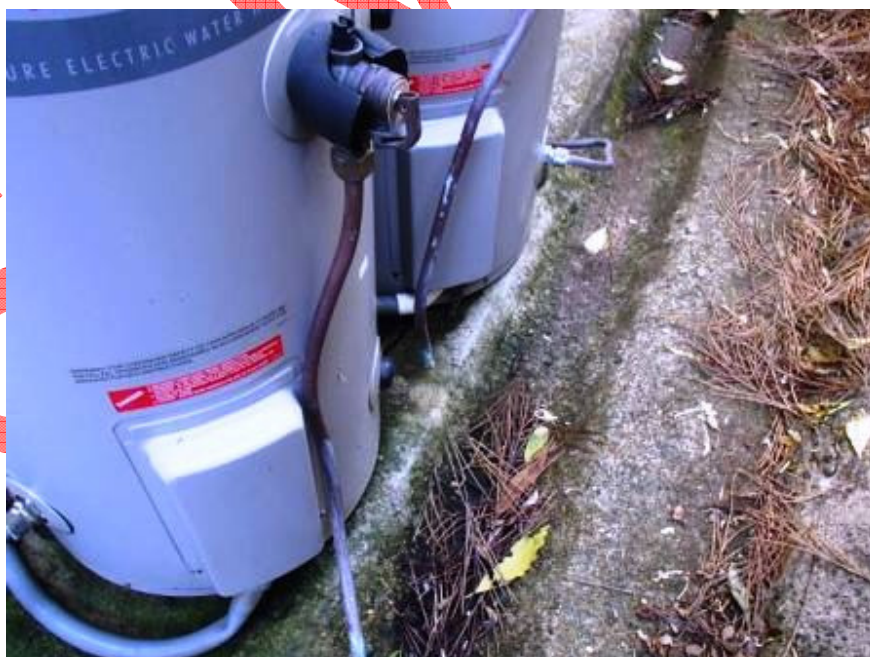
5.2 Hot water services or air conditioning units which release water alongside or near to building walls need to be connected to a drain. If this is not possible then their water outlet needs to be piped several meters away from the building, as the resulting wet area is highly conducive to termites. Is there a need for this work to be carried out? **Yes, to the hot water heater's x 2.**
