## **Visual Termite Inspection Report in accordance with AS 3660.2-2000**

## Visual Termite Inspection Report in accordance with AS 3660.2-2000

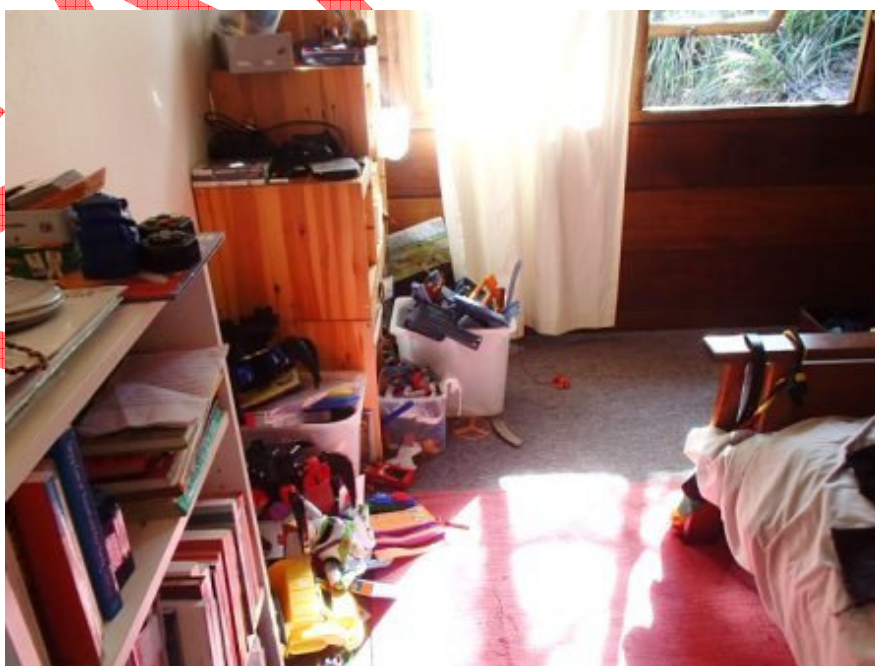
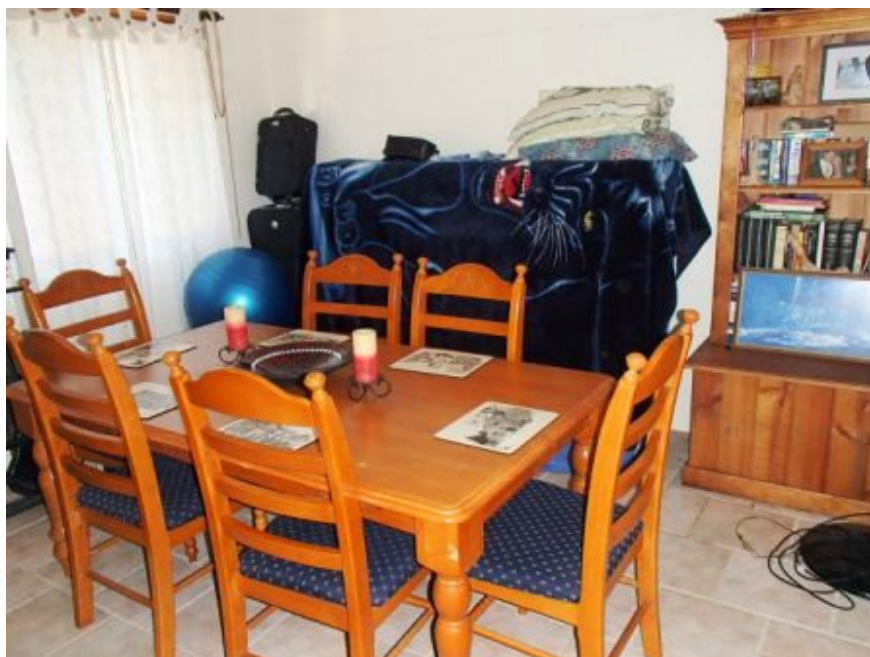
- Interior due to stored goods, furniture and floor coverings

- Sections of the exterior due to foliage, hot water heater and stored goods

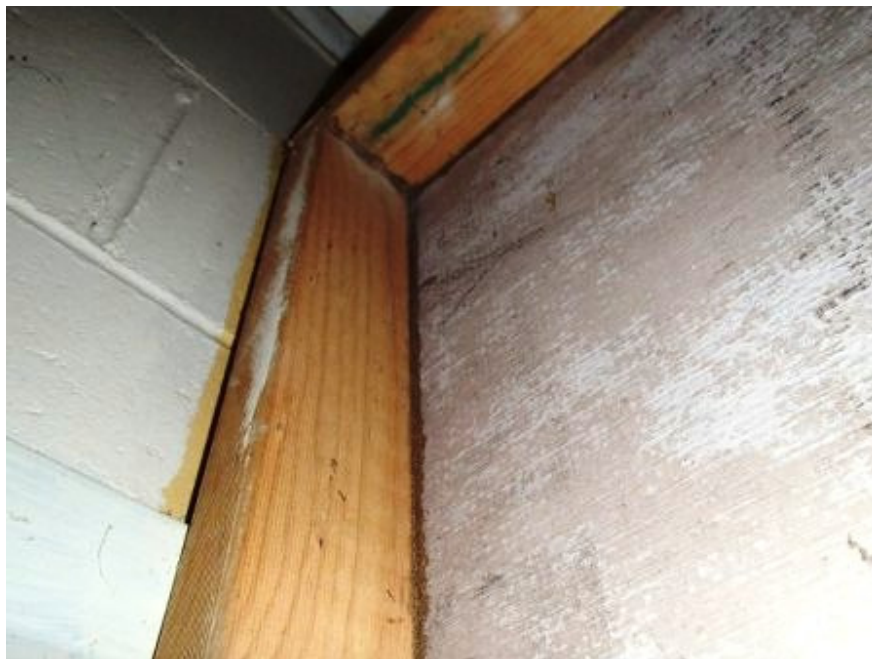
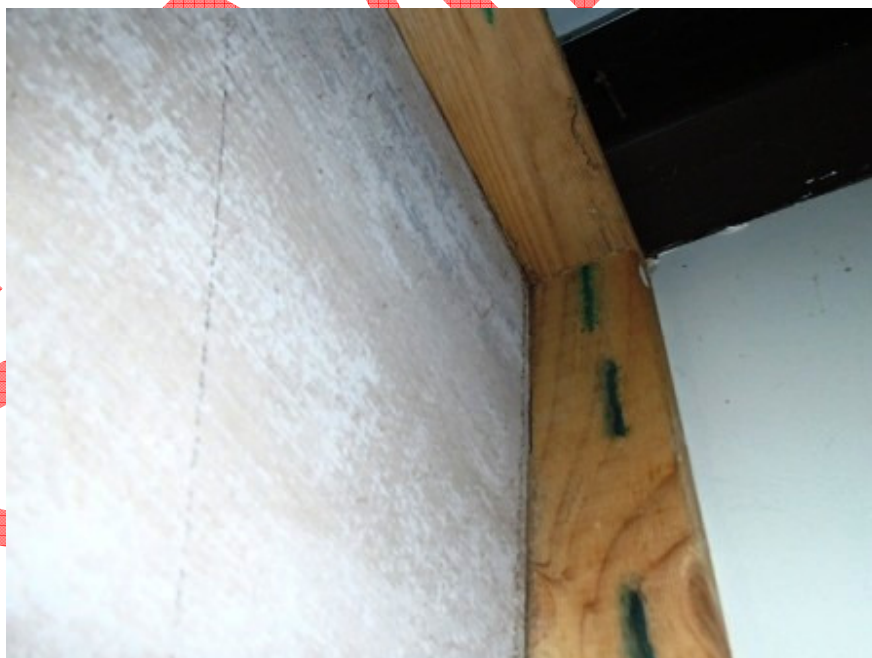
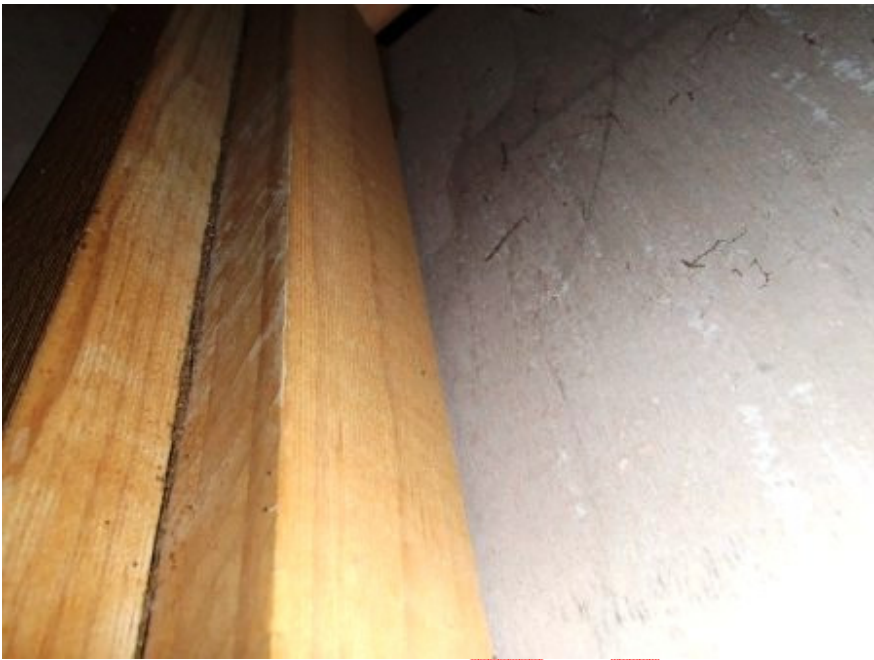
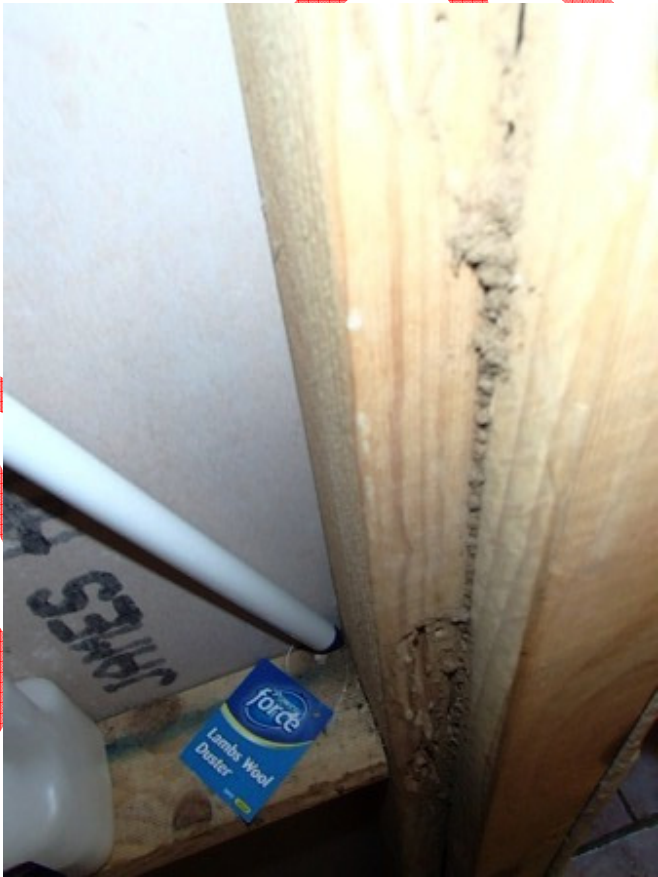
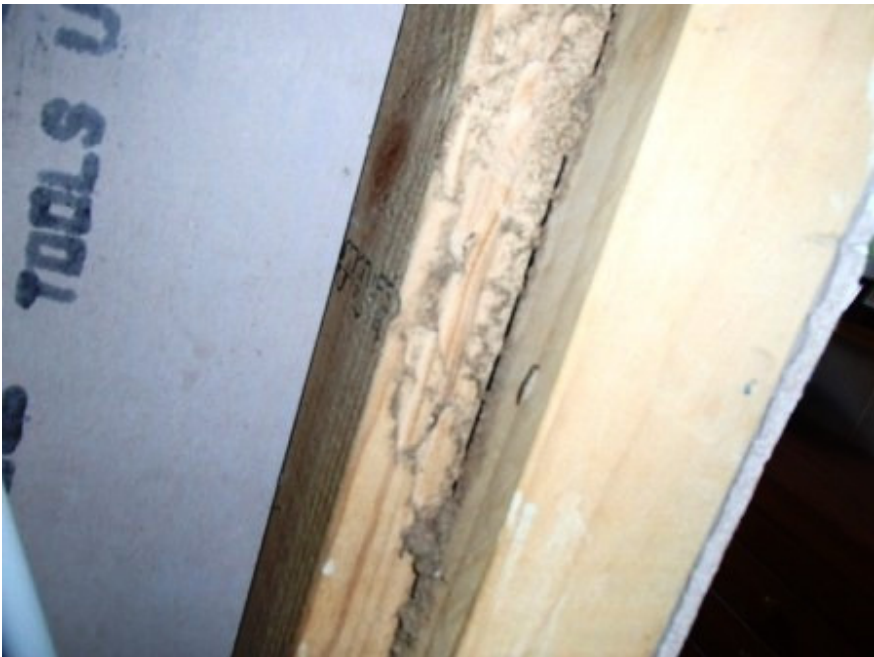
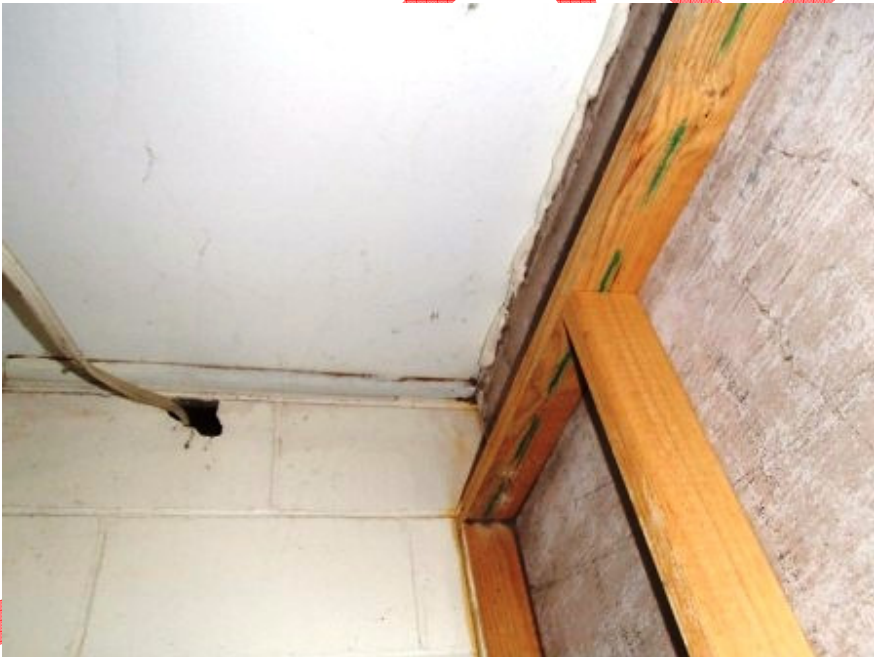
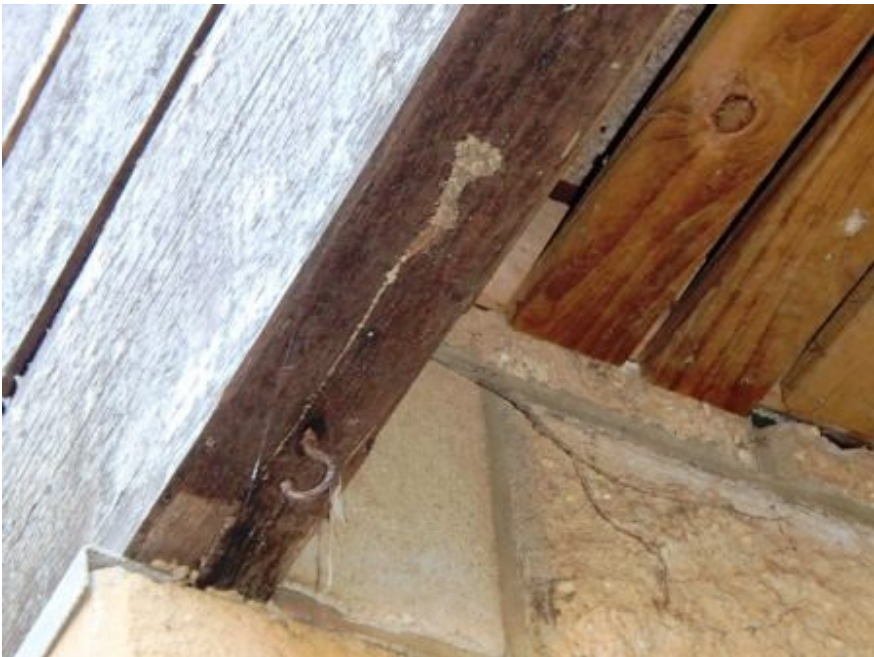
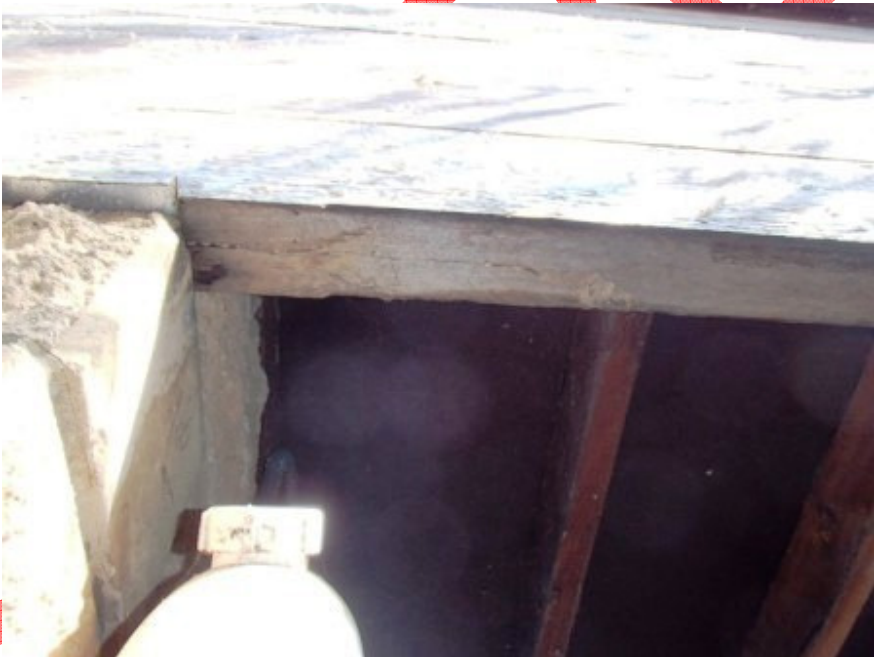
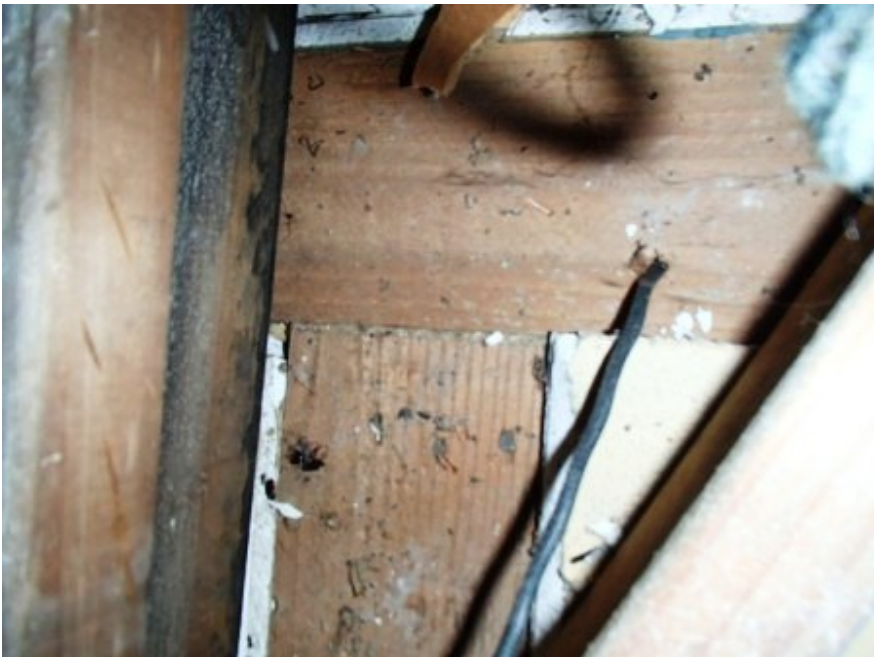
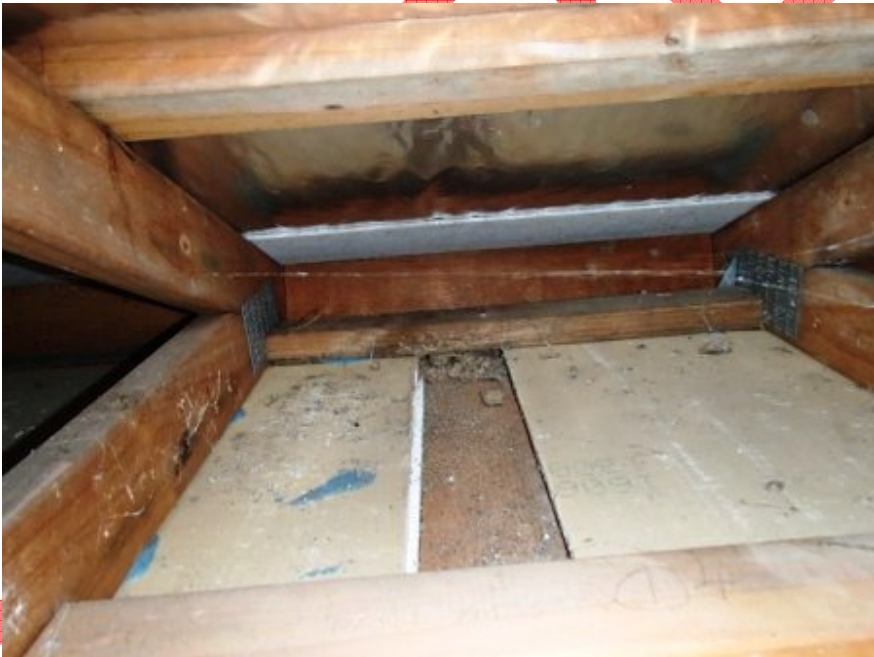
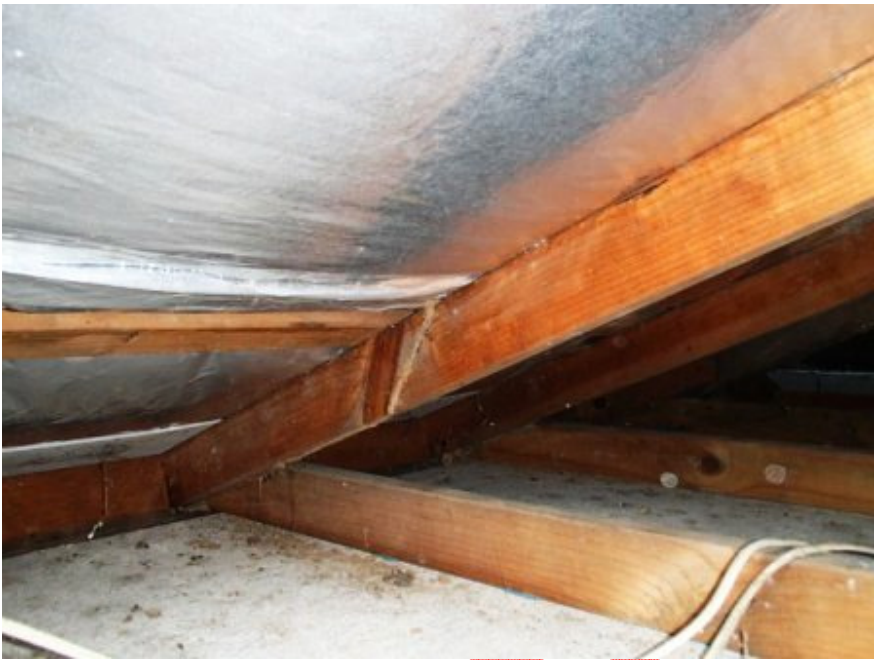
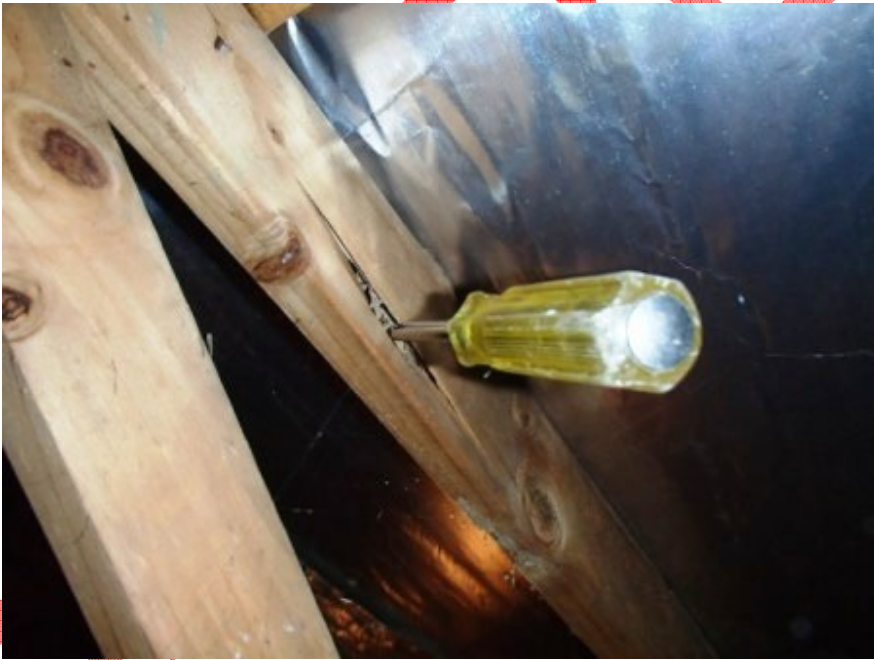
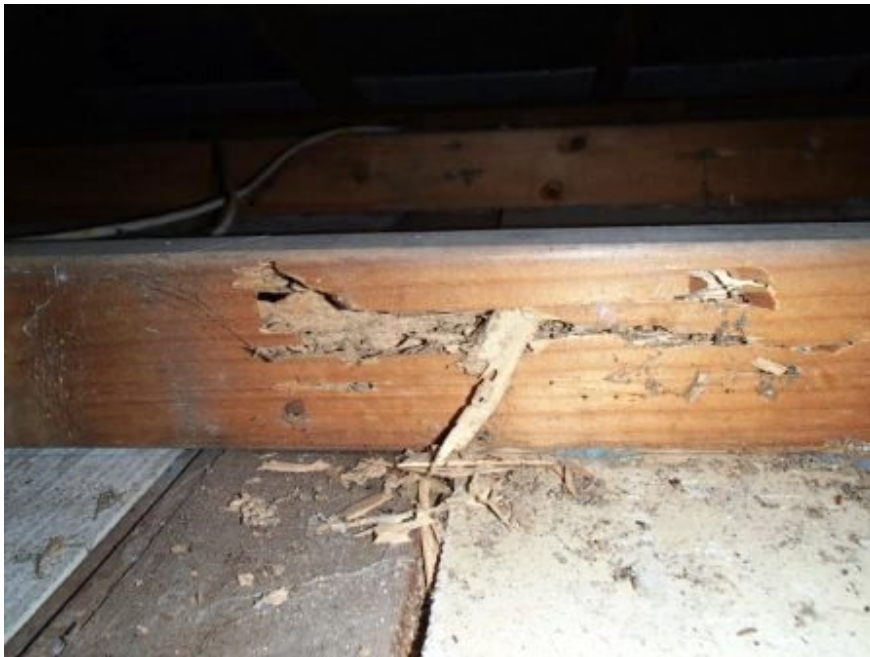
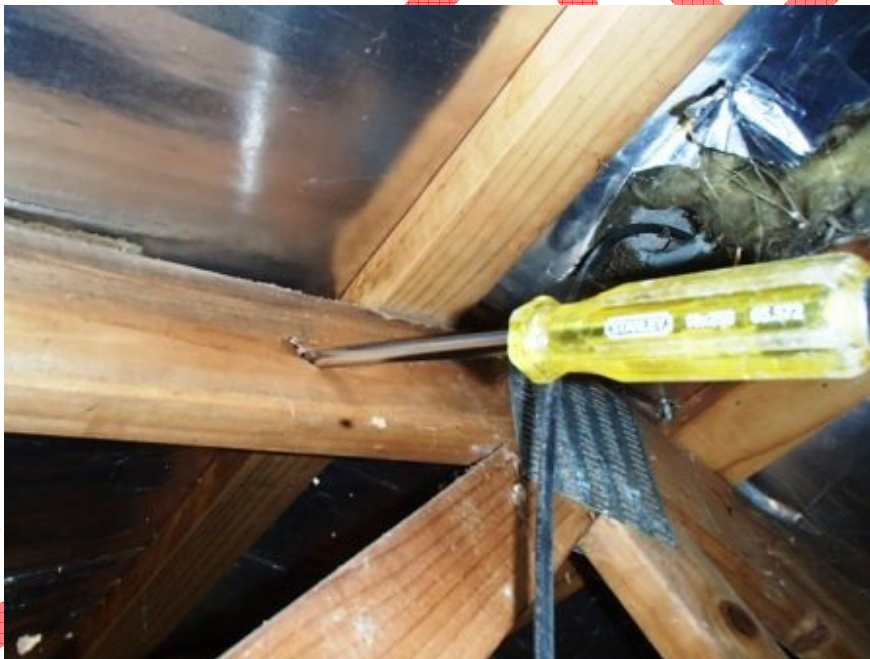
**2.4 Termite damage and/or workings were found mainly in but not limited to: the ground floor laundry wall frame, kitchen linen cupboard wall frames, balcony beams to the rear and right sides, floor joist to the front left corner of the home and the upper front door area interior and exterior, roof trusses and wall top plates throughout the roof void area of the home.**

Whilst we are not builders, the termite damage appears to be:- **extensive and severe**. See Clause 4 on page 1. If a treatment proposal is attached then note areas marked on the sketch (mud map) for more information on areas of damage and activity.

**2.7 Subterranean termite treatment recommendation:** A suitable management program that accords with AS 3660 against subterranean termites is considered to be **essential**.

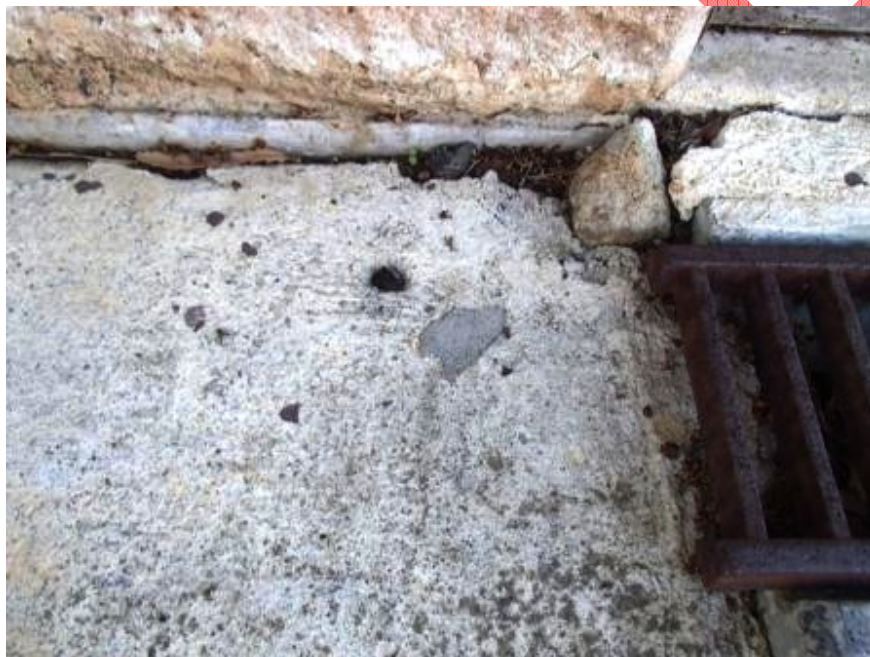
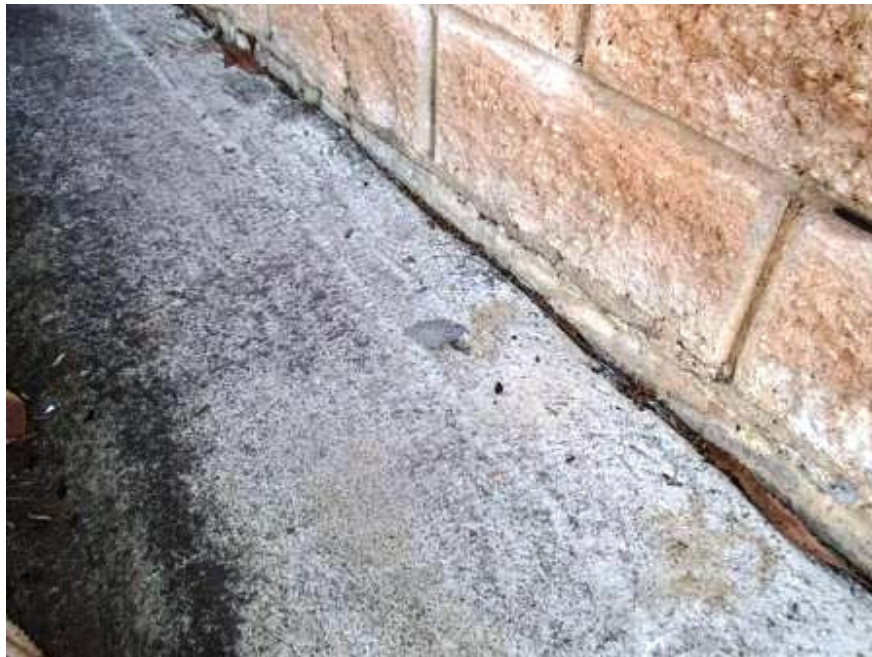
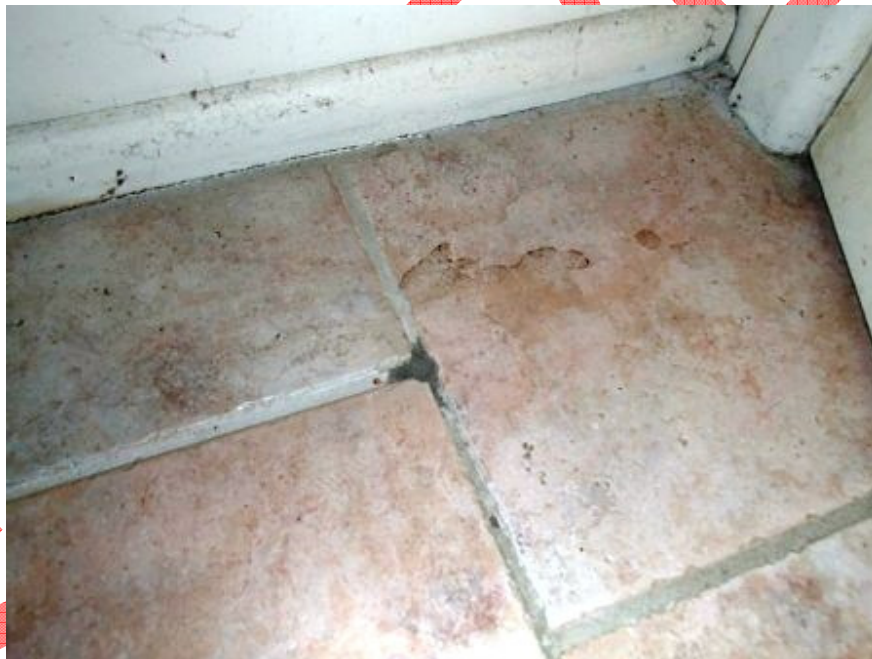
**2.5 The following evidence of a possible previous treatment was found: Drill holes were found that may be evidence of a possible previous termite treatment to the exterior paving and interior ground floor concrete floor.**

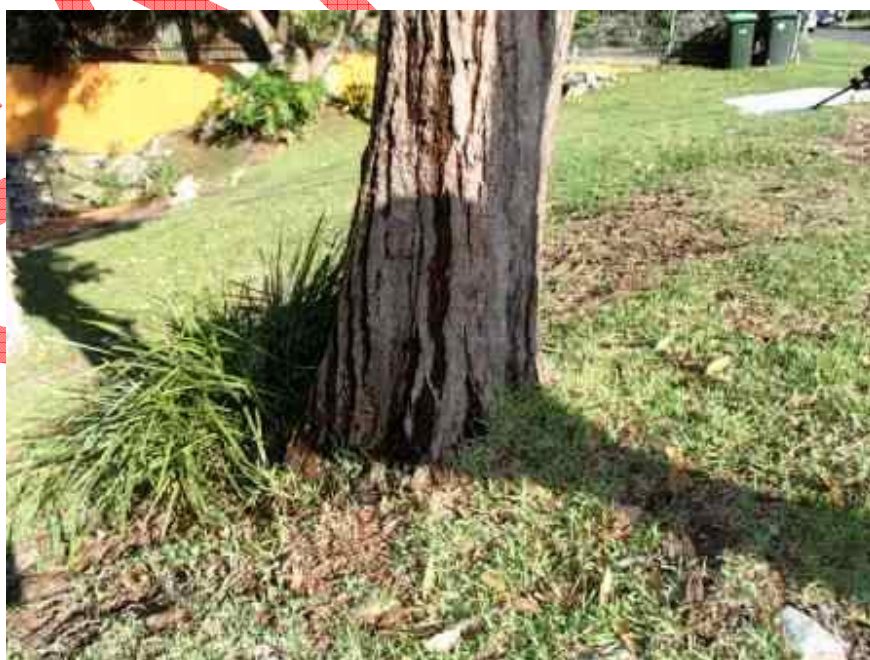
- Access should be provided to the roof void of the home as this area may show signs of timber pest activity.
- Large old growth trees with a girth greater than 100mm diameter are within 50 metres of the dwelling. It is very difficult, and generally impossible to locate termite nests since they are underground and evidence in trees is usually well concealed. We therefore strongly recommend that you arrange to have trees test drilled for evidence of termite nests.

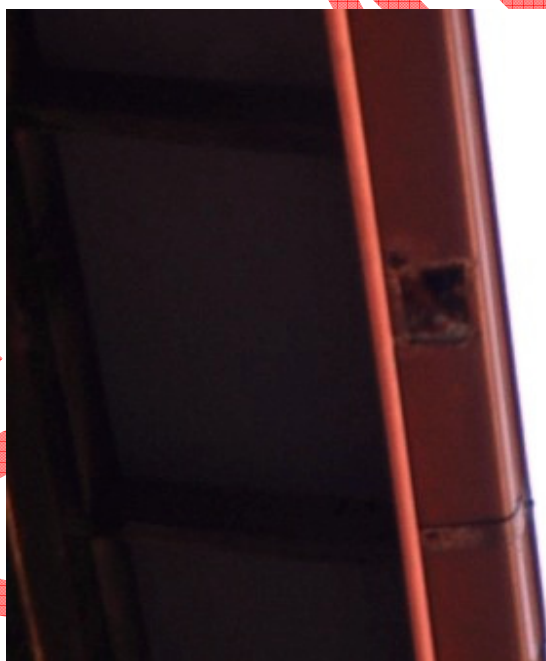
Areas where leaks should be attended to by a plumber or other expert and why:  
**leaks were found to be present in the rusted roof gutters.**

Where drainage is considered inadequate or water leaks are reported then a plumber, builder or other building expert should be consulted.

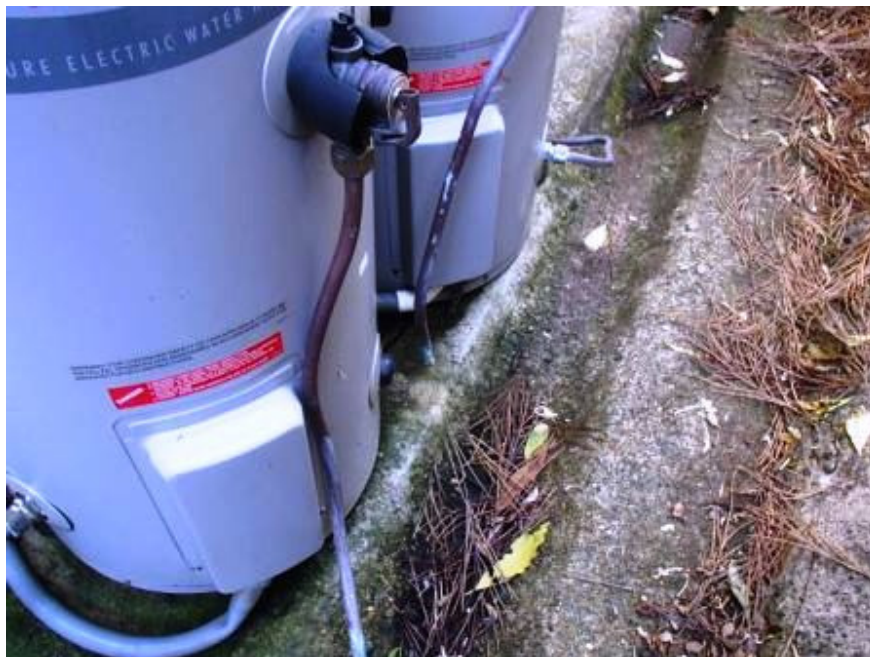
Is there a need for this work to be carried out? **Yes, to the hot water heater's x 2.**
