# Dilapidation Report

## **Building Dilapidation Report (Except ACT)**

Building Dilapidation Report in accordance with Australian Standard AS 4349.0—2007. Inspection of Buildings – General Requirements for the purpose of assessing the general condition of the structure.

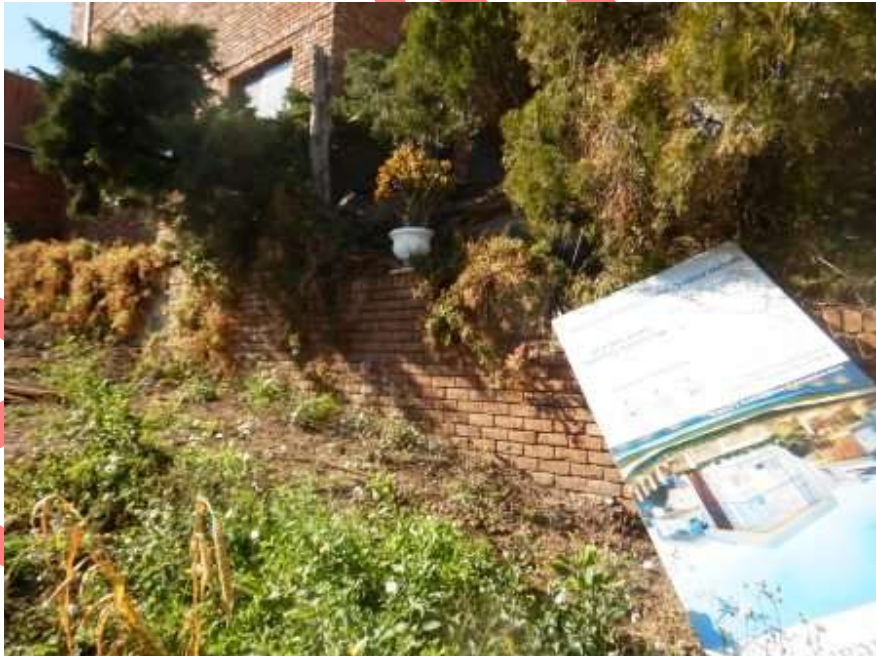
Location	Defect
Exterior left side boundary retaining wall.	Existing condition and location photo. <div> </div>
Exterior left side boundary retaining wall.	Existing condition and location photo. <div>

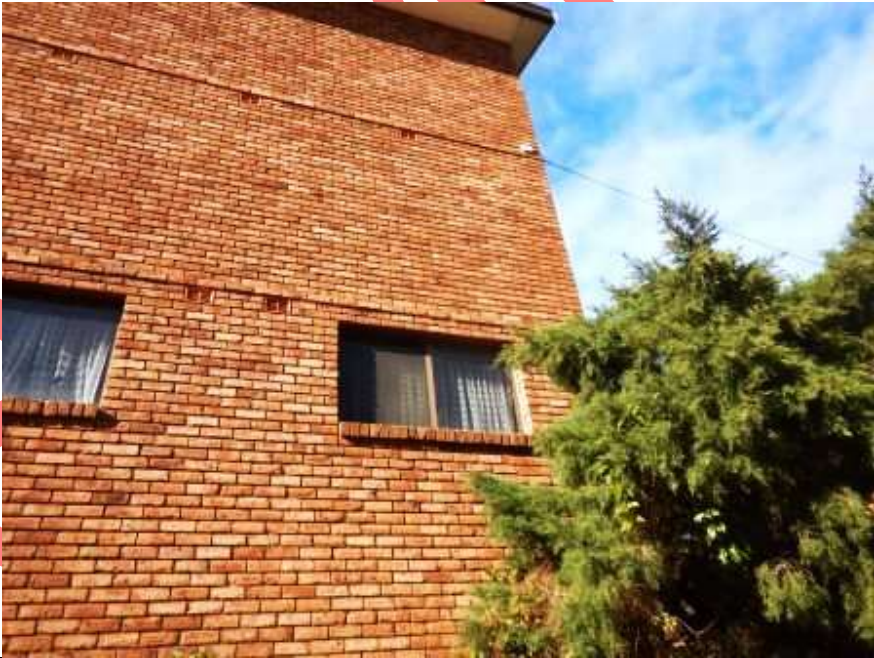
</div>
Exterior left side.	Existing condition and location photo. <div>

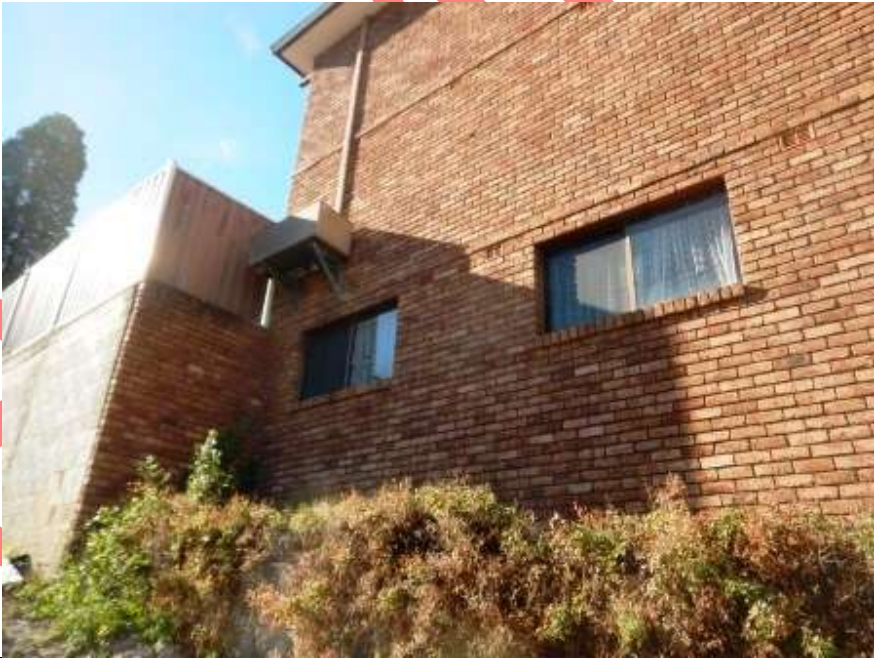
</div>
Exterior left side.	<div>Existing condition and location photo.</div> <div>

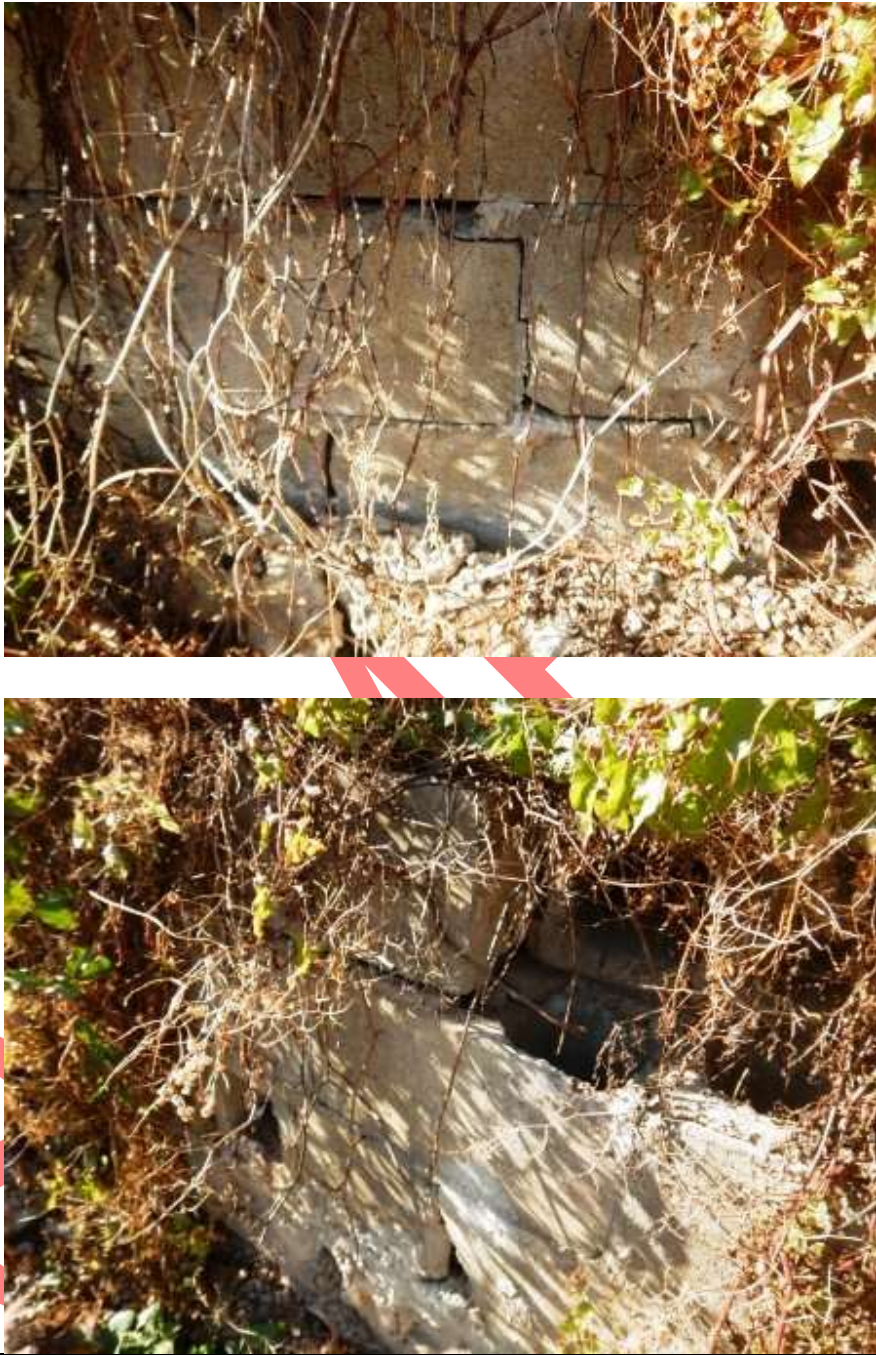
Location	Defect
Exterior left side boundary retaining wall.	<div>Category 3: Cracks 5 mm to 15 mm in width.</div> <div>

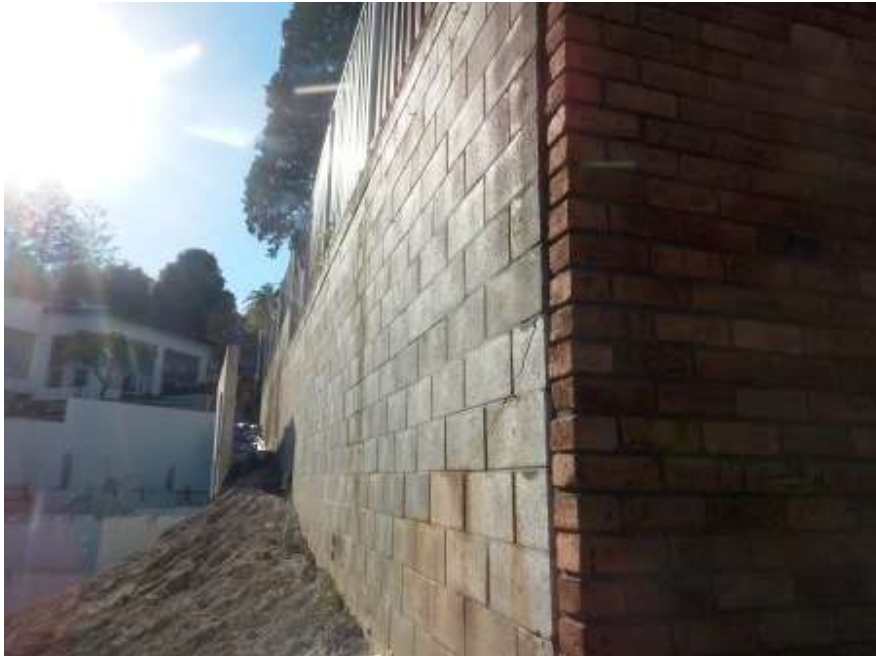
Location	Defect
Exterior left side boundary retaining wall.	Existing condition and location photo. <div>

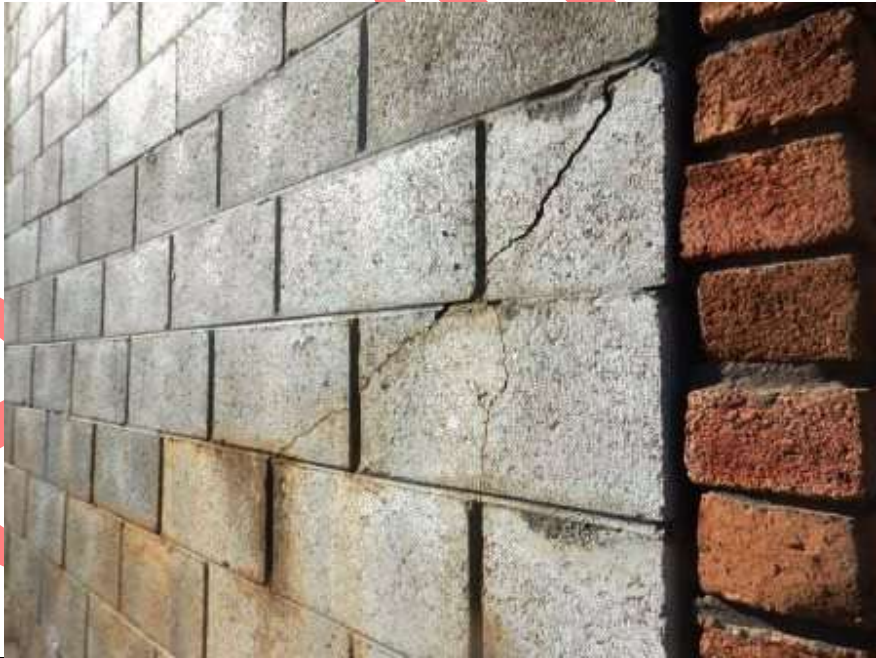
</div>
Exterior left side boundary retaining wall.	Category 3: Cracks 5 mm to 15 mm in width. <div>

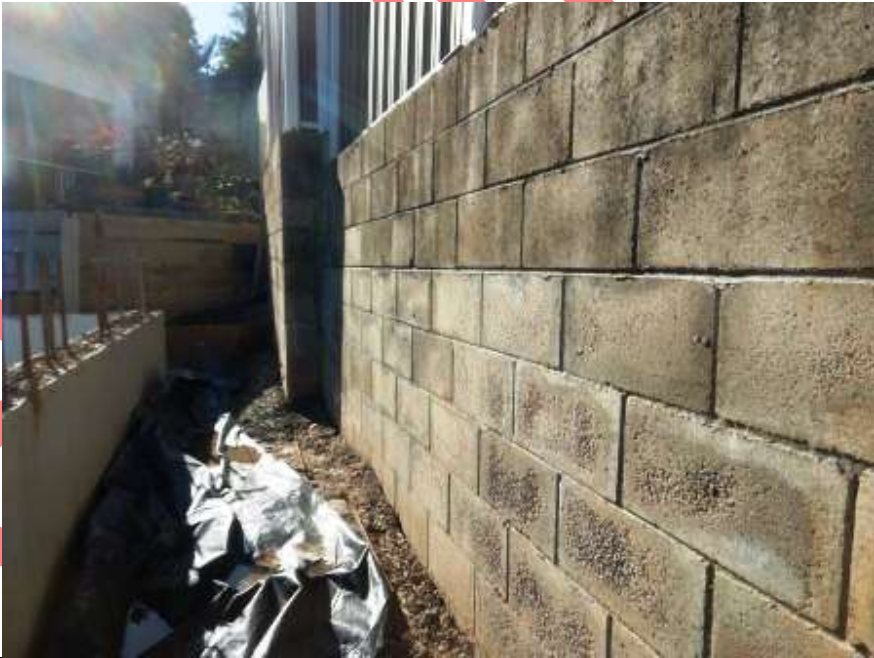
</div>
Exterior left side boundary retaining wall.	Existing condition and location photo. <div>

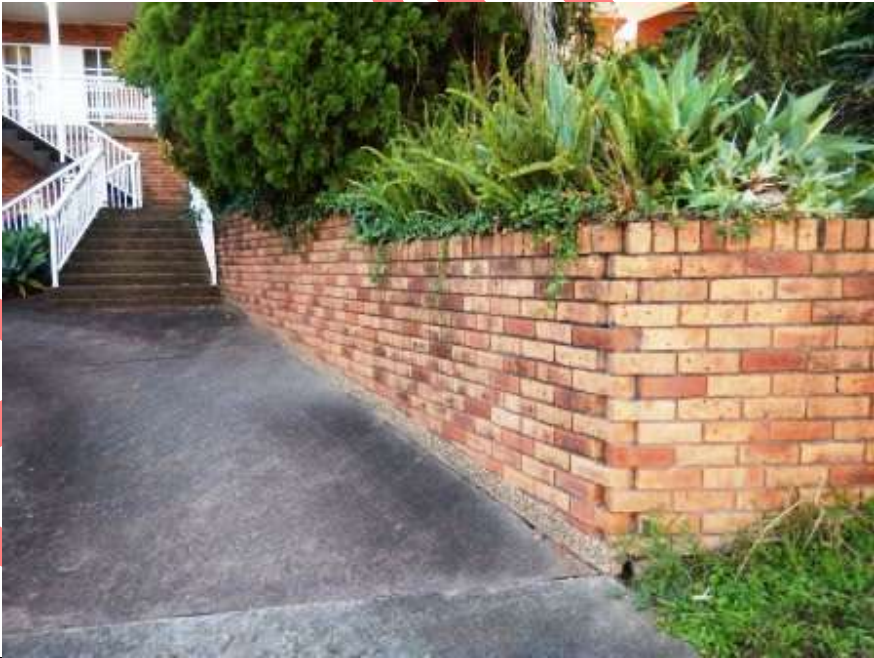
</div>
Exterior front retaining wall.	<div>Existing condition and location photo.</div> <div>

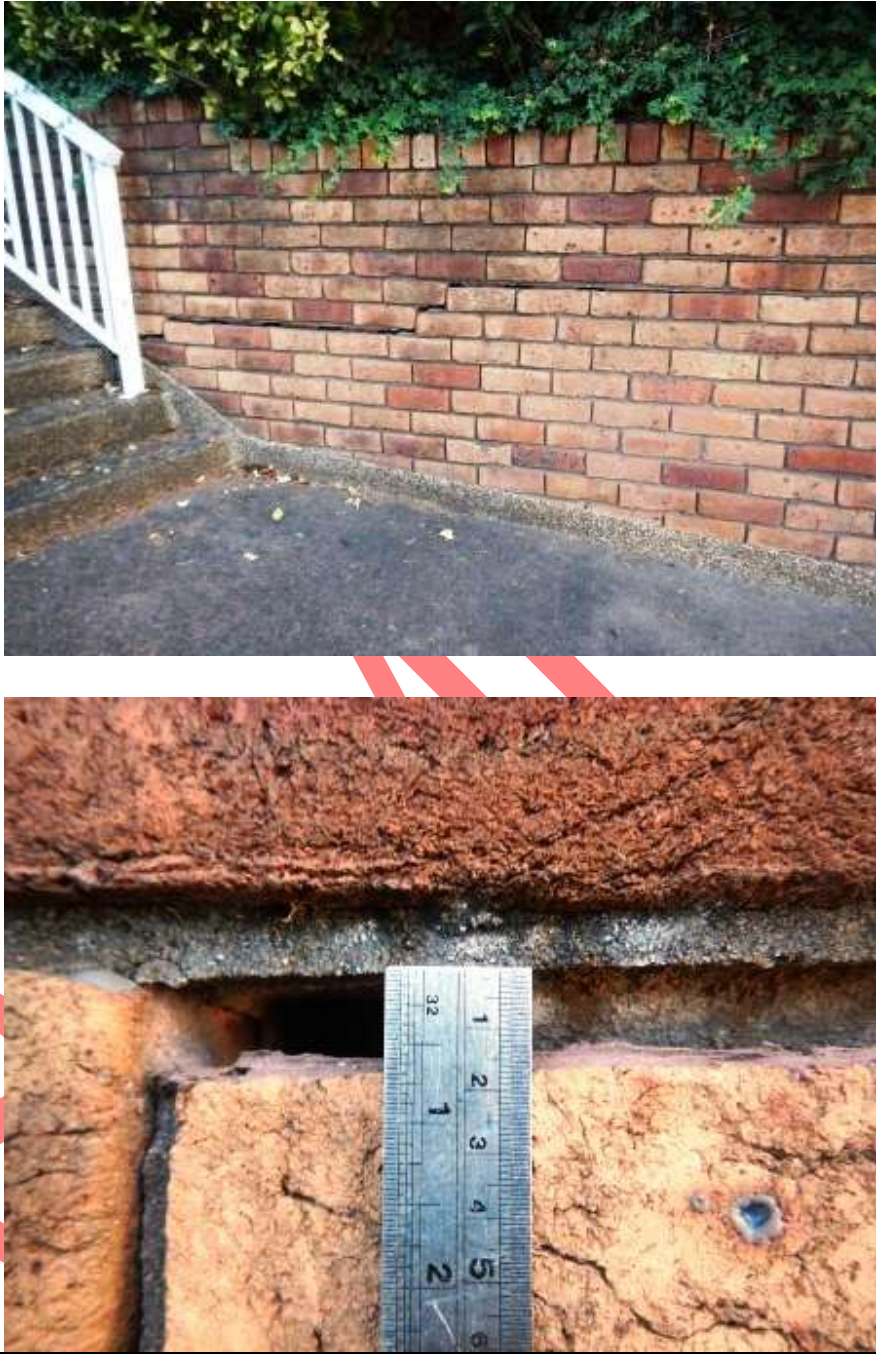
Location	Defect
Exterior front retaining wall.	<div>Existing condition and location photo and category 4: Cracks 15 mm to 25 mm in width.</div> <div>

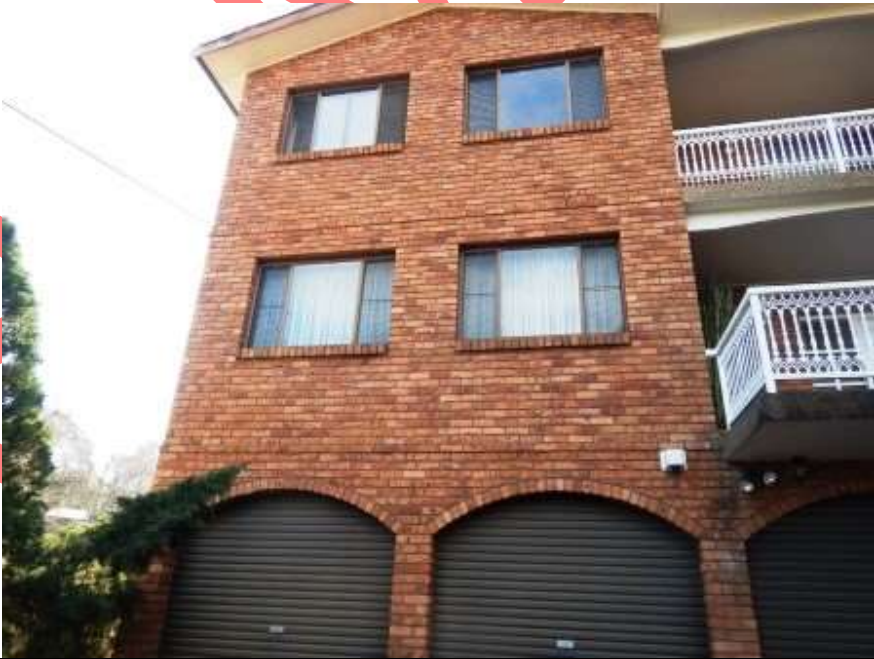
Location	Defect
Exterior front steps.	<div>Category 2: Distinct cracks, Slab noticeably curved or changed in level, &lt; 2.0 mm in width and &lt; 15 mm change in offset from a 3 m straight edge placed over the crack.</div> <div> </div>
Exterior front.	<div>Existing condition and location photo.</div> <div>

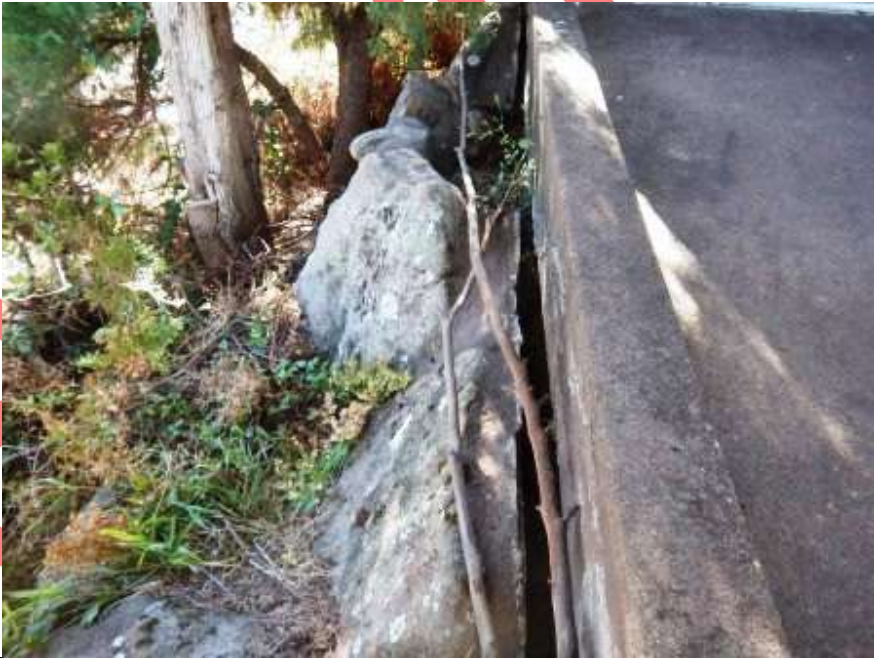
</div>
Exterior front driveway garden walls.	Land slip and subsidence to the stone garden retaining walls. <div>

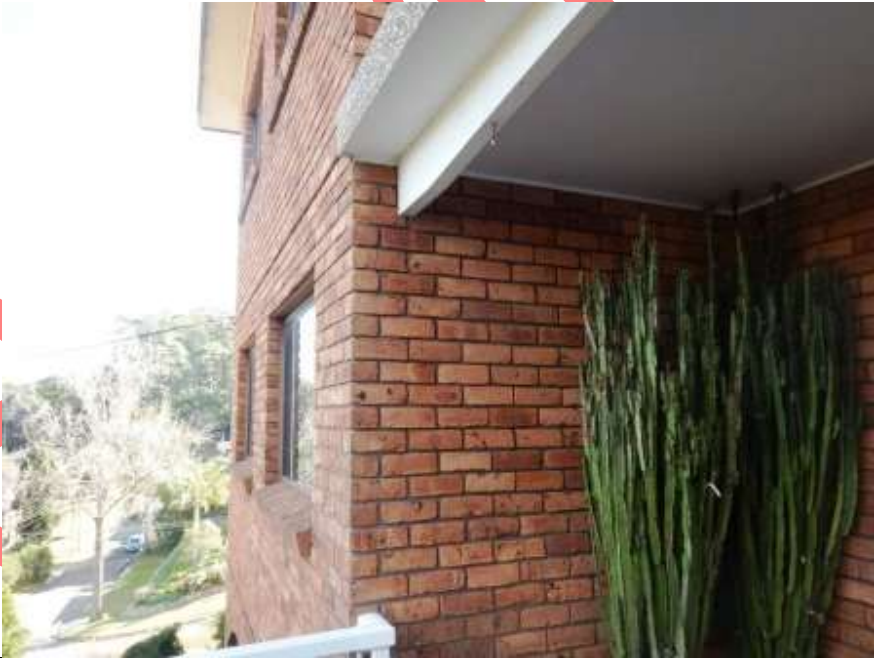
Location	Defect
Exterior front steps.	Existing condition and location photo. <div> </div>
Exterior front lower balcony area.	Existing condition and location photo. <div>

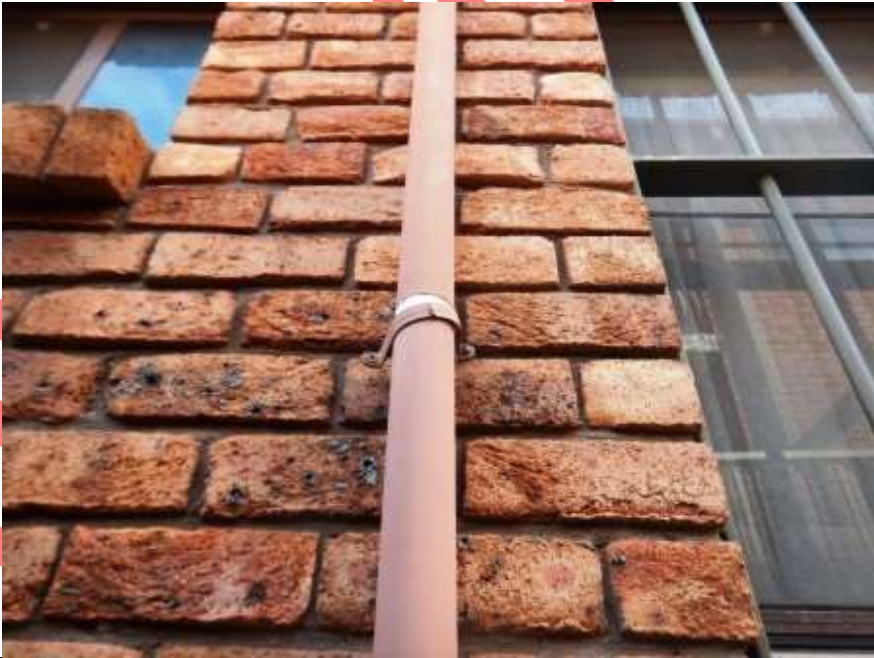
</div>
Exterior right side.	Loose vent pipe support bracket. <div>

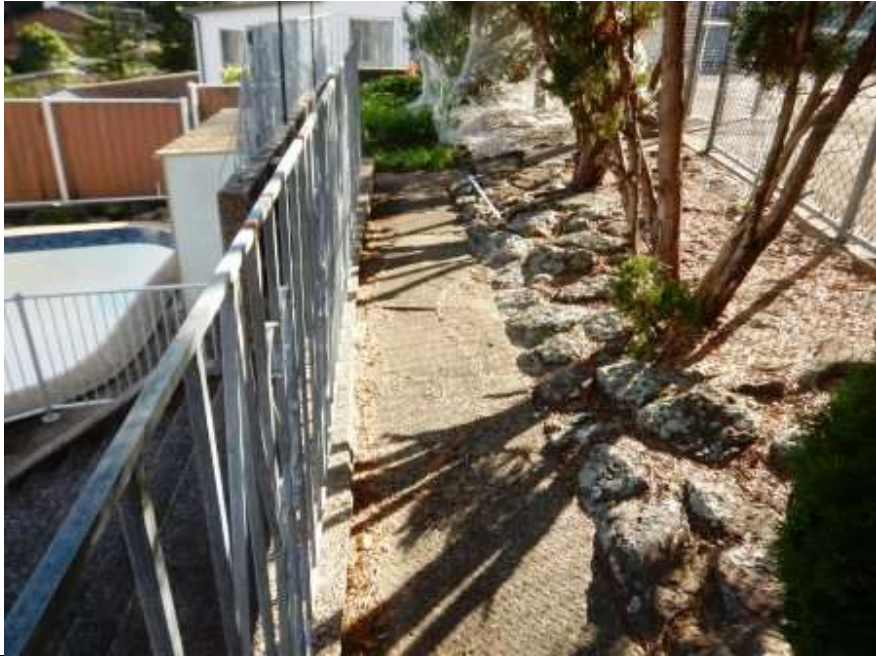
Location	Defect
Exterior rear.	<div>Subsidence of the paving tiles, existing condition and location photo.</div> <div>

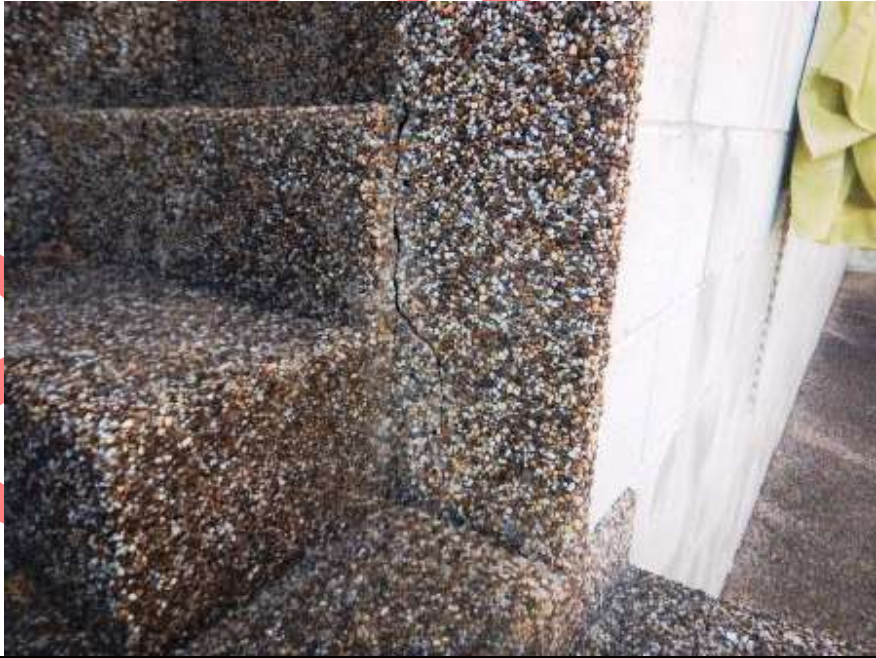
</div>
Exterior rear.	<div>Category 3: Cracks 5 mm to 15 mm in width.</div> <div>

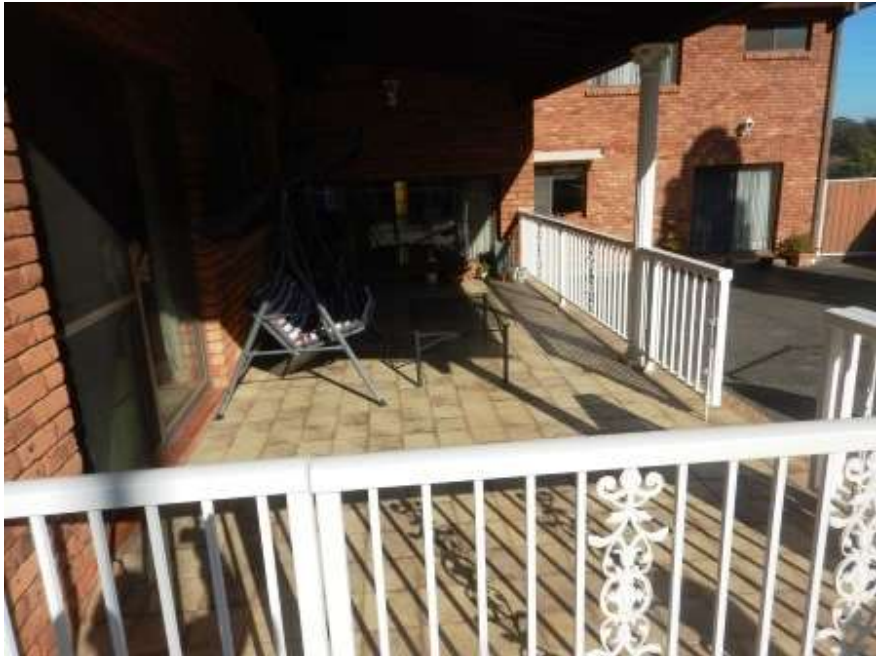
Location	Defect
Exterior rear balcony.	Existing condition and location photo. <div>

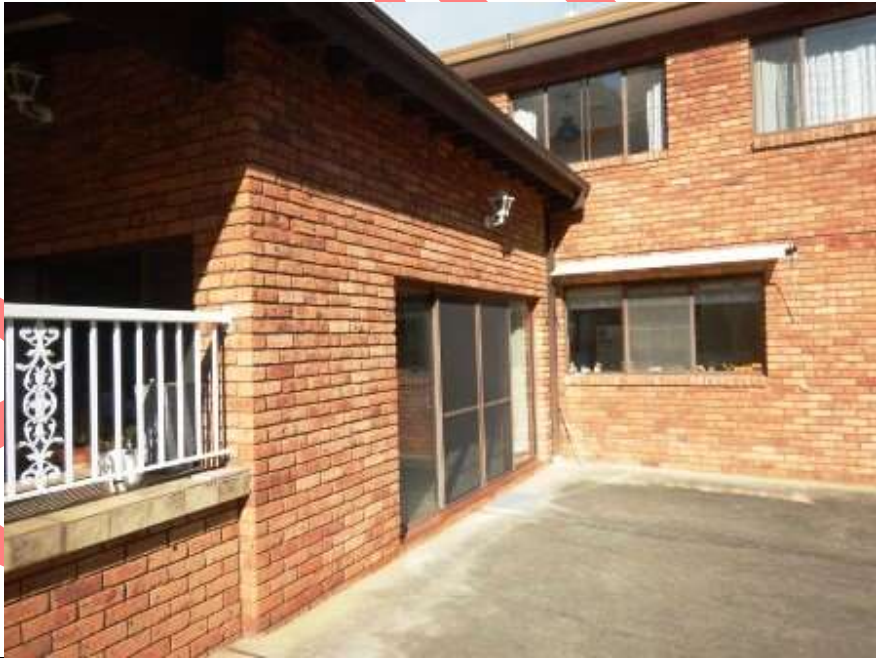
</div>
Exterior rear.	Existing condition and location photo. <div>

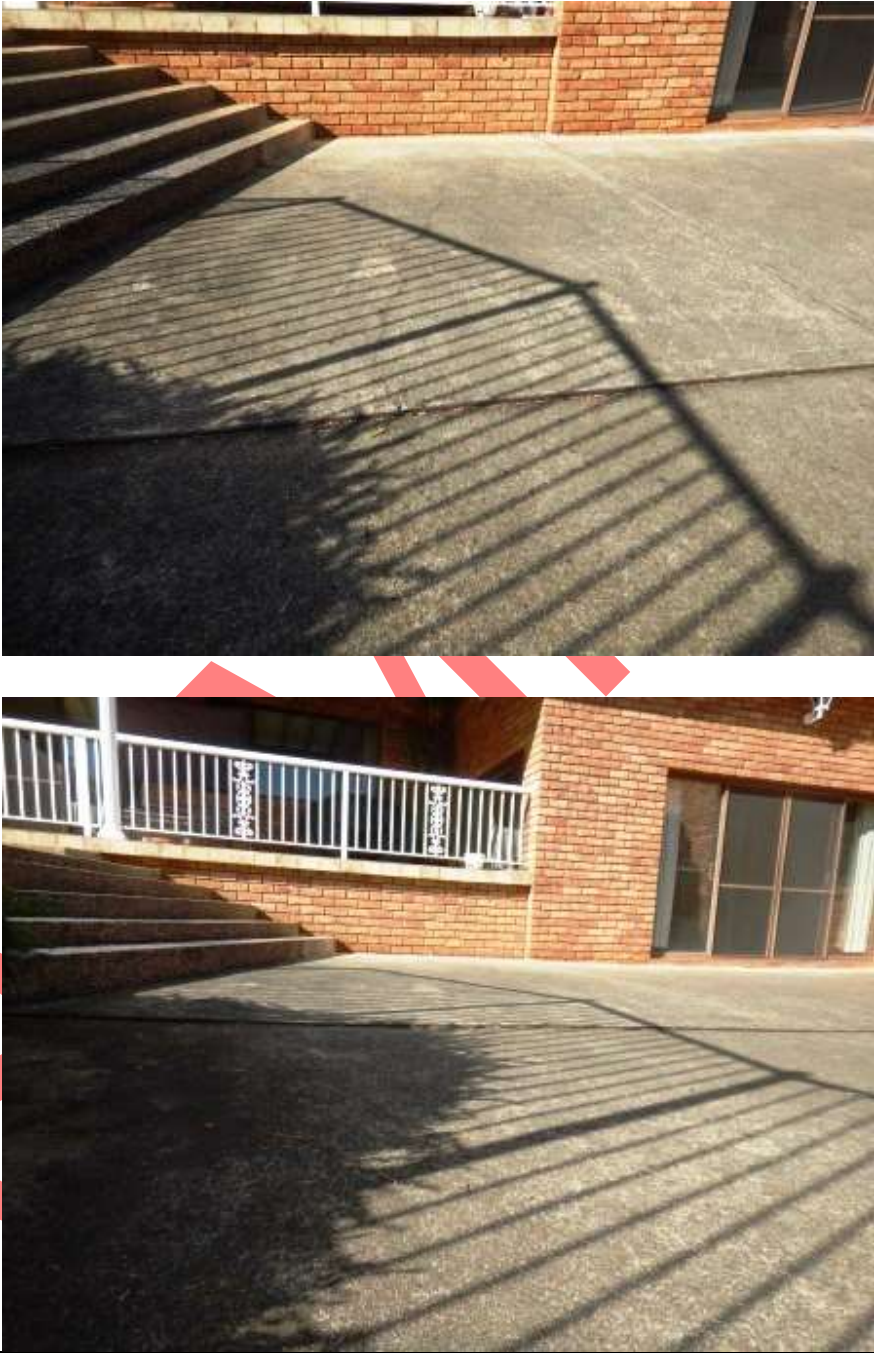
Location	Defect
Exterior rear.	<div>Category 3: Wide cracks, Obvious curvature or change in level, 2 mm to 4 mm in width and 15 mm to 25 mm change in offset from a 3 m straight edge placed over the crack.</div> <div>

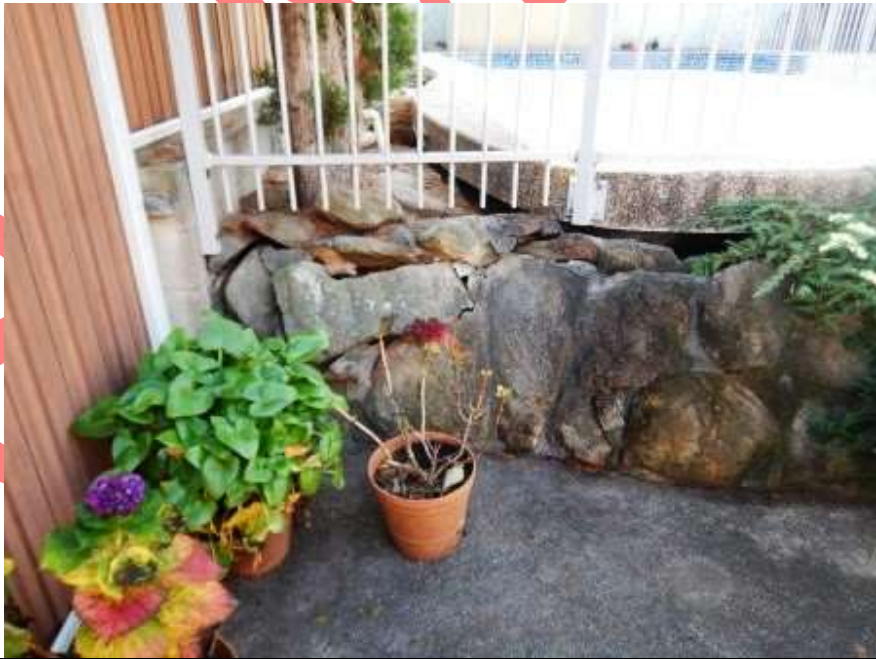
Exterior rear.	<p>Land slip and subsidence to the stone garden retaining walls.</p>

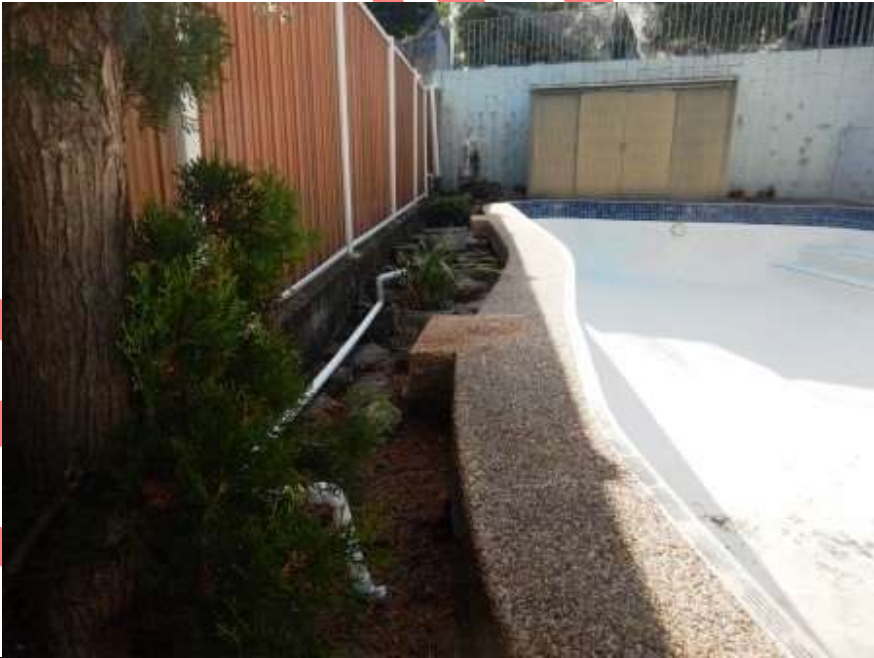
Location	Defect
Exterior rear pool area.	Land slip and subsidence to the stone garden retaining walls. <div> </div>
Exterior rear pool area.	Land slip and subsidence to the stone garden retaining walls. <div>

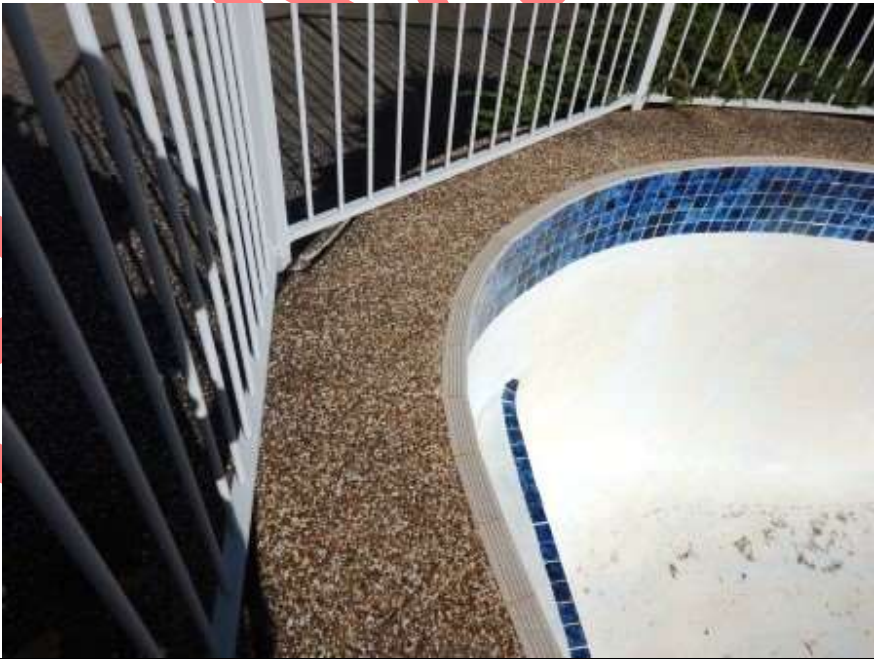
</div>
Exterior rear pool area.	<div>Category 3: Wide cracks, Obvious curvature or change in level, 2 mm to 4 mm in width and 15 mm to 25 mm change in offset from a 3 m straight edge placed over the crack.</div> <div>

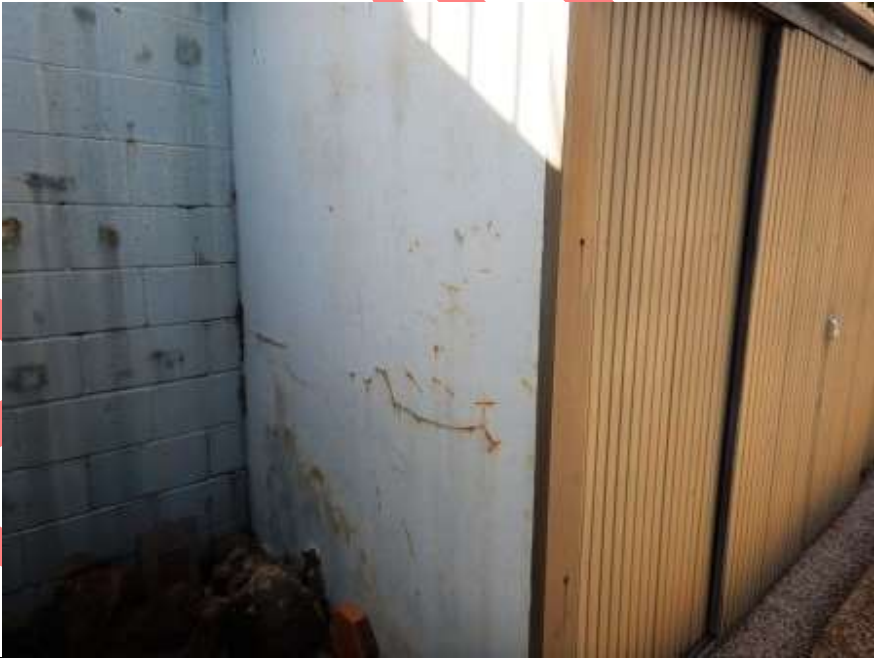
</div>
Exterior rear pool area.	<div>Category 1: Fine cracks that do not need repair &lt; 1mm in width.</div> <div>

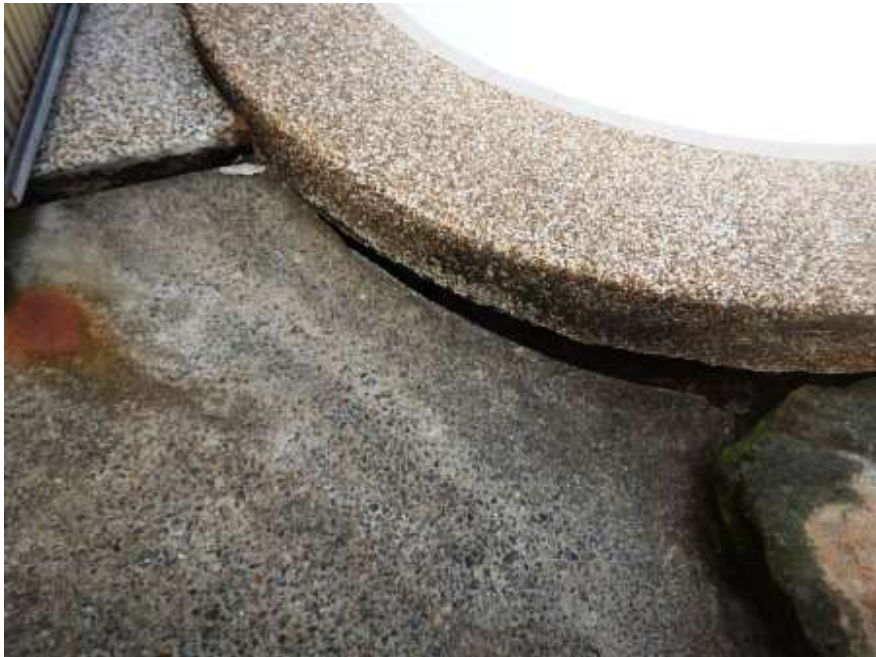
Location	Defect
Exterior rear pool area.	<p>Land slip and Category 4: Gaps in slab, Disturbing curvature or change in level, 4 mm to 10 mm in width and &gt; 25 mm change in offset from a 3 m straight edge placed over the crack.</p>

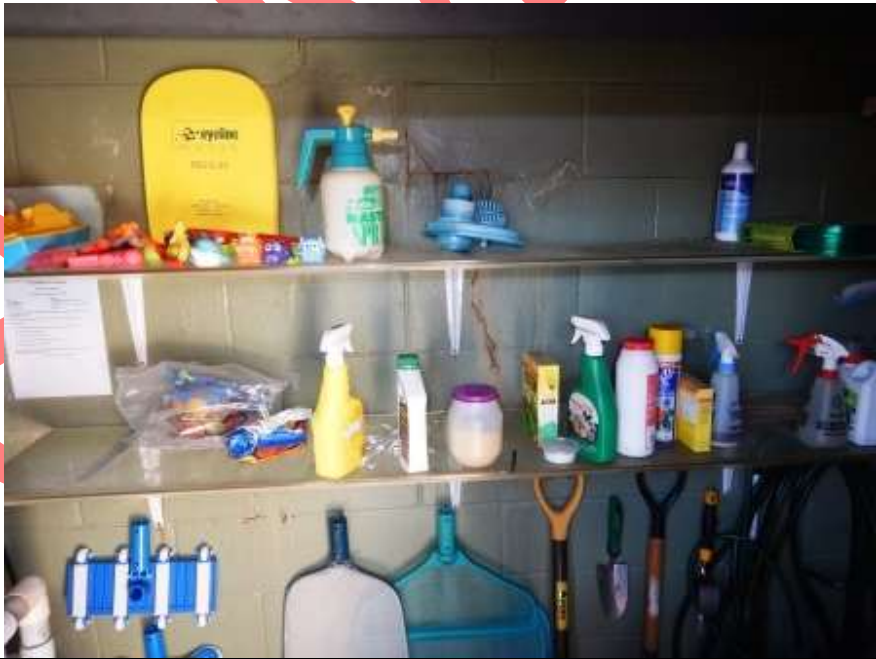
Exterior rear pool area.	<p>Category 2: Cracks noticeable but easily filled &lt; 5 mm in width.</p>

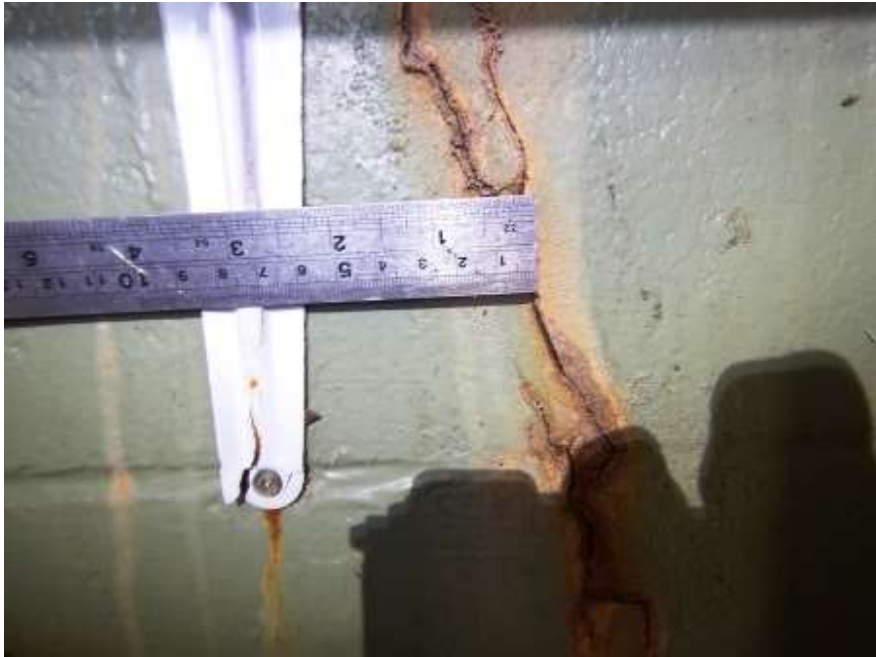
Location	Defect
Exterior rear pool area.	<p>Category 2: Cracks noticeable but easily filled &lt; 5 mm in width.</p>

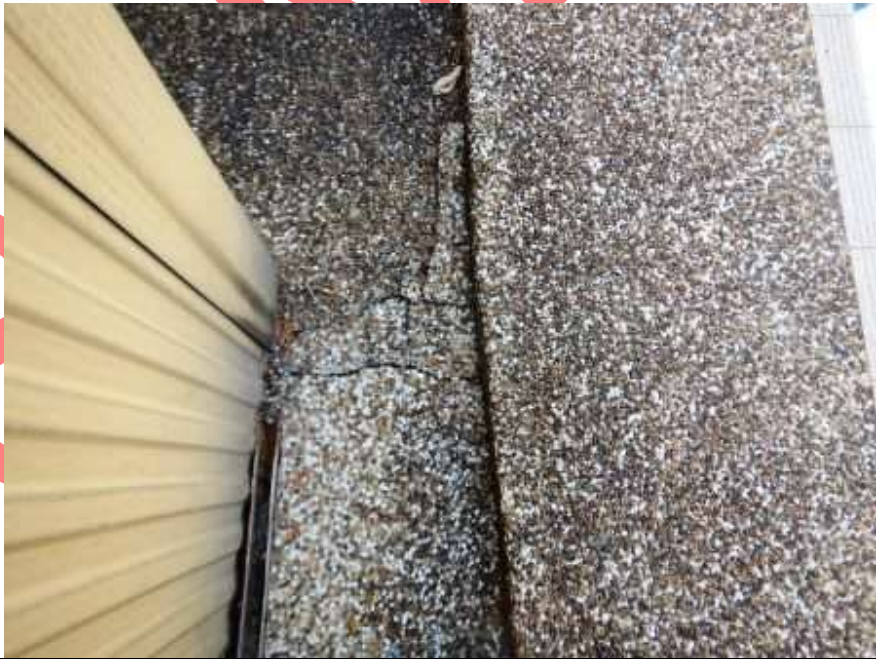
Exterior rear pool area.	<p>Category 2: Distinct cracks, Slab noticeably curved or changed in level, &lt; 2.0 mm in width and &lt; 15 mm change in offset from a 3 m straight edge placed over the crack.</p>

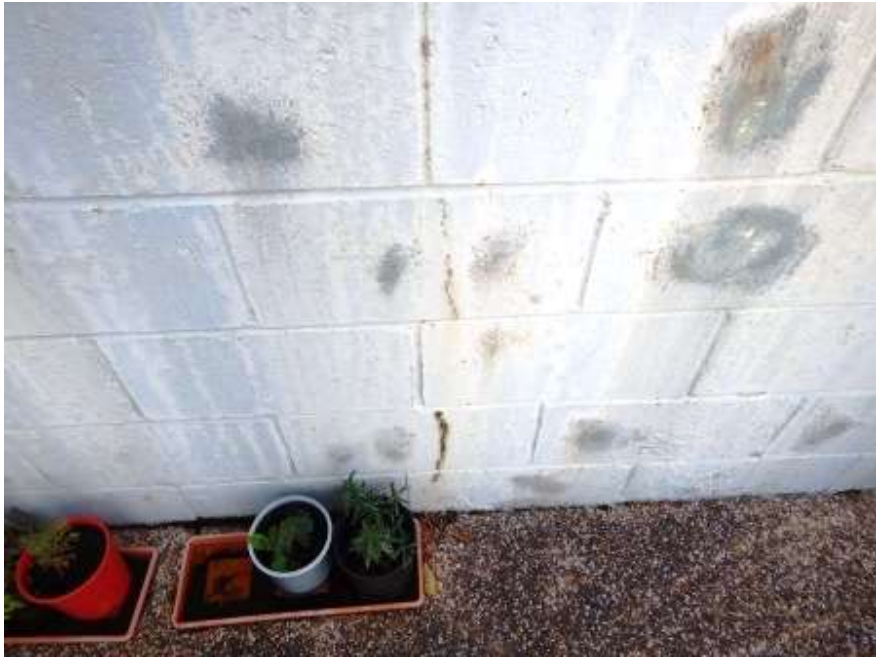
Location	Defect
Exterior rear pool area.	<div>Category 1: Fine cracks that do not need repair &lt; 1mm in width.</div> <div>

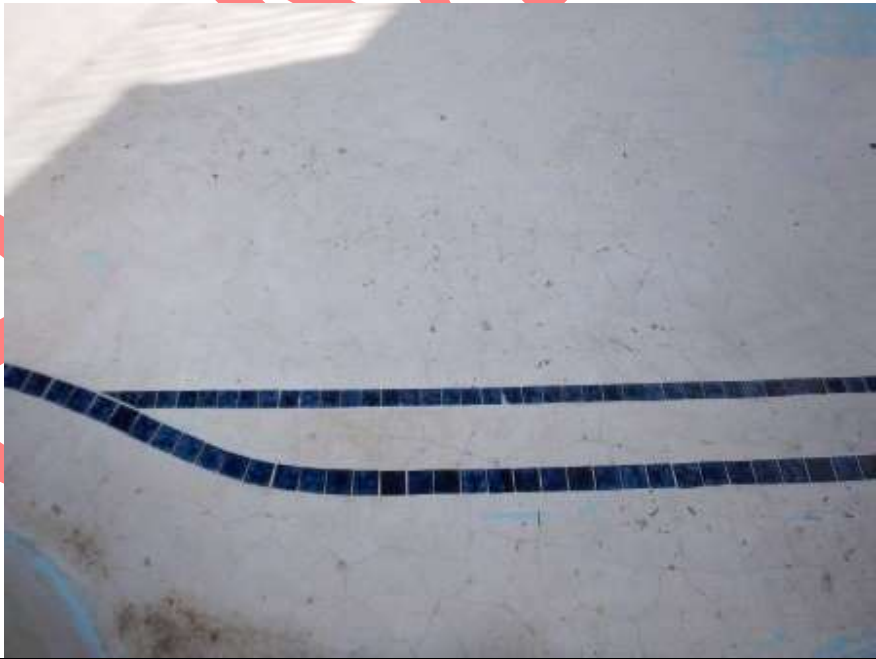
</div>
Exterior rear pool area.	<div>Category 0: Hairline cracks, insignificant movement of the slab level, &lt; 0.3 mm in width and &lt; 8 mm change in offset from a 3m straight edge placed over the crack.</div> <div>

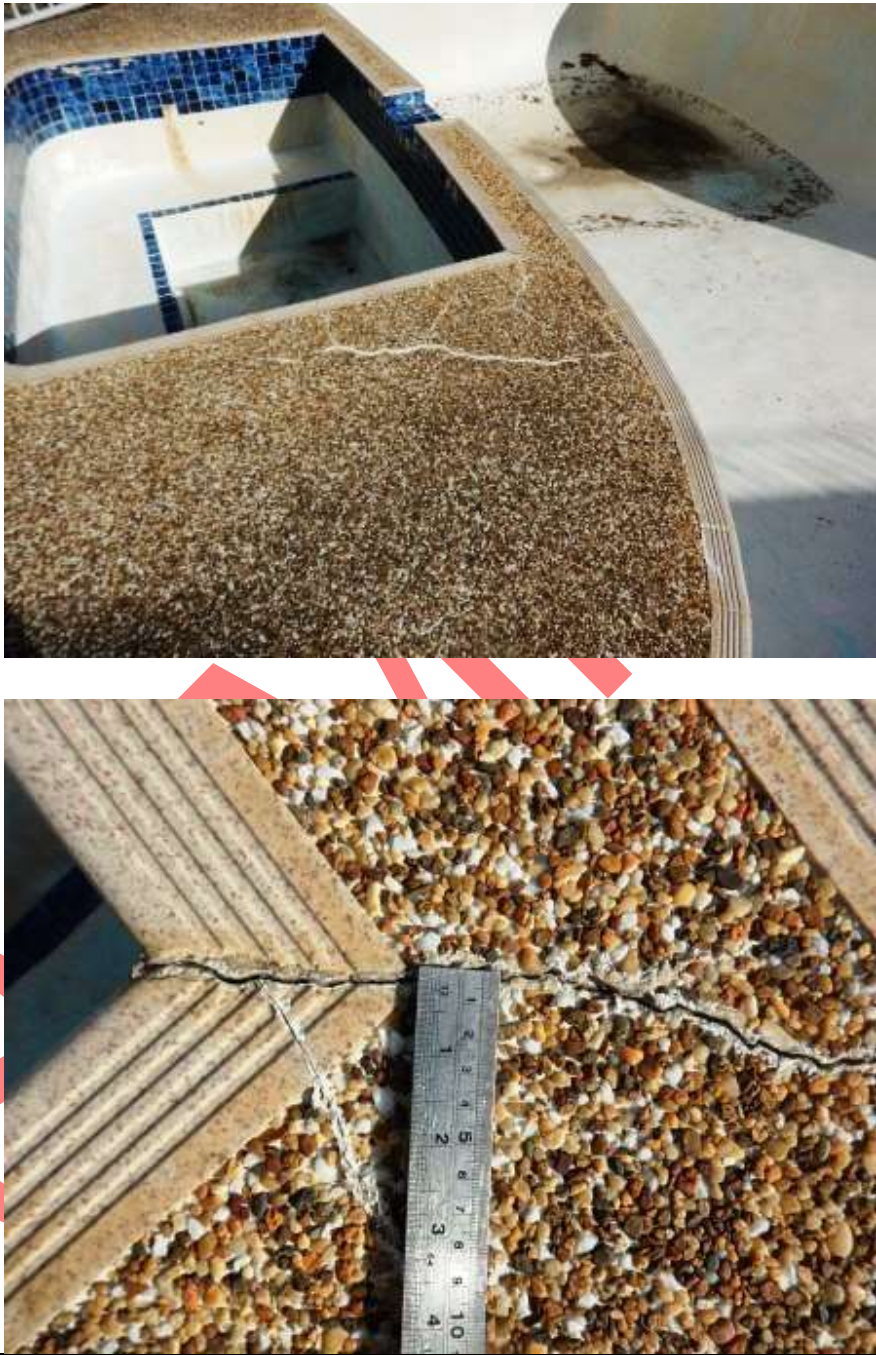
Location	Defect
Exterior rear pool area.	<p>Category 1: Fine but noticeable cracks, Slab reasonably level, &lt; 1.0 mm in width and &lt; 10 mm change in offset from a 3 m straight edge placed over the crack.</p>

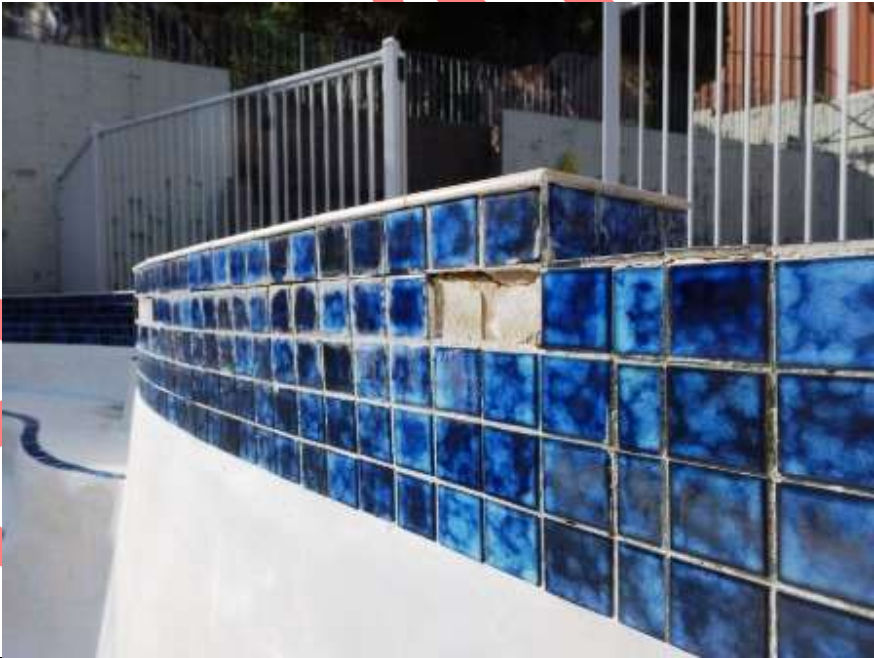
Location	Defect
Exterior rear pool area.	<div>Missing and drummy coping tiles.</div> <div> A photograph showing the exterior rear pool area. The pool has a white coping and blue mosaic tiles. A large red checkmark is overlaid on the right side of the image.</div>
Exterior rear pool area.	<div>Missing and drummy coping tiles.</div> <div>

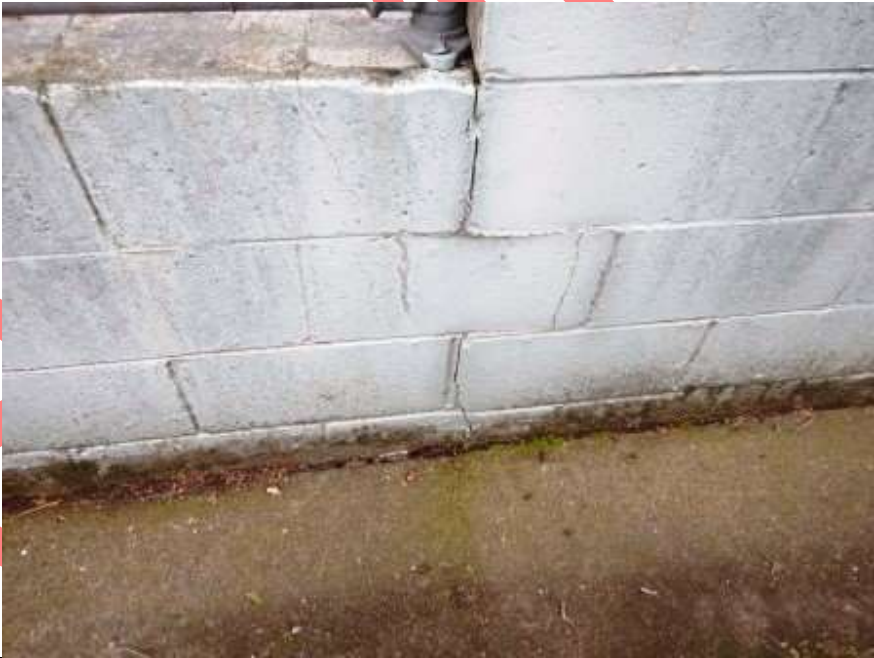
Location	Defect
Exterior upper rear tennis court level.	Existing condition and location photo. <div> </div>
Exterior upper rear tennis court level.	Category 2: Cracks noticeable but easily filled < 5 mm in width. <div>

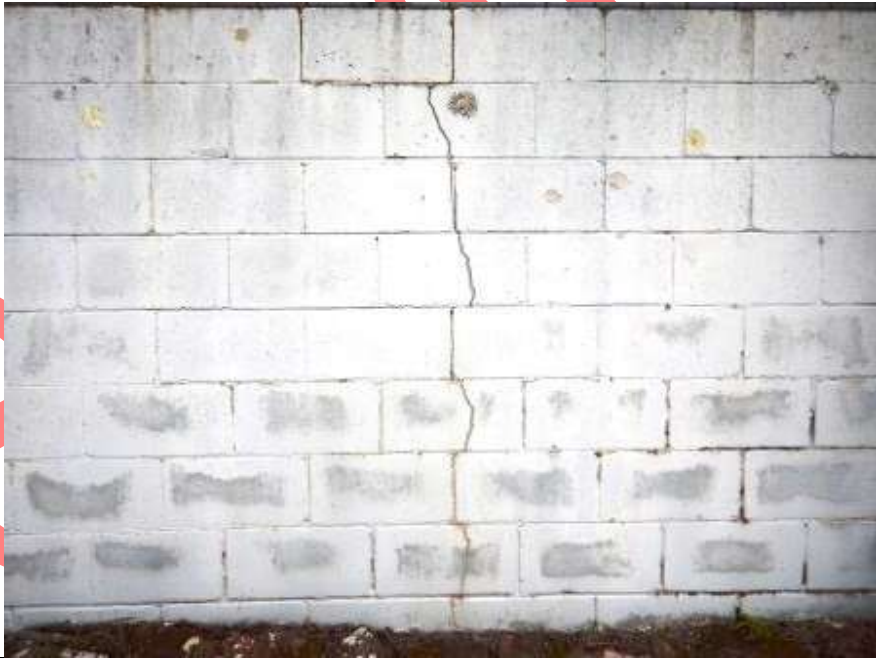
</div>
Exterior upper rear tennis court level.	Category 2: Cracks noticeable but easily filled < 5 mm in width. <div>

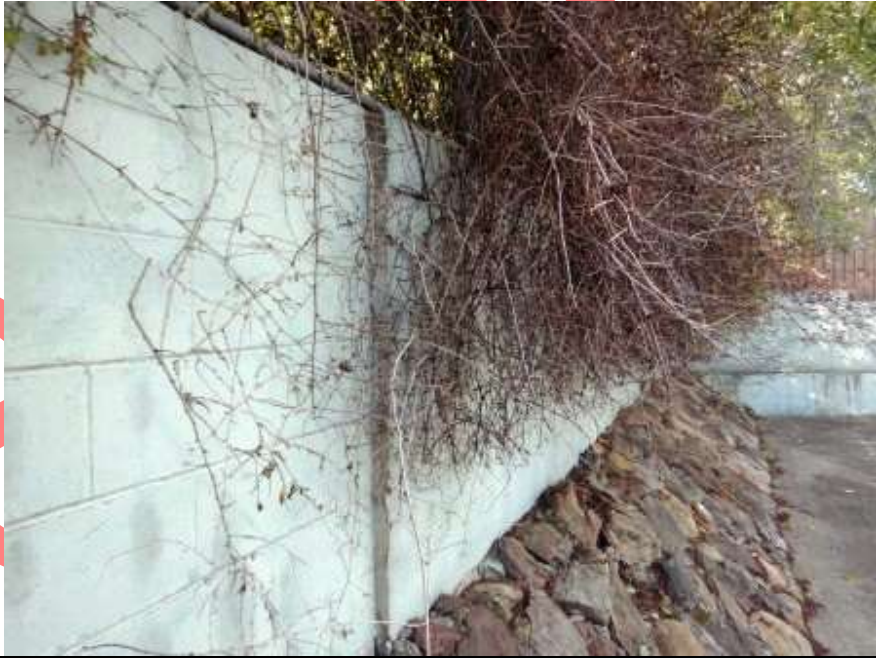
Location	Defect
Exterior upper rear tennis court level.	<div>Existing condition, location photo, subsidence and structural failure to the wall.</div> <div>
