# Dilapidation Report

## **Building Dilapidation Report (Except ACT)**

Building Dilapidation Report in accordance with Australian Standard AS 4349.0—2007. Inspection of Buildings – General Requirements for the purpose of assessing the general condition of the structure.

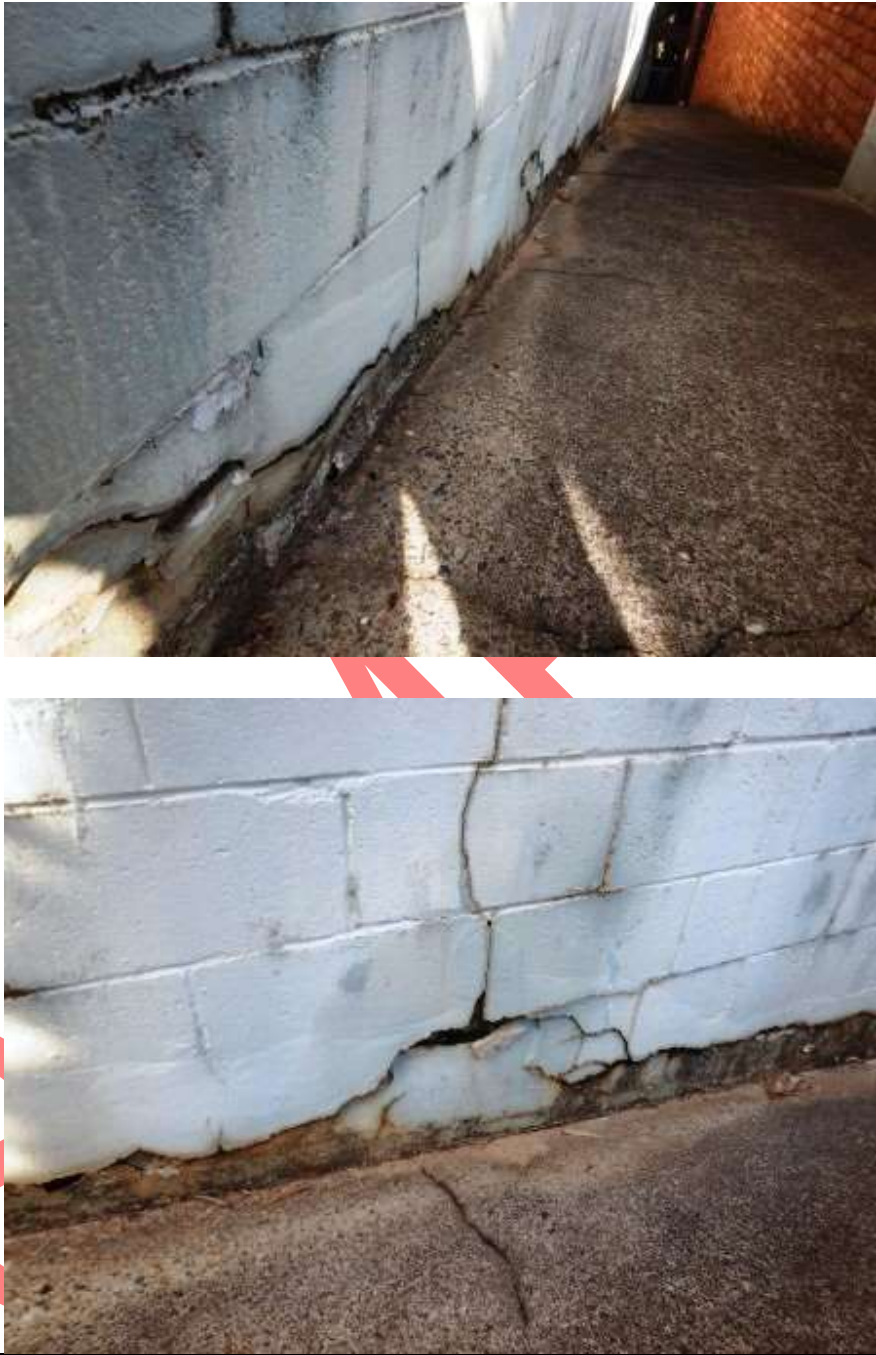
Location	Defect
Exterior right side.	<div>Category 3: Cracks 5 mm to 15 mm in width.</div> <div>

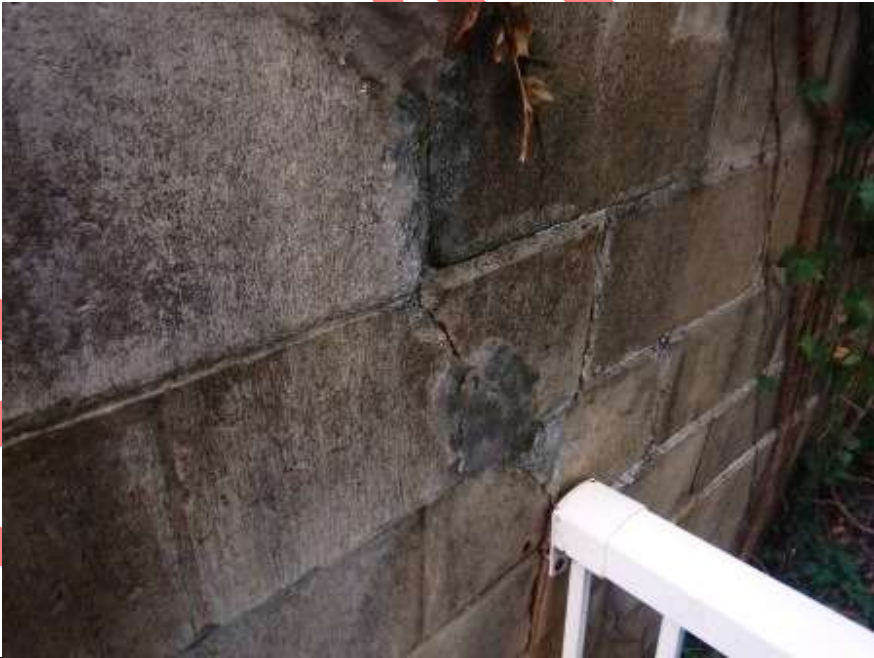
</div>
Exterior right side.	<div>Category 3: Cracks 5 mm to 15 mm in width.</div> <div>

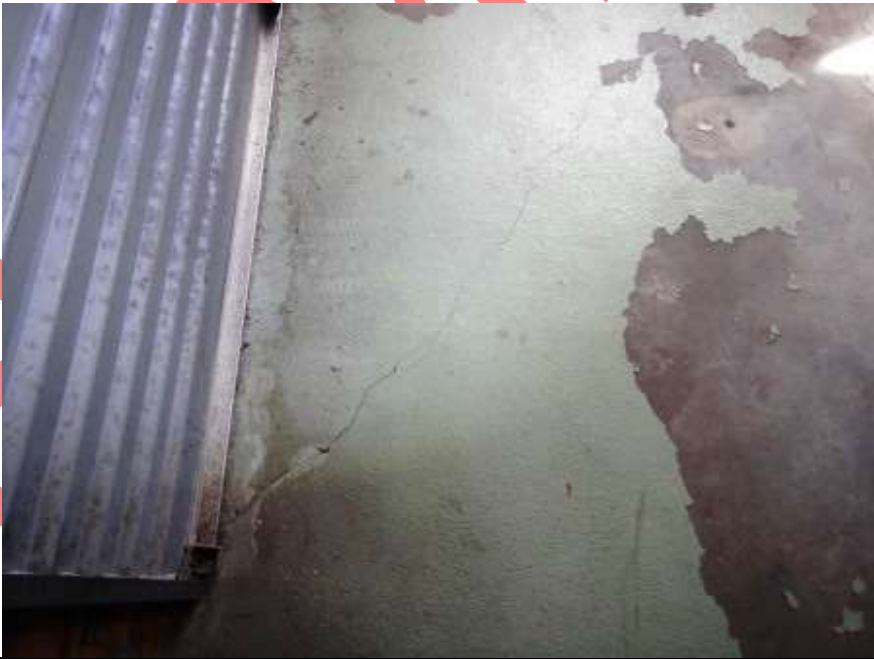
Location	Defect
Interior garage.	<div>Category 1: Fine but noticeable cracks, Slab reasonably level, &lt; 1.0 mm in width and &lt; 10 mm change in offset from a 3 m straight edge placed over the crack.</div> <div>

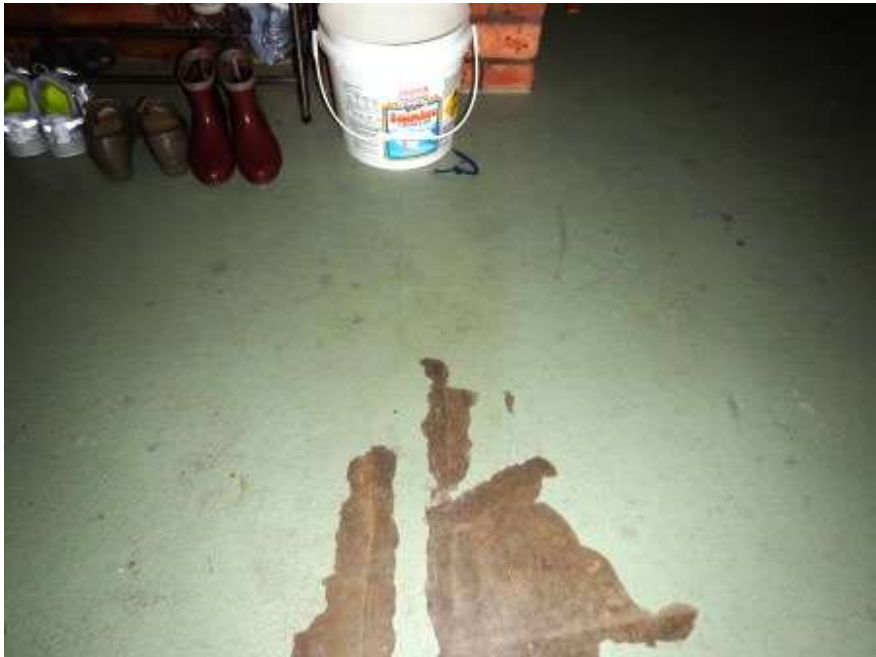
Location	Defect
Interior garage.	<p>Category 1: Fine but noticeable cracks, Slab reasonably level, &lt; 1.0 mm in width and &lt; 10 mm change in offset from a 3 m straight edge placed over the crack.</p>

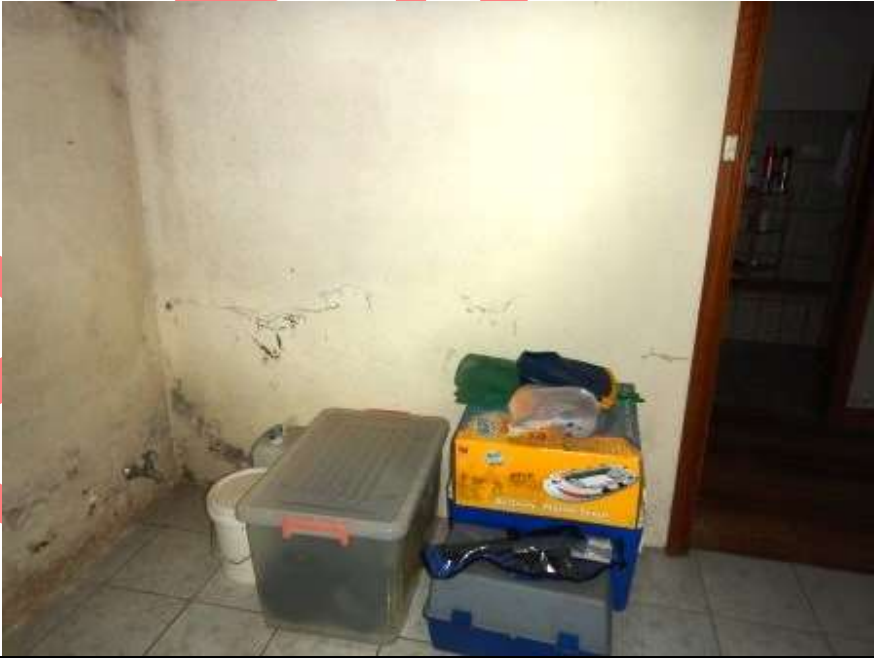
Interior lower level vacant room.	Water damaged and category 1: Fine cracks that do not need repair < 1mm in width.

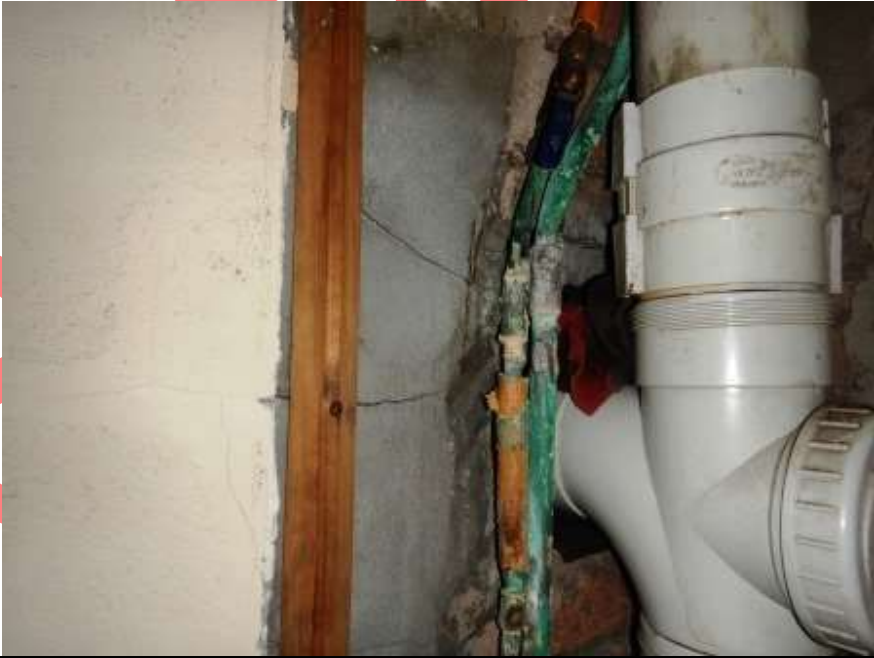
</div>
Interior lower level vacant room.	<div>Category 2: Cracks noticeable but easily filled &lt; 5 mm in width.</div> <div>

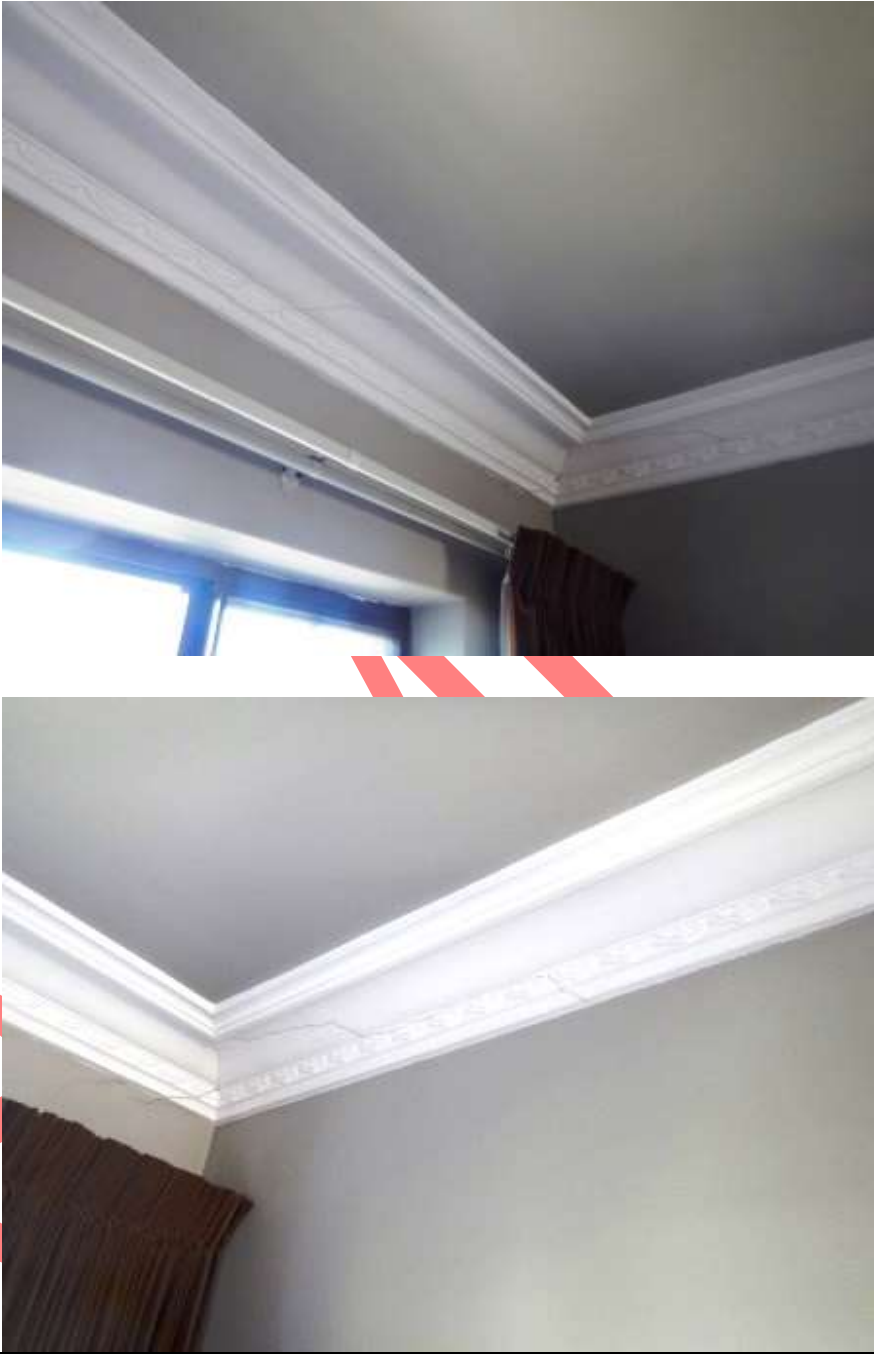
Location	Defect
Interior middle level front lounge room.	<div><p>Hairline cracking to the ceiling cornice and Category 1: Fine cracks that do not need repair &lt; 1mm in width.</p><div>

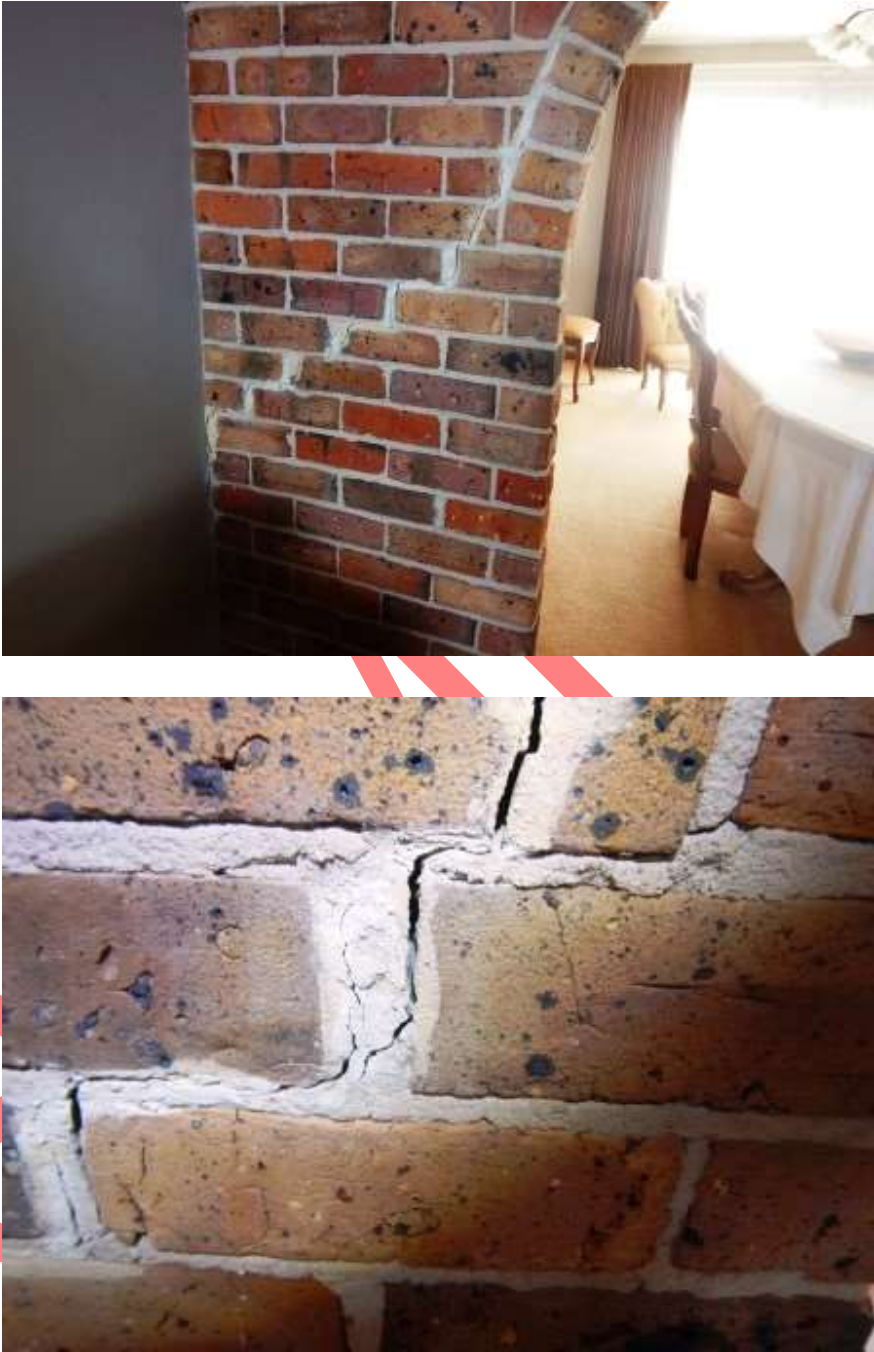
Location	Defect
Interior middle level front lounge room.	<div>Category 4: Cracks 15 mm to 25 mm in width which have been repaired in the past.</div> <div>

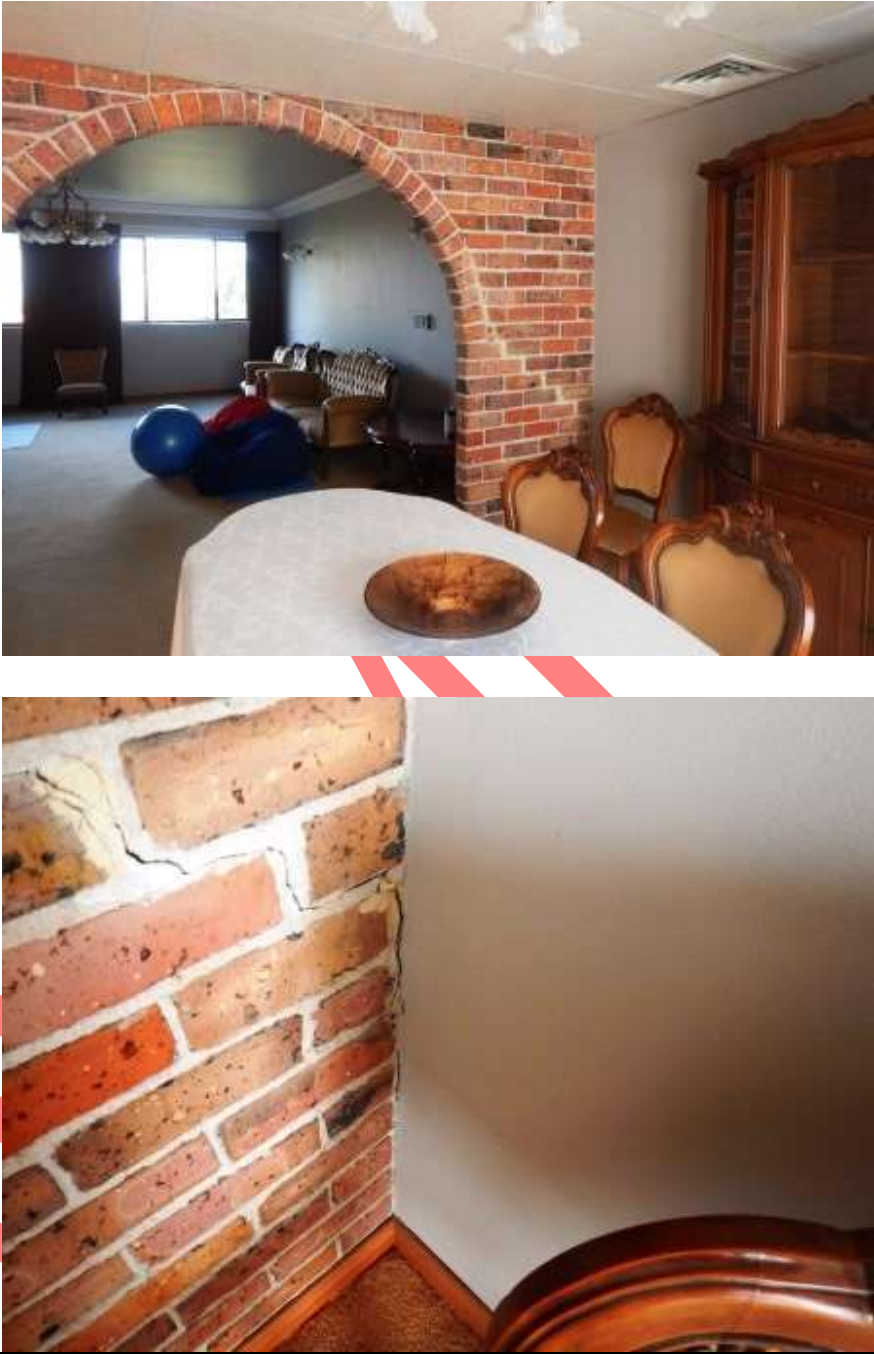
Location	Defect
Interior middle level front lounge room.	<div>Existing condition, location photo and category 4: Cracks 15 mm to 25 mm in width which have been repaired in the past.</div> <div>

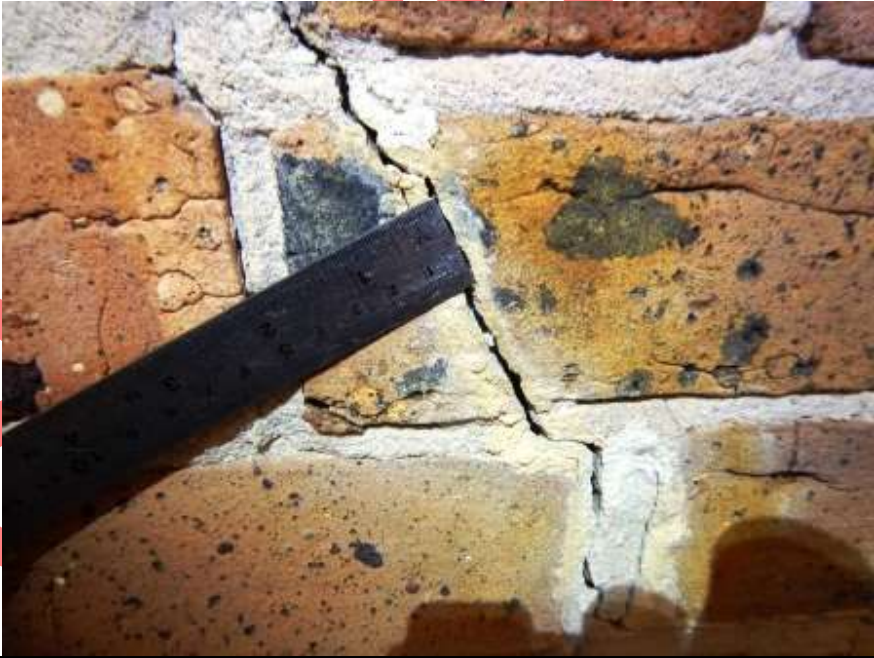
Location	Defect
Interior middle level front lounge room.	<div>Category 4: Cracks 15 mm to 25 mm in width which have been repaired in the past.</div> <div>

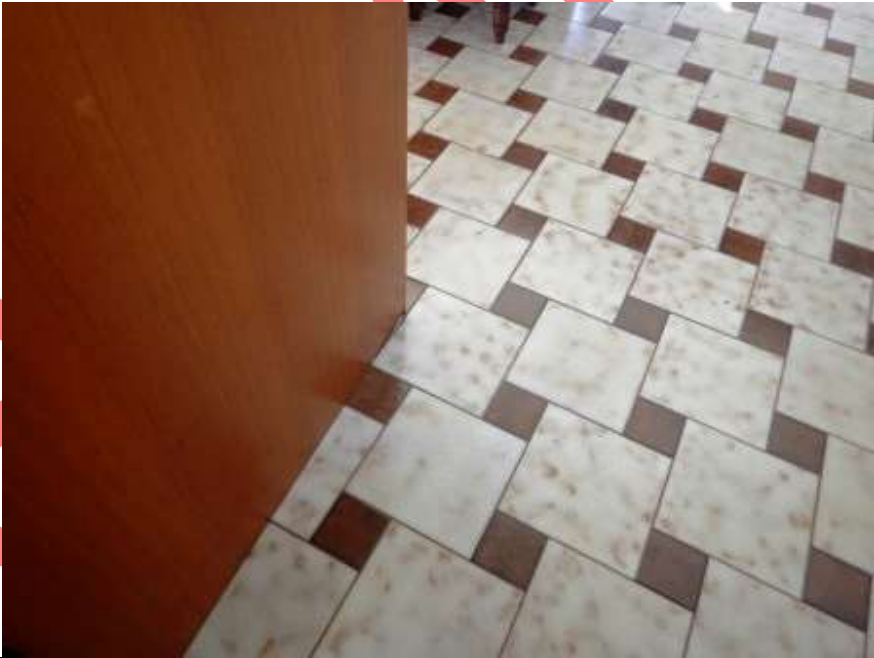
A photograph showing the interior middle level front door entry area. The walls are made of red brick. A wooden door frame is visible, leading into a room with a checkered tile floor. A green bag is hanging on the wall to the right of the door. A large red checkmark is overlaid on the right side of the image.</div>
Interior middle level kitchen / dining room door.	<div>Door binding on the tiles.</div> <div>

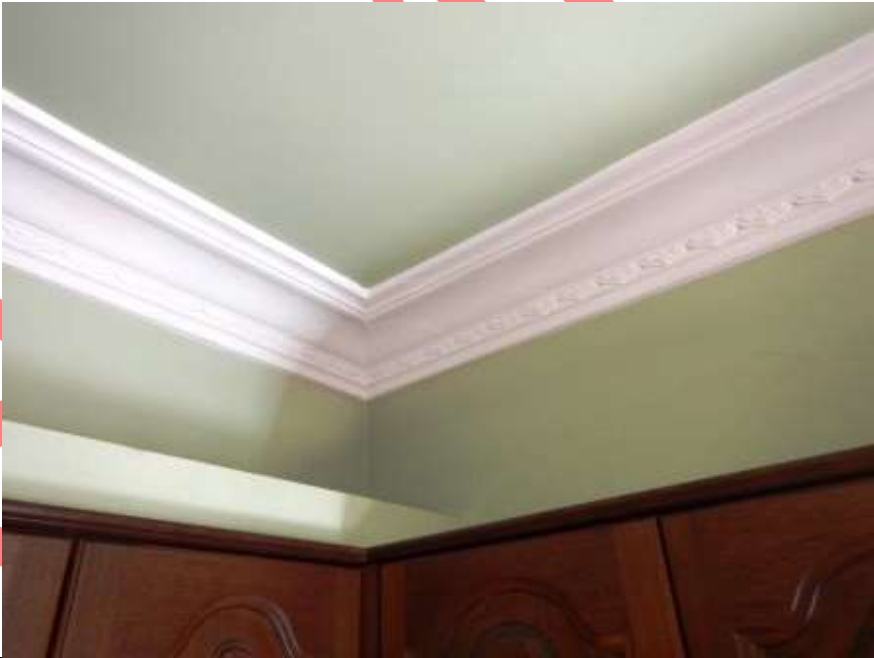
</div>
Interior middle level kitchen area.	<div>Hairline cracking to the ceiling cornice.</div> <div>

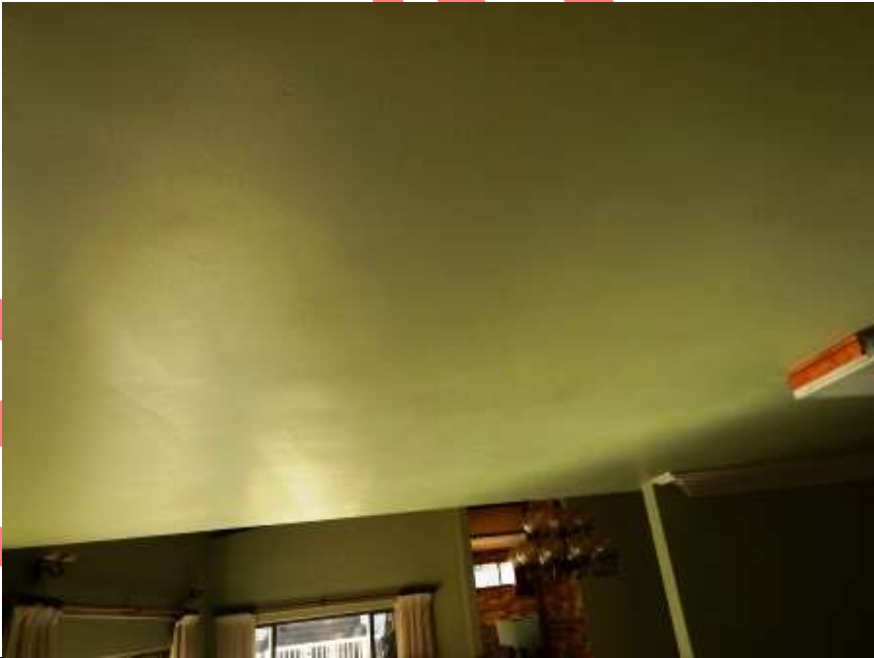
A wide-angle photograph of a bright, modern lounge room. The room features light-colored walls, a dark wood ceiling with exposed beams, and a large tiled floor. A large glass sliding door on the left leads to a balcony. In the background, there is a dining area with a white table and chairs, and a kitchen area with a brick wall and a large chandelier. A large red checkmark is overlaid on the right side of the image.</div>
Interior middle level rear lounge room.	<div>Hairline cracking to the ceiling lining.</div> <div>

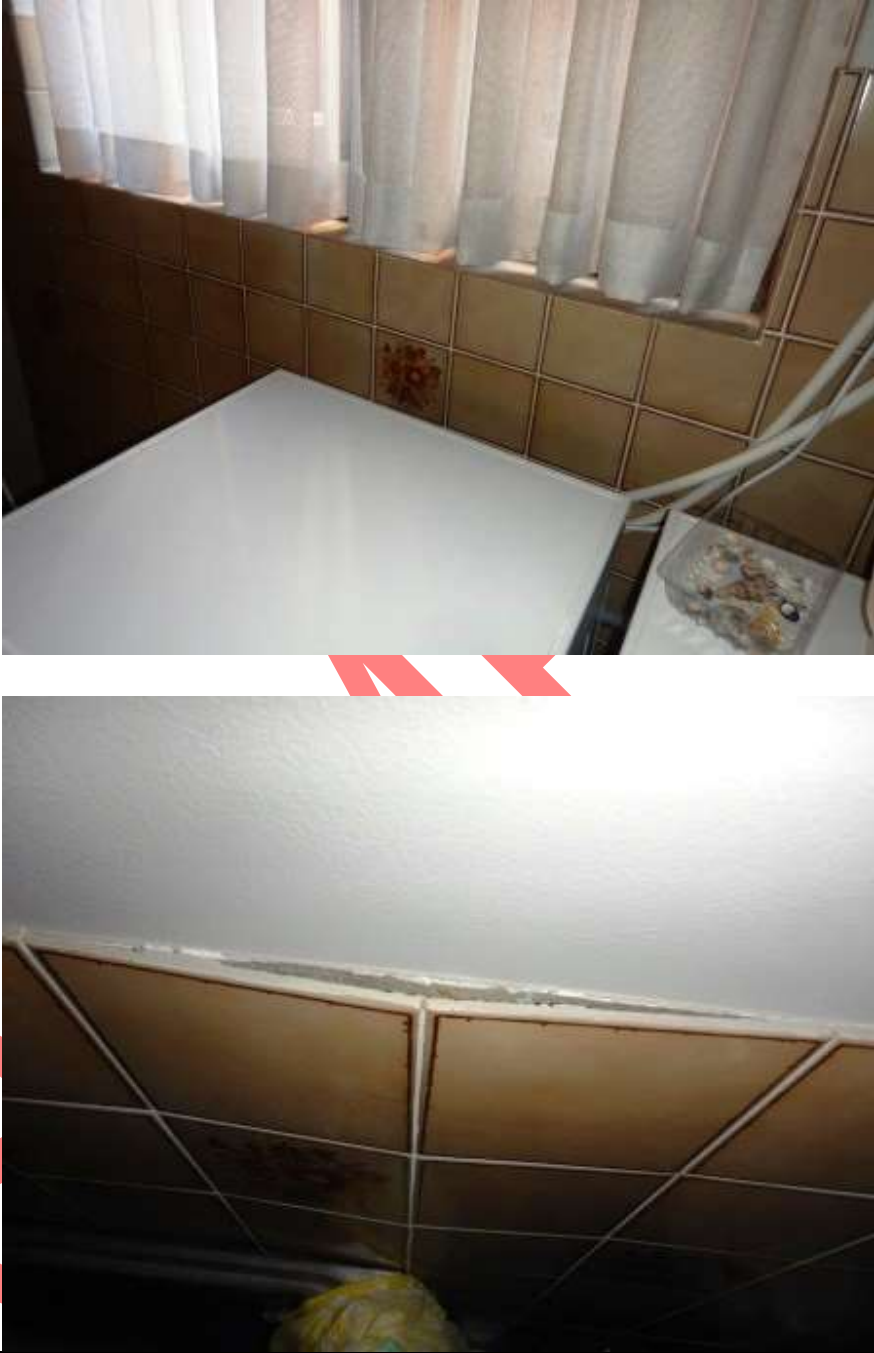
Location	Defect
Interior middle level laundry.	Existing condition, location photo, loose and drummy wall tiles. <div>

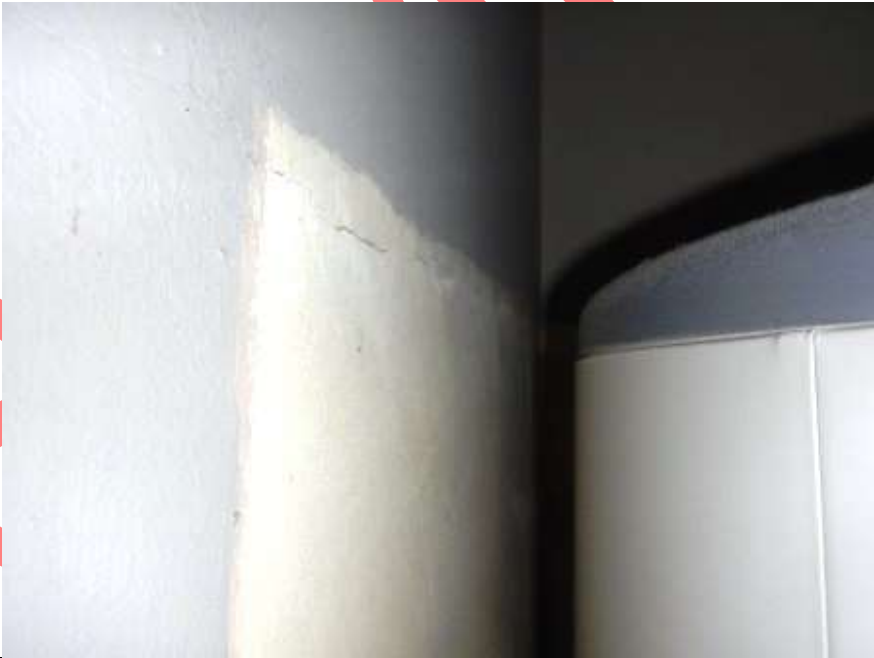
</div>
Interior middle level laundry.	<div>Category 1: Fine cracks that do not need repair &lt; 1mm in width.</div> <div>

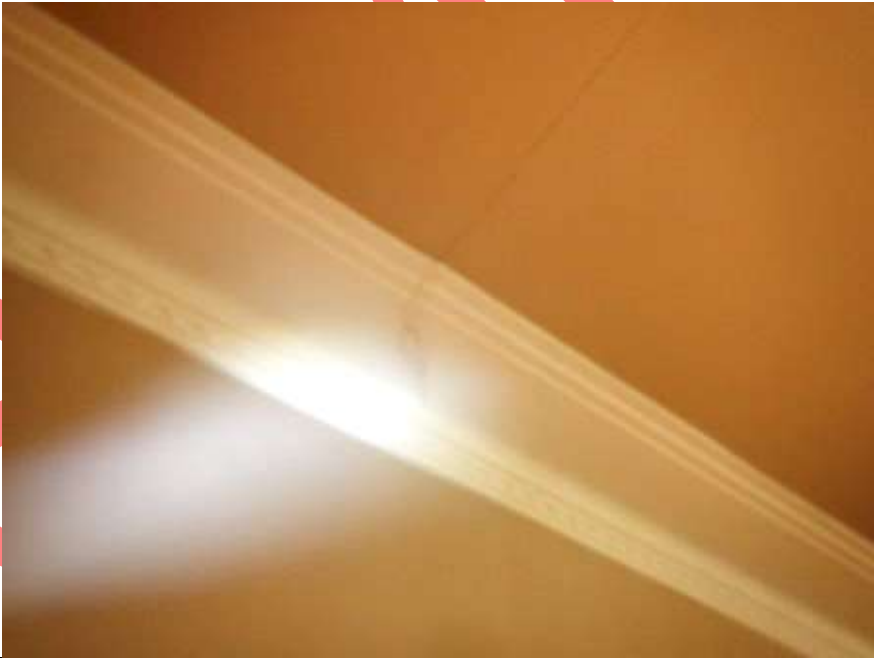
</div>
Interior top floor rear bedroom 3.	Cracking to the ceiling cornice and lining. <div>
