Residential Building Report

Pre-Purchase Inspection - Residential Building Report- (Except ACT)

Residential Pest Report

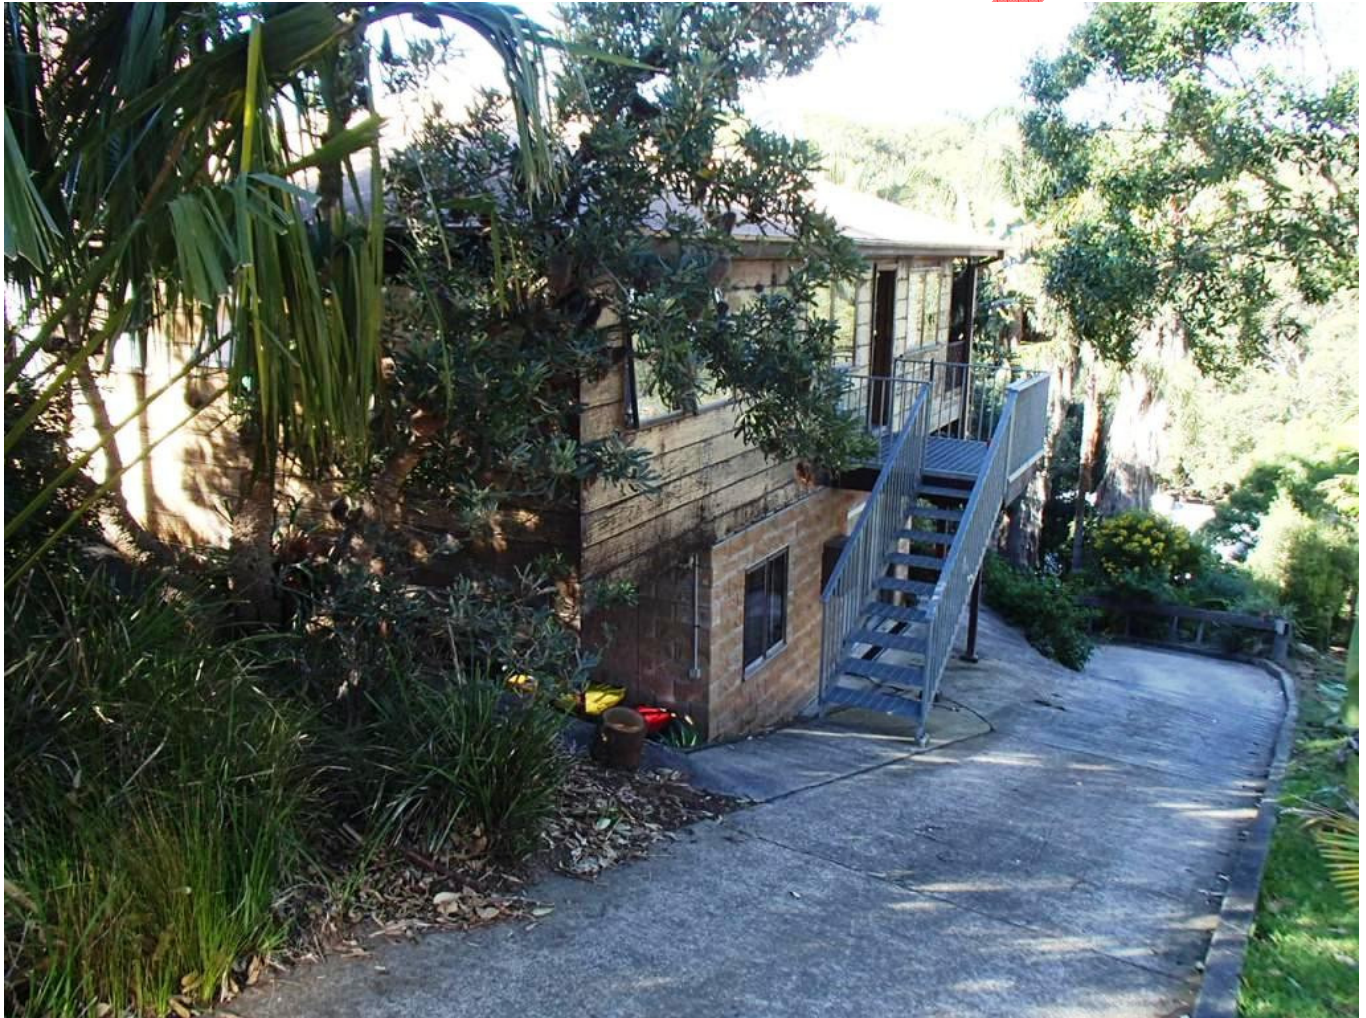
DWELLING

The property inspected is a two storey, free standing home of concrete block work, timber frame clad with timber weatherboards construction. This structure is on a concrete raft slab footings with a pitched roof covered in corrugated colour bond steel sheeting.

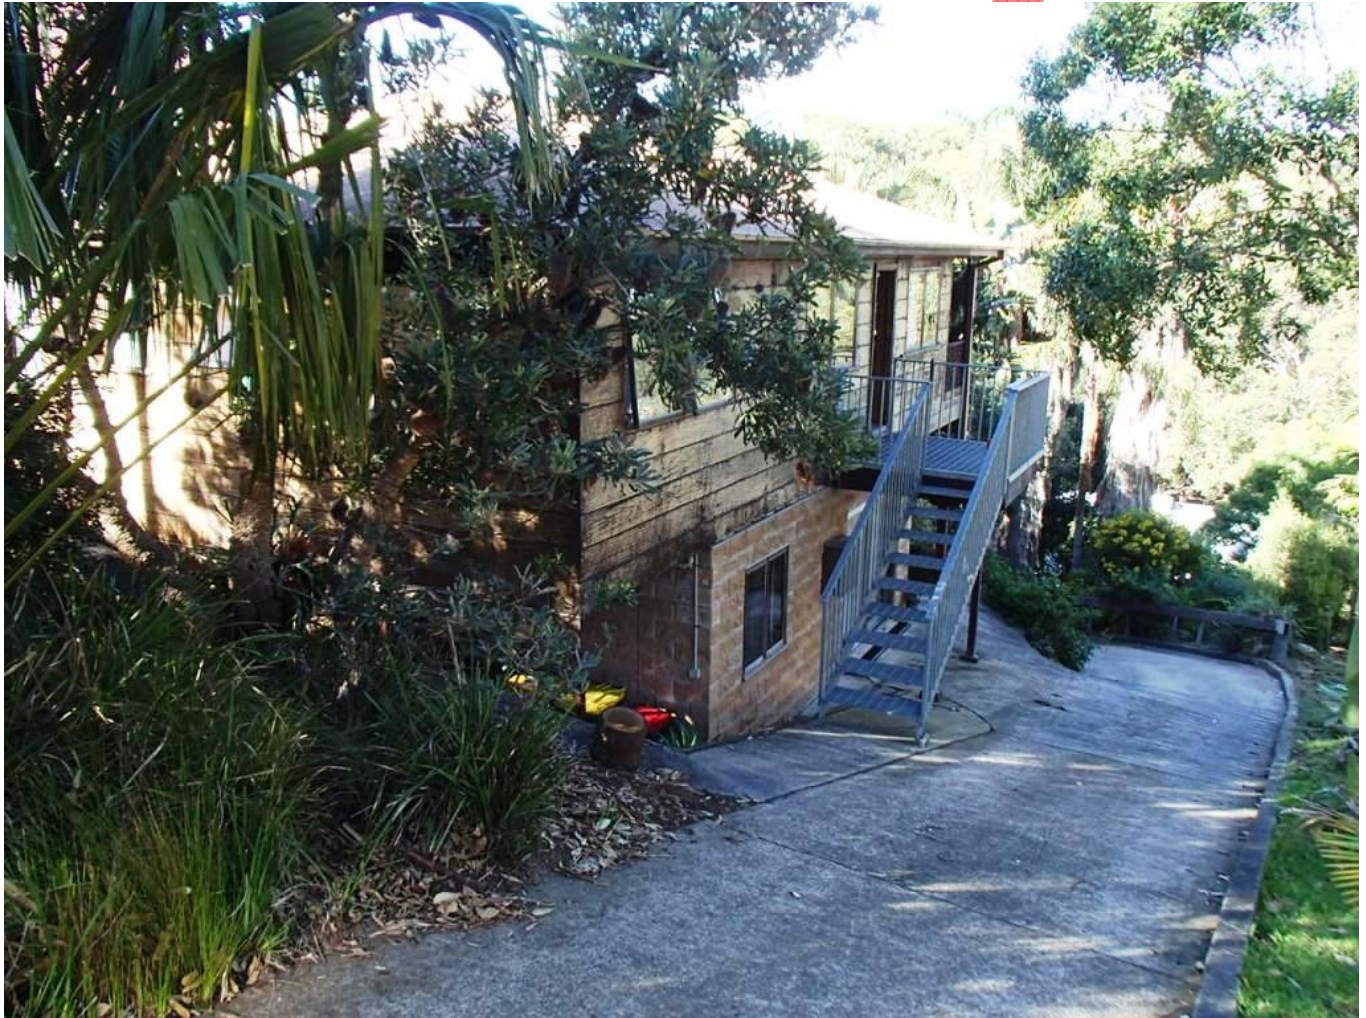
DWELLING

The property inspected is a two storey, free standing home of concrete block work, timber frame clad with timber weatherboards construction. This structure is on a concrete raft slab footings with a pitched roof covered in corrugated colour bond steel sheeting.

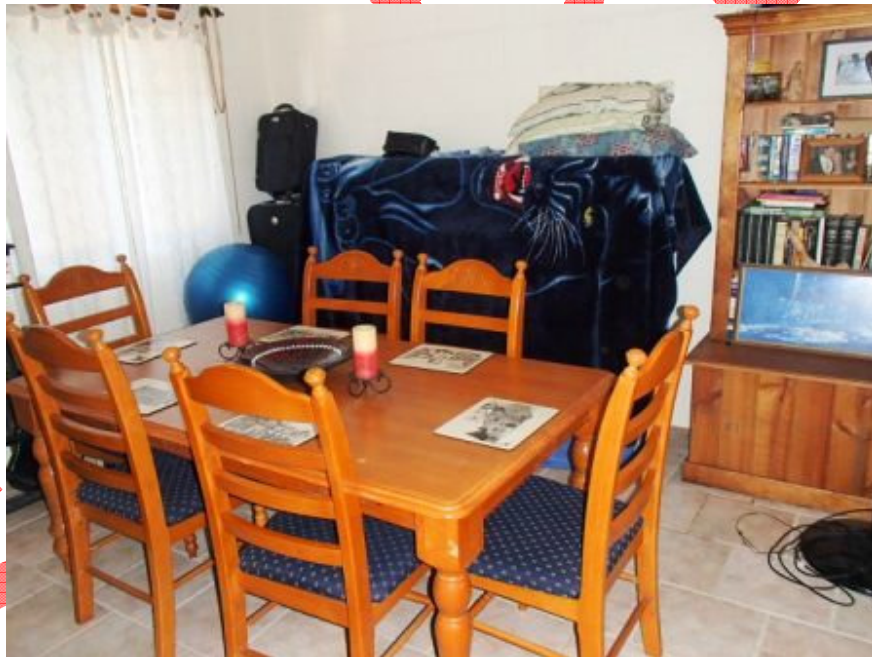
- Interior due to stored goods, furniture and floor coverings
