Residential Pest Report

Visual Timber Pest Inspection & Report in accordance with AS 4349.3 – 2010
(For use in all States & Northern Territory but not the Australian Capital Territory)

DWELLING

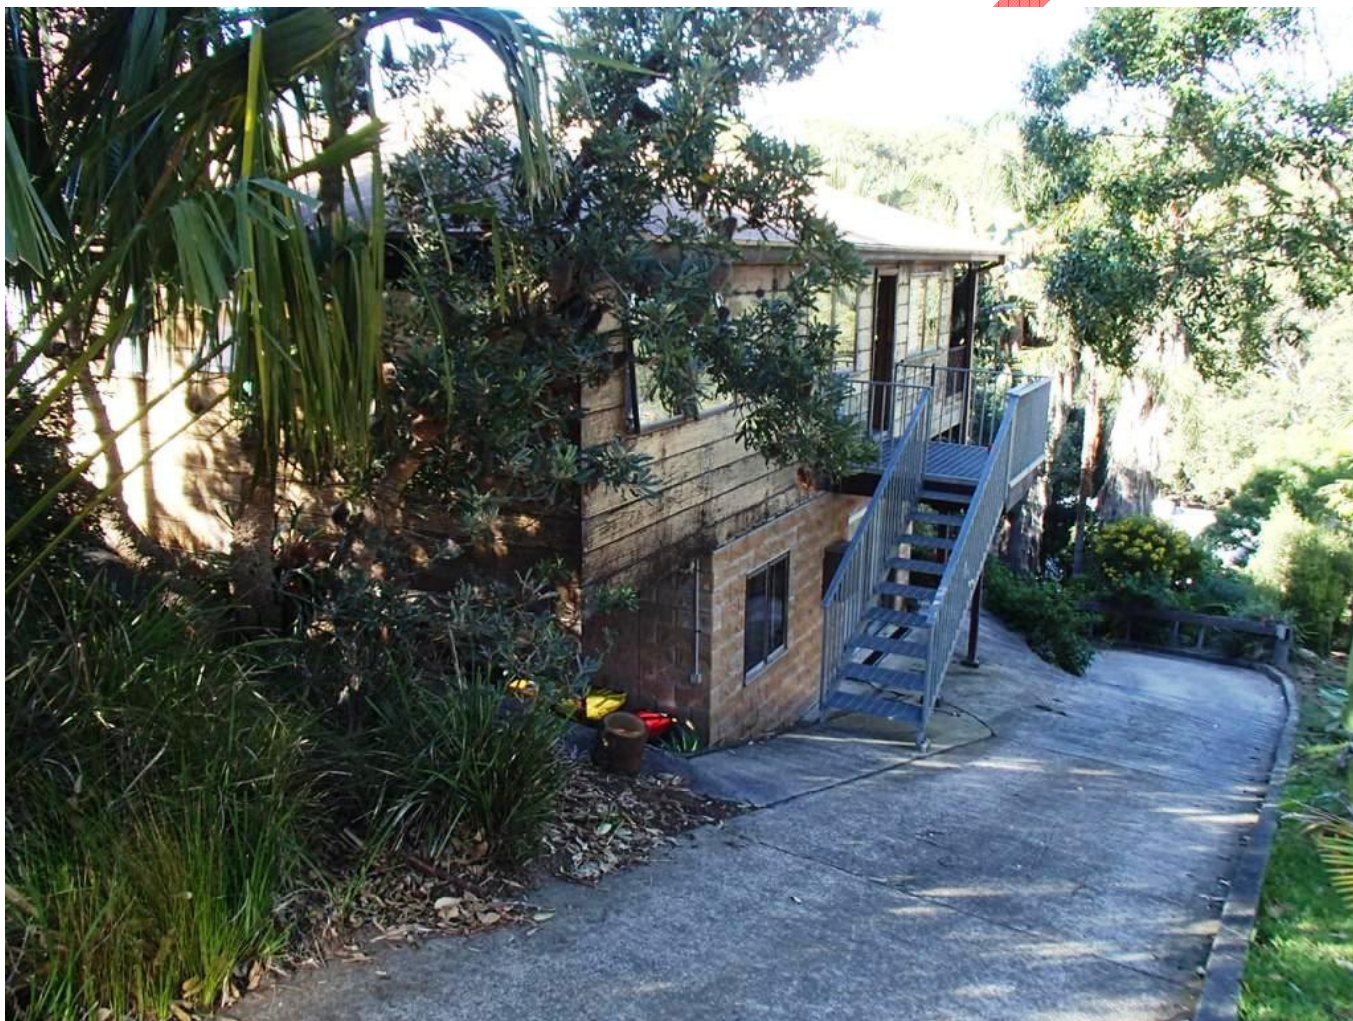
The property inspected is a two storey, free standing home of concrete block work, timber frame clad with timber weatherboards construction. This structure is on a concrete raft slab footings with a pitched roof covered in corrugated colour bond steel sheeting.
