# Dilapidation Report

## **Building Dilapidation Report (Except ACT)**

Building Dilapidation Report in accordance with Australian Standard AS 4349.0—2007. Inspection of Buildings – General Requirements for the purpose of assessing the general condition of the structure.

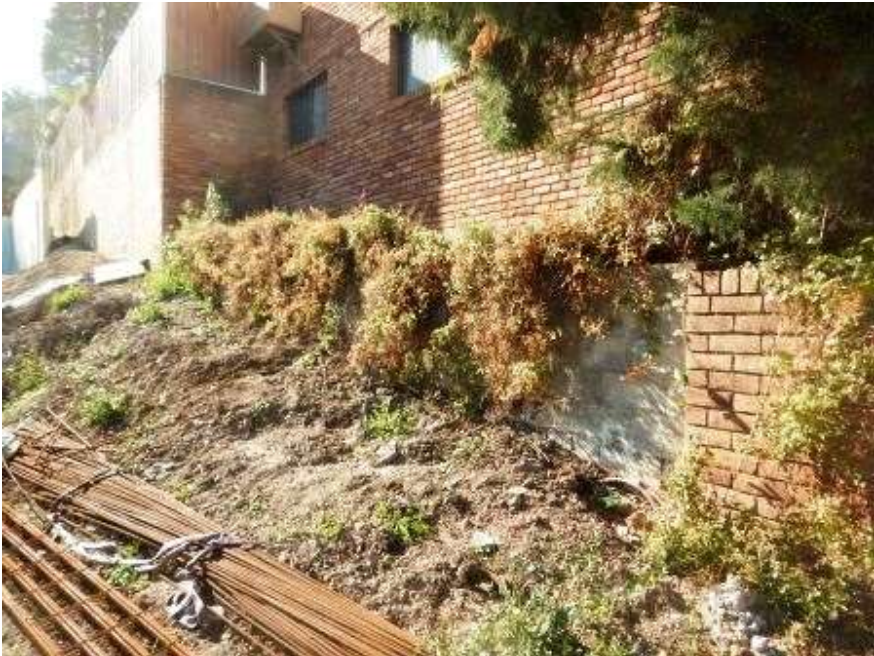
Location	Defect
Exterior left side boundary retaining wall.	Existing condition and location photo. <div>

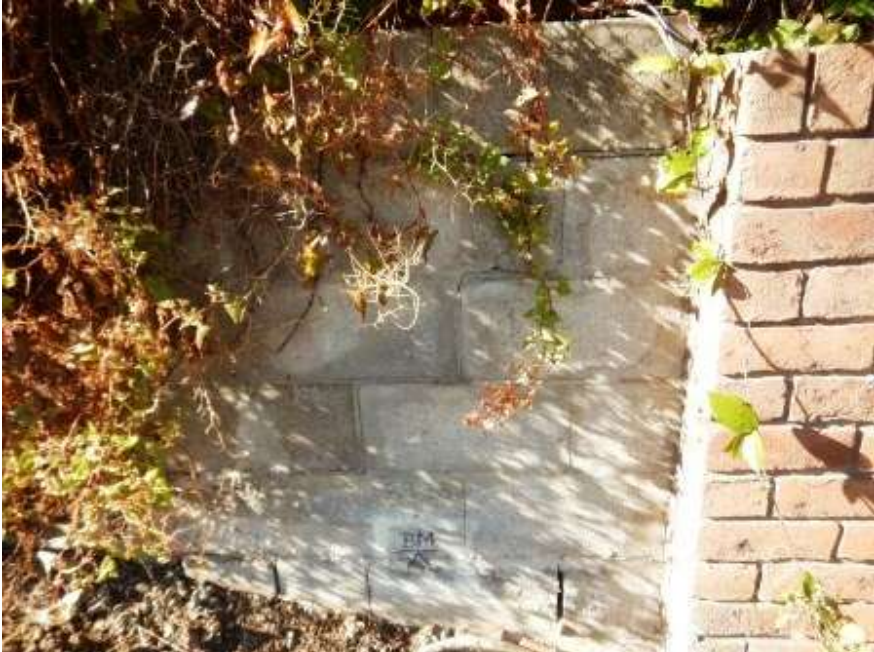
Location	Defect
Exterior left side boundary retaining wall.	<div>Category 2: Cracks noticeable but easily filled &lt; 5 mm in width.</div> <div>

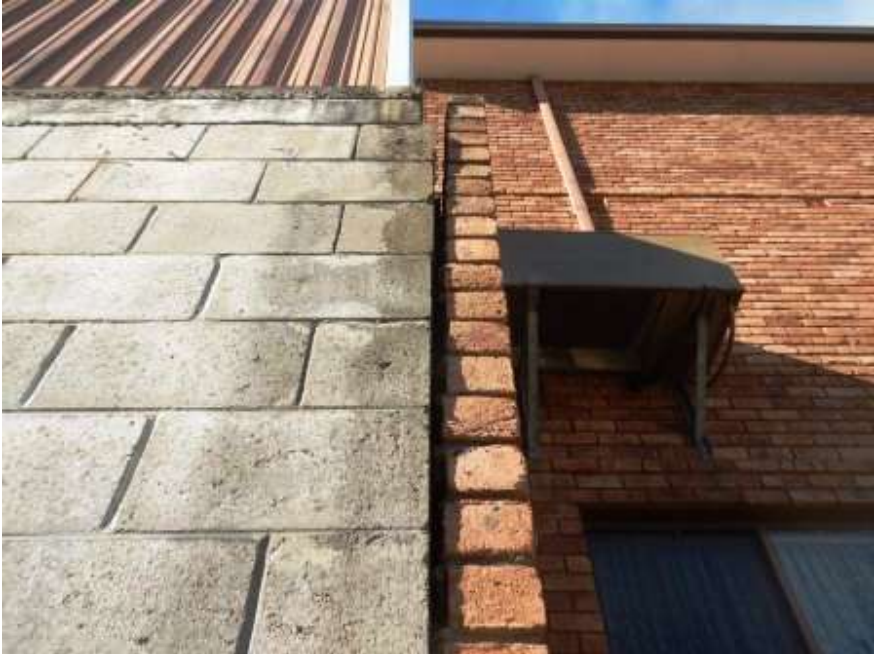
Location	Defect
Exterior left side boundary retaining wall.	Existing condition and location photo. <div>

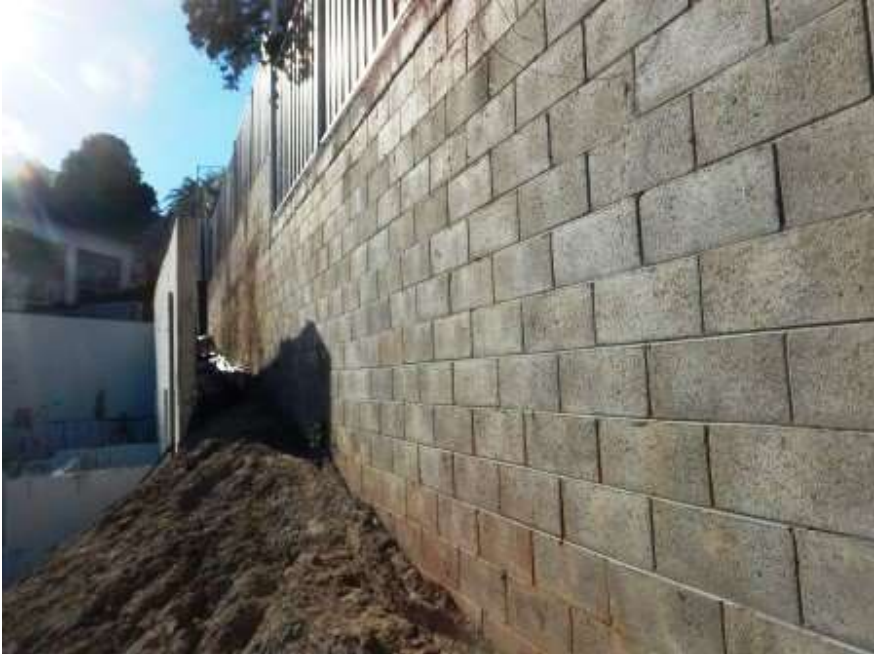
Location	Defect
Exterior left side boundary retaining wall.	<div>Existing condition and location photo.</div> <div>

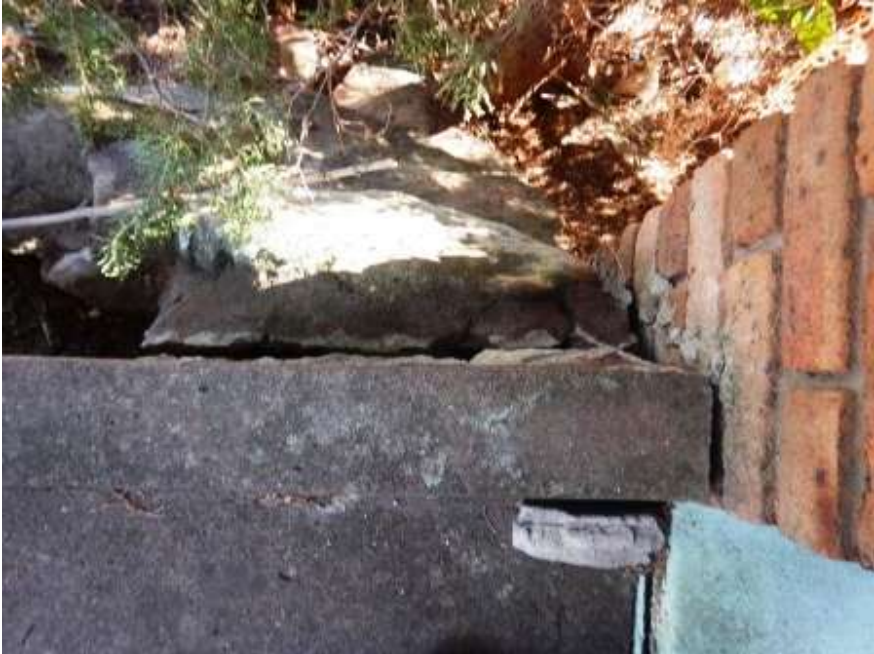
Location	Defect
Exterior front driveway garden walls.	Land slip and subsidence to the stone garden retaining walls. <div>

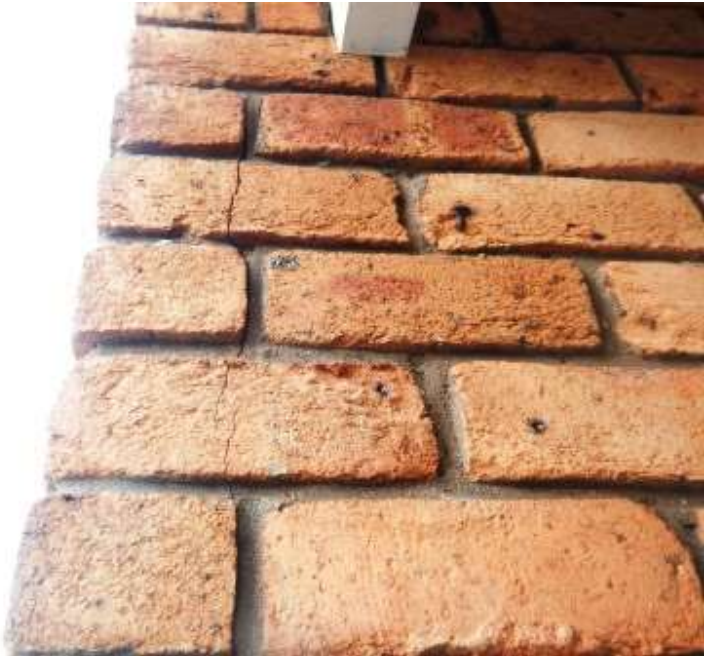
Location	Defect
Exterior front lower balcony area.	<div>Category 2: Cracks noticeable but easily filled &lt; 5 mm in width.</div> <div>

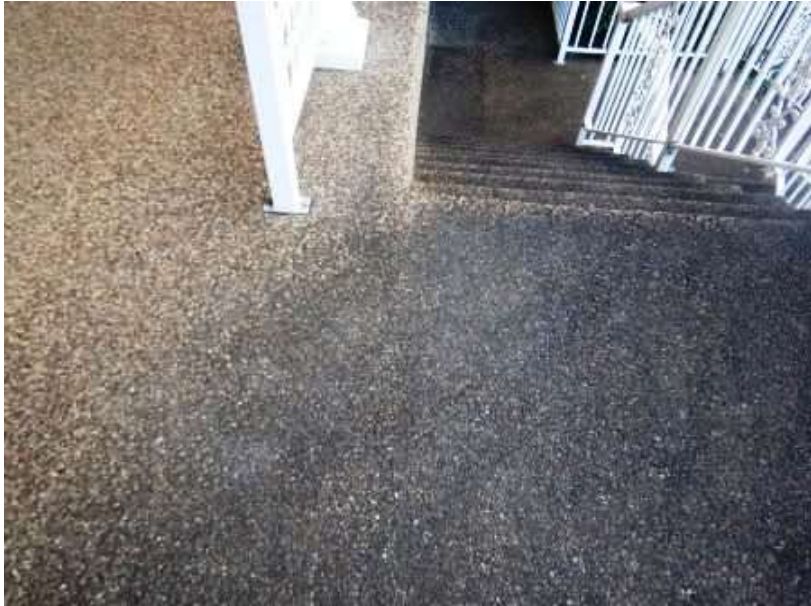
Location	Defect
Exterior front lower balcony area.	<p>Category 1: Fine but noticeable cracks, Slab reasonably level, &lt; 1.0 mm in width and &lt; 10 mm change in offset from a 3 m straight edge placed over the crack.</p>

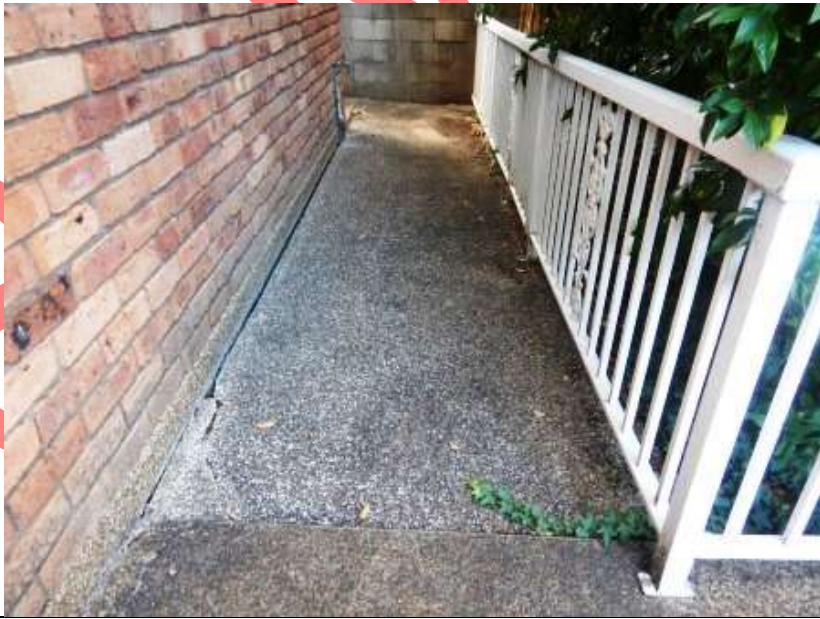
Exterior paving at the front.	<p>Category 4: Gaps in slab, Disturbing curvature or change in level, 4 mm to 10 mm in width and &gt; 25 mm change in offset from a 3 m straight edge placed over the crack.</p>

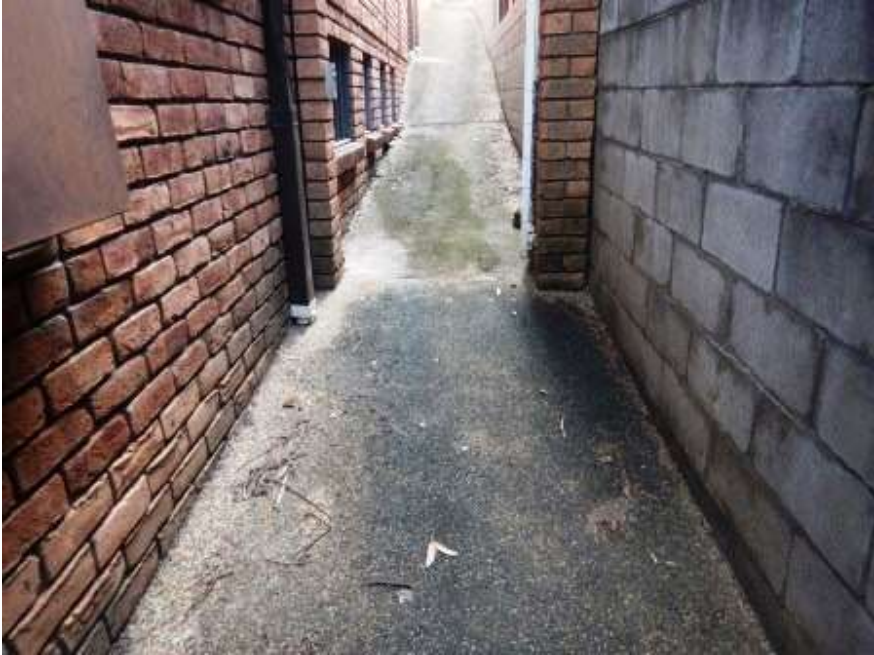
Location	Defect
Exterior paving to the right side.	<div>Existing condition and location photo.</div> <div>

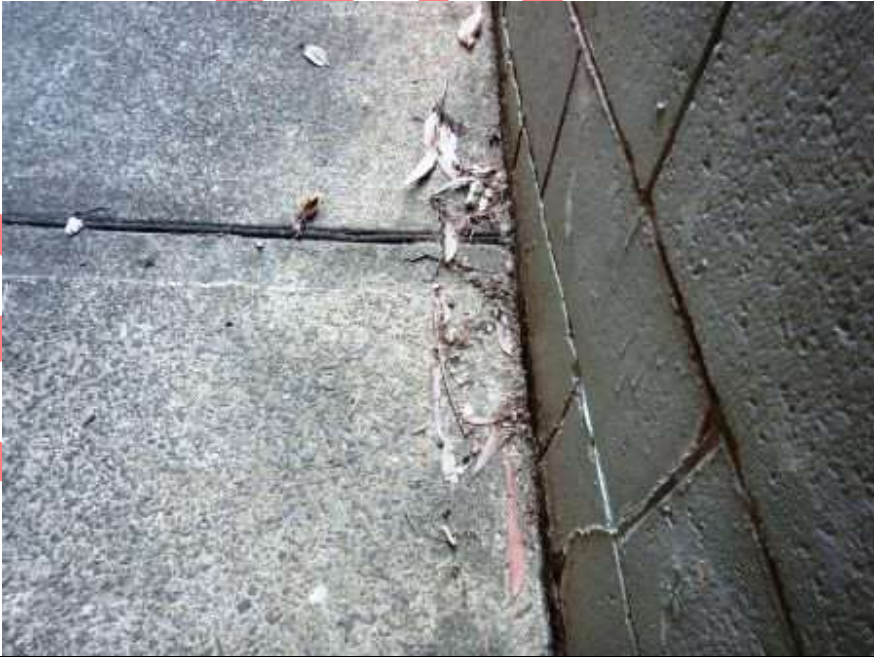
</div>
Exterior paving to the right side.	<div>Category 3: Wide cracks, Obvious curvature or change in level, 2 mm to 4 mm in width and 15 mm to 25 mm change in offset from a 3 m straight edge placed over the crack.</div> <div>

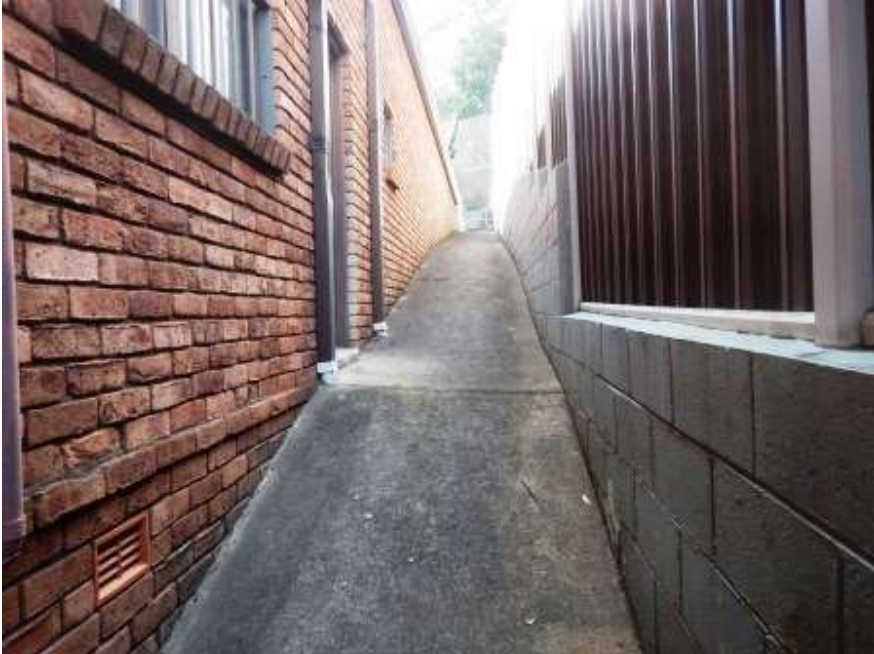
Location	Defect
Exterior right side.	Existing condition and location photo. <div>

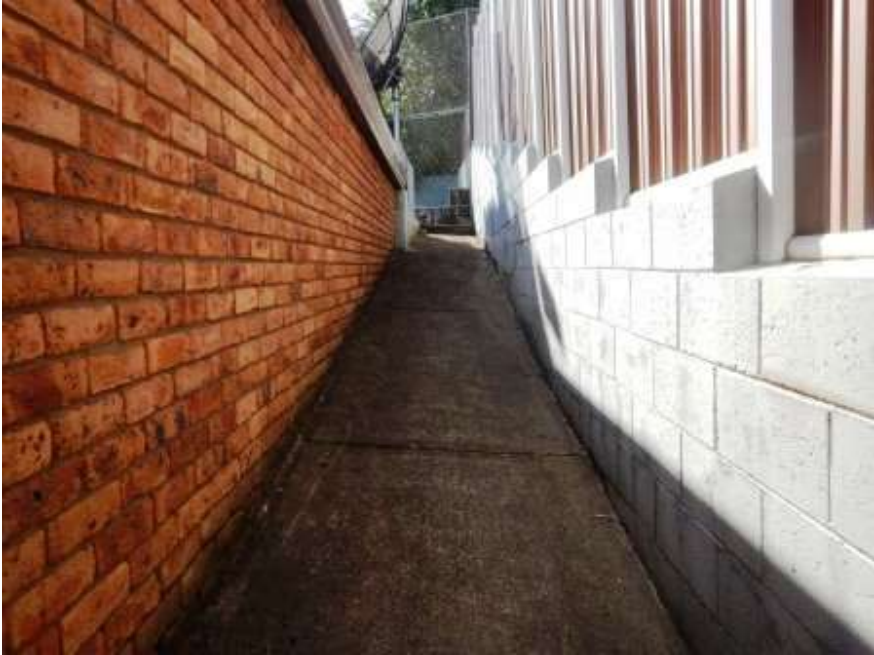
Location	Defect
Exterior right side.	Existing condition and location photo.

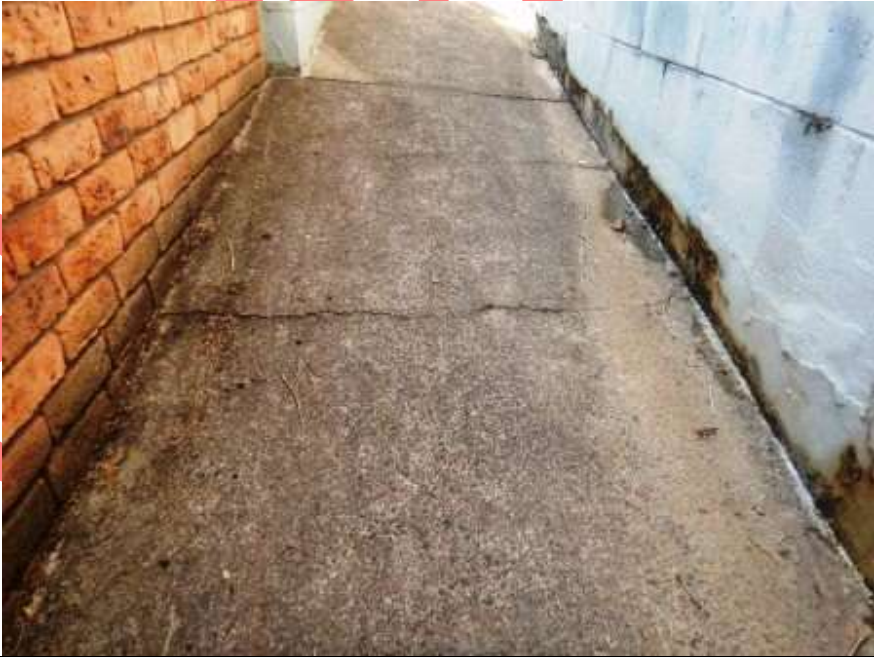
Exterior right side.	Category 2: Distinct cracks, Slab noticeably curved or changed in level, < 2.0 mm in width and < 15 mm change in offset from a 3 m straight edge placed over the crack.

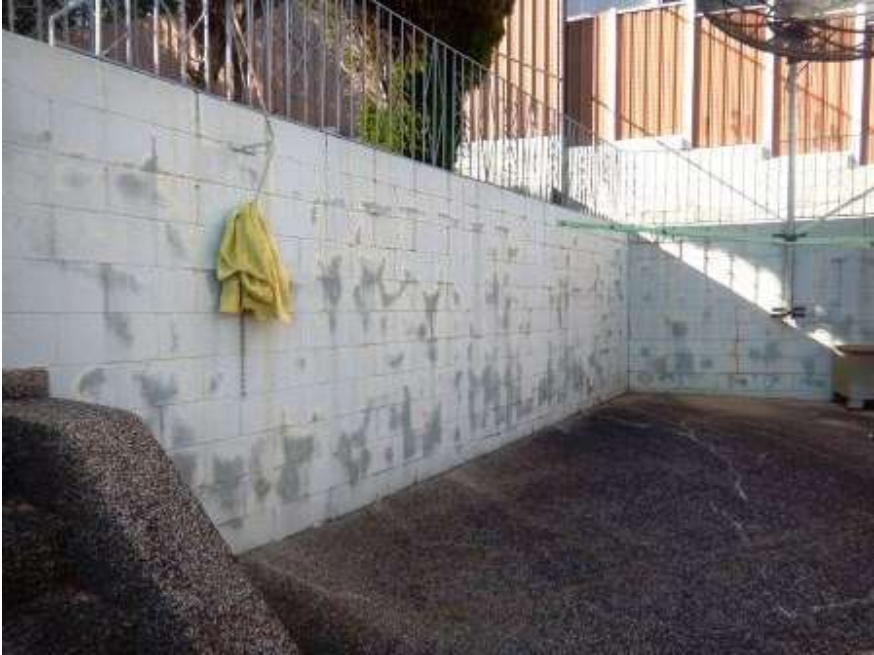
Location	Defect
Exterior rear retaining wals.	<div>Existing condition and location photo.</div> <div>

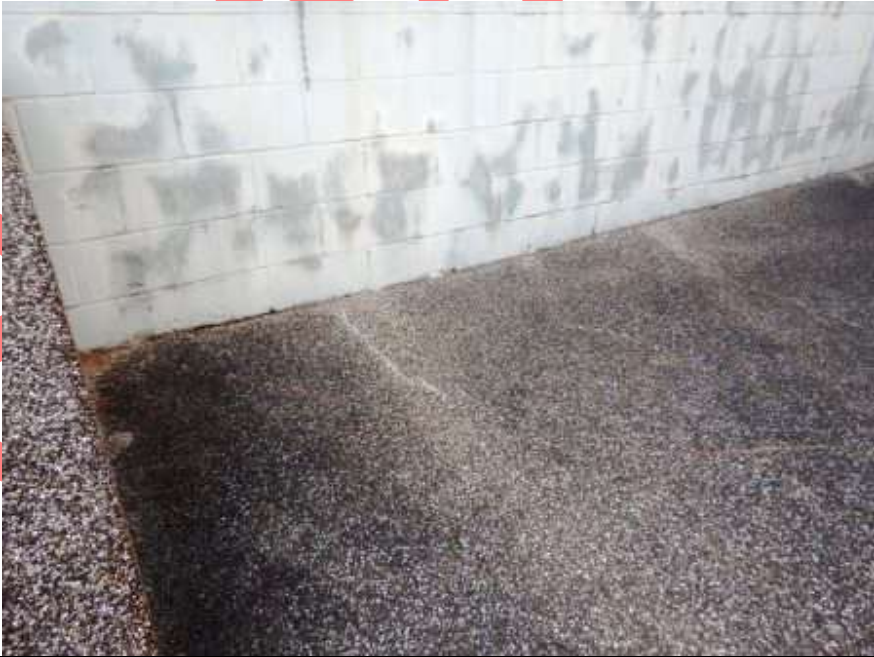
</div>
Exterior rear.	<div>Category 2: Distinct cracks, Slab noticeably curved or changed in level, &lt; 2.0 mm in width and &lt; 15 mm change in offset from a 3 m straight edge placed over the crack.</div> <div>

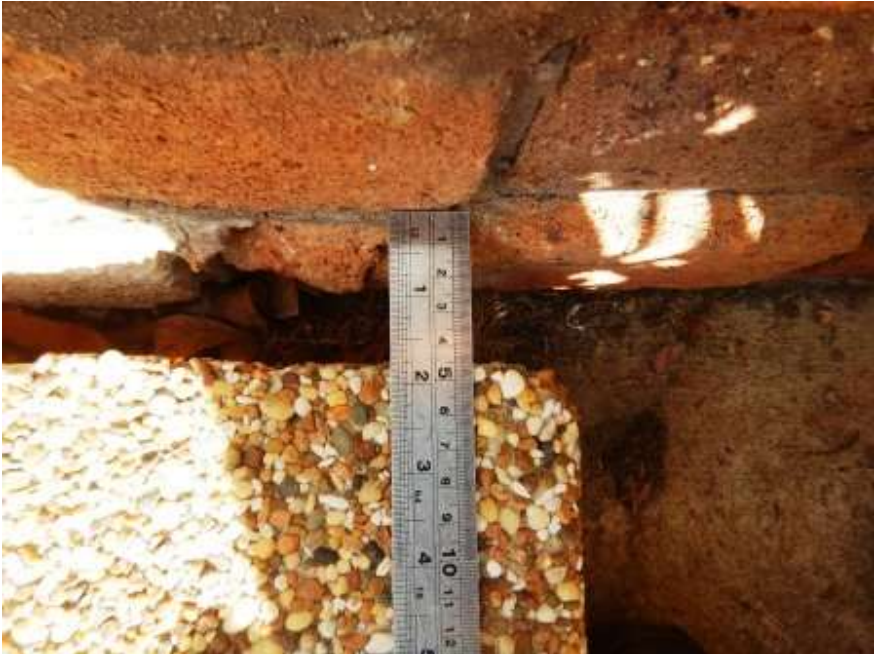
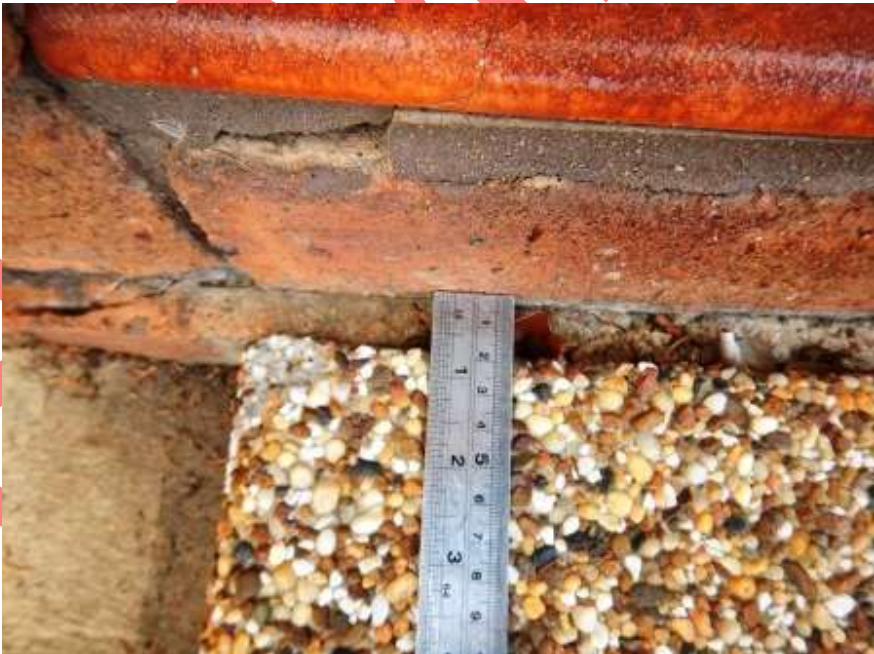
Location	Defect
Exterior rear.	<div>Category 4: Gaps in slab, Disturbing curvature or change in level, 4 mm to 10 mm in width and &gt; 25 mm change in offset from a 3 m straight edge placed over the crack.</div> <div>

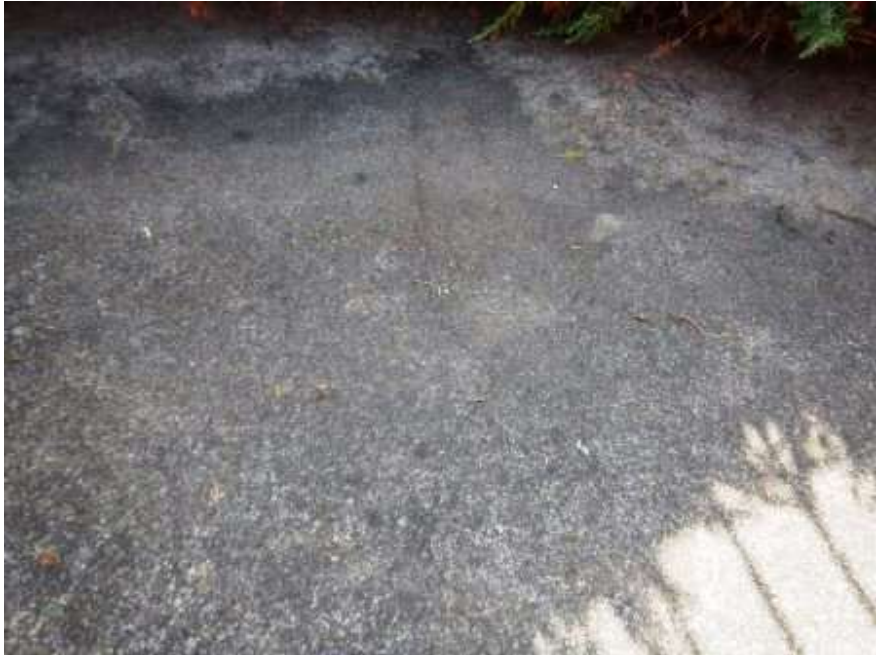
Location	Defect
Exterior rear.	<p>Category 1: Fine but noticeable cracks, Slab reasonably level, &lt; 1.0 mm in width and &lt; 10 mm change in offset from a 3 m straight edge placed over the crack.</p>

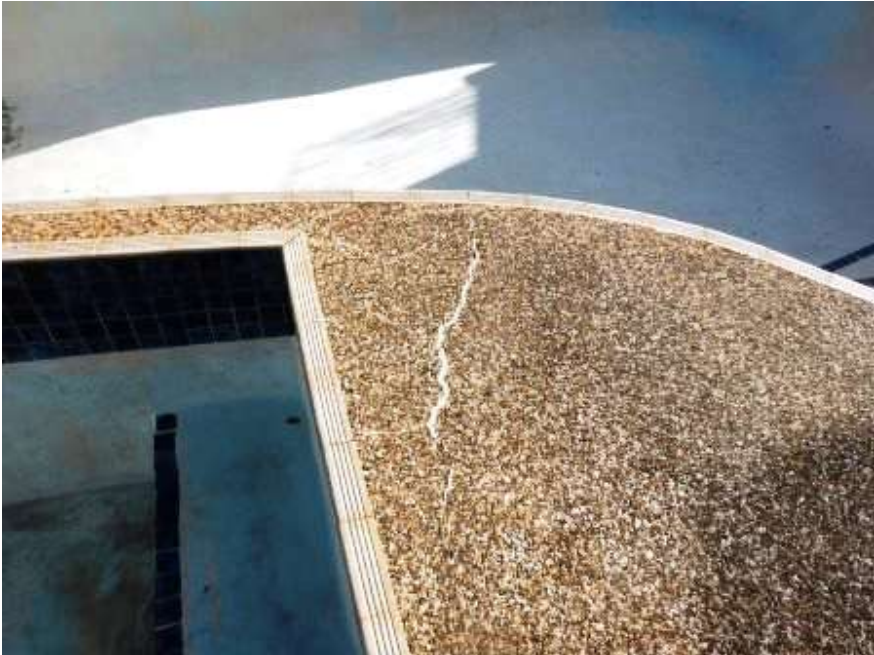
Location	Defect
Exterior rear pool area.	<p>Category 2: Distinct cracks, Slab noticeably curved or changed in level, &lt; 2.0 mm in width and &lt; 15 mm change in offset from a 3 m straight edge placed over the crack.</p>

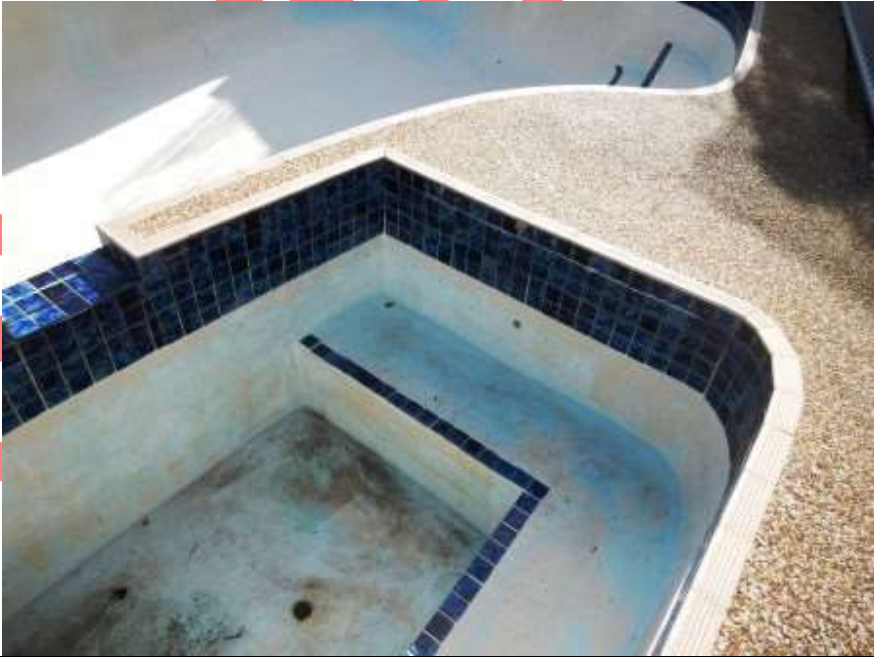
<p>A close-up photograph of a curved concrete slab, likely part of a pool deck or wall. A distinct, vertical crack is visible on the surface. The slab is covered with a light-colored, textured material, possibly aggregate or pebbles. A large red checkmark is overlaid on the right side of the image.</p>
Exterior rear pool area.	<p>Existing condition and location photo.</p>

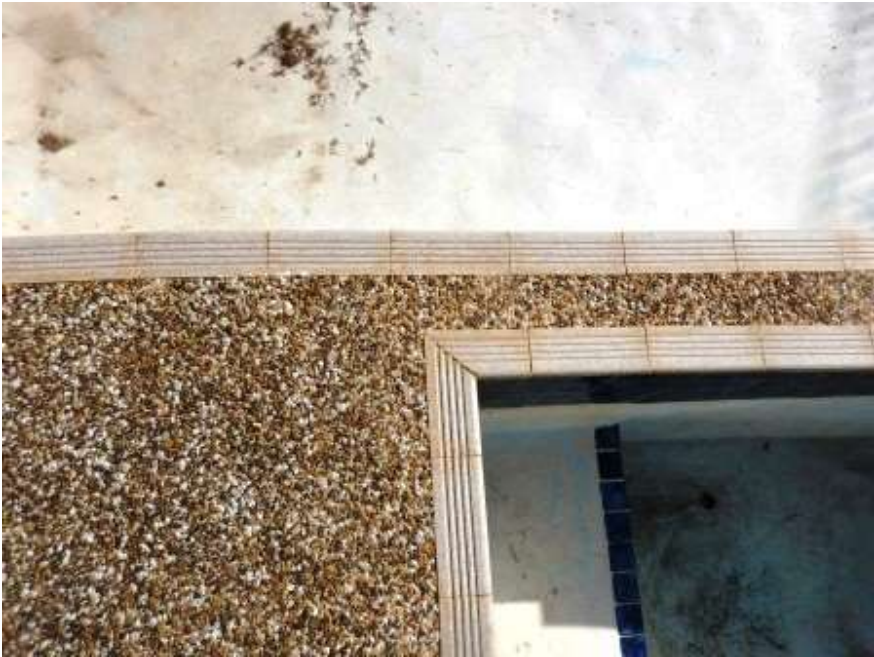
Location	Defect
Exterior rear pool area.	<div>Existing condition and location photo.</div> <div>

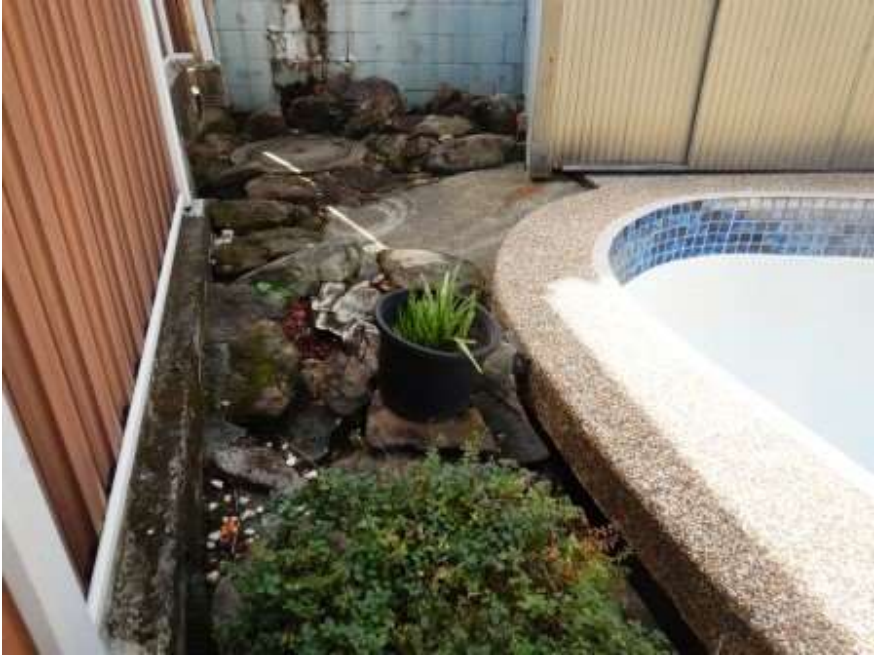
Location	Defect
Exterior rear pool area.	<div>Land slip and subsidence to the stone garden retaining walls.</div> <div>

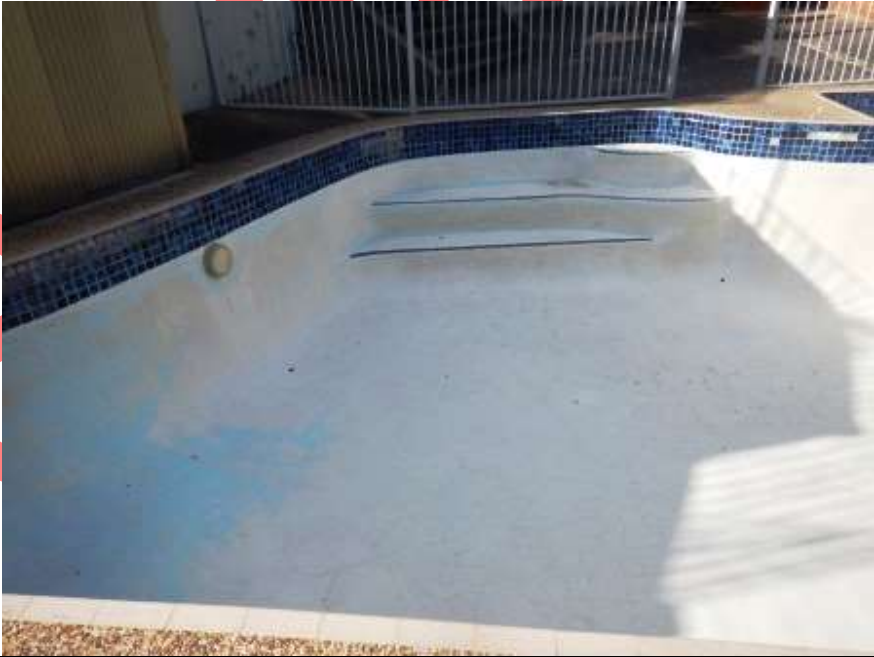
</div>
Exterior rear pool area.	<div>Category 0: Hairline cracks, insignificant movement of the slab level, &lt; 0.3 mm in width and &lt; 8 mm change in offset from a 3m straight edge placed over the crack.</div> <div>

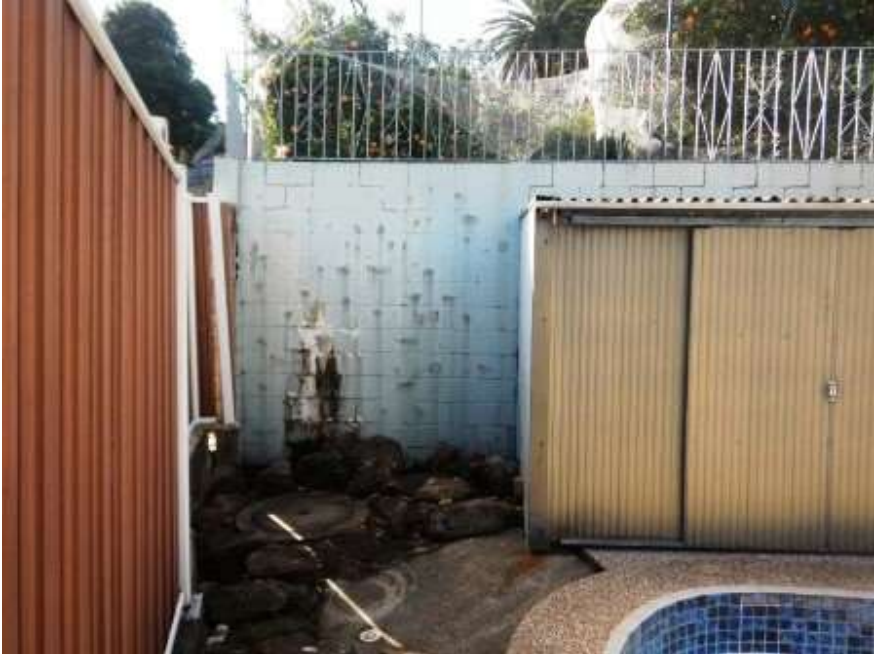
Location	Defect
Exterior rear pool area.	Existing condition and location photo. <div>

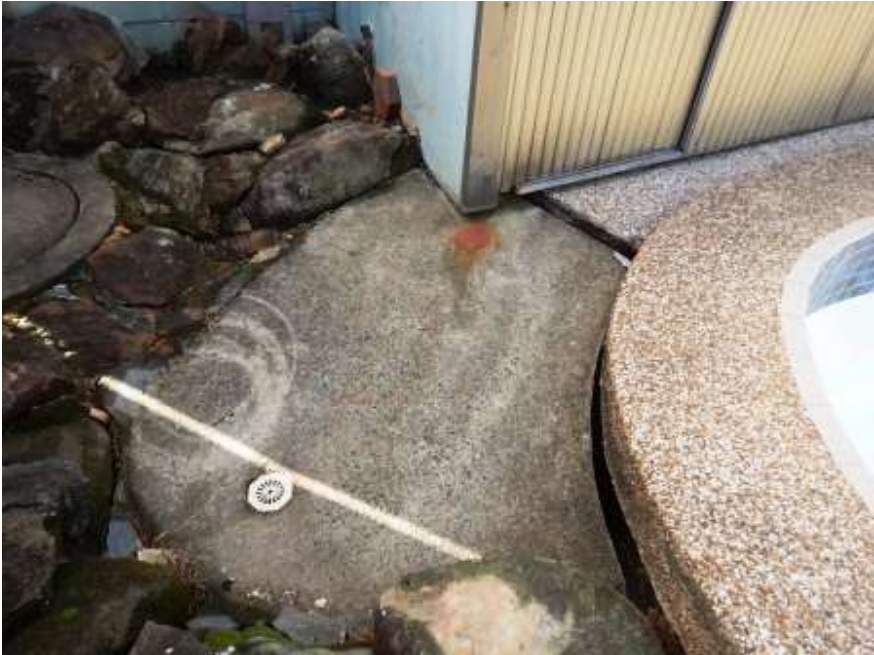
Location	Defect
Exterior rear pool area.	<p>Land slip and Category 4: Gaps in slab, Disturbing curvature or change in level, 4 mm to 10 mm in width and &gt; 25 mm change in offset from a 3 m straight edge placed over the crack.</p>

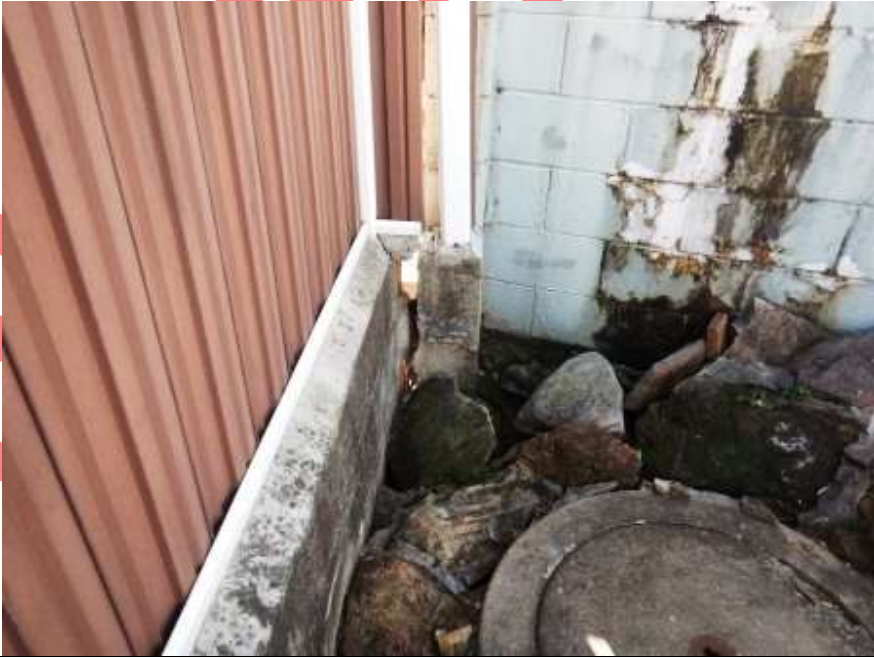
Exterior rear pool area.	<p>Category 4: Cracks 15 mm to 25 mm in width.</p>

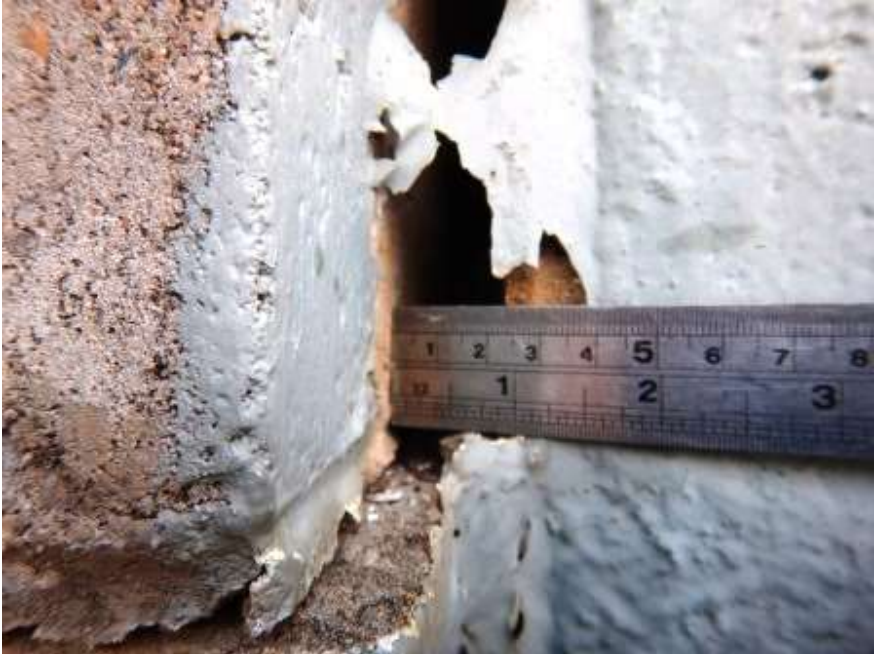
Location	Defect
Exterior rear pool area.	<div>Category 4: Cracks 15 mm to 25 mm in width.</div> <div>

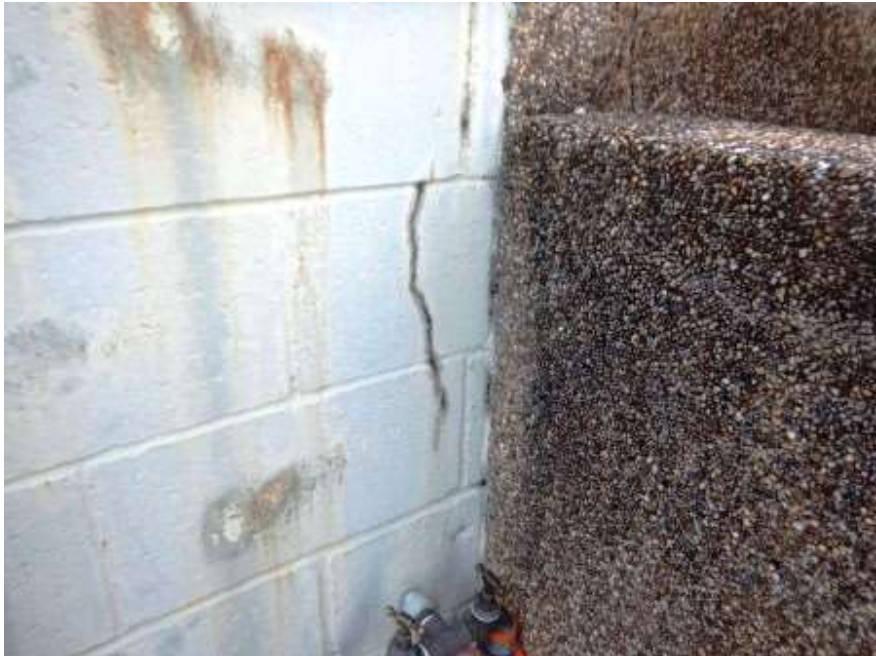
Location	Defect
Exterior rear retaining wall.	<div>Category 1: Fine cracks that do not need repair &lt; 1mm in width.</div> <div>

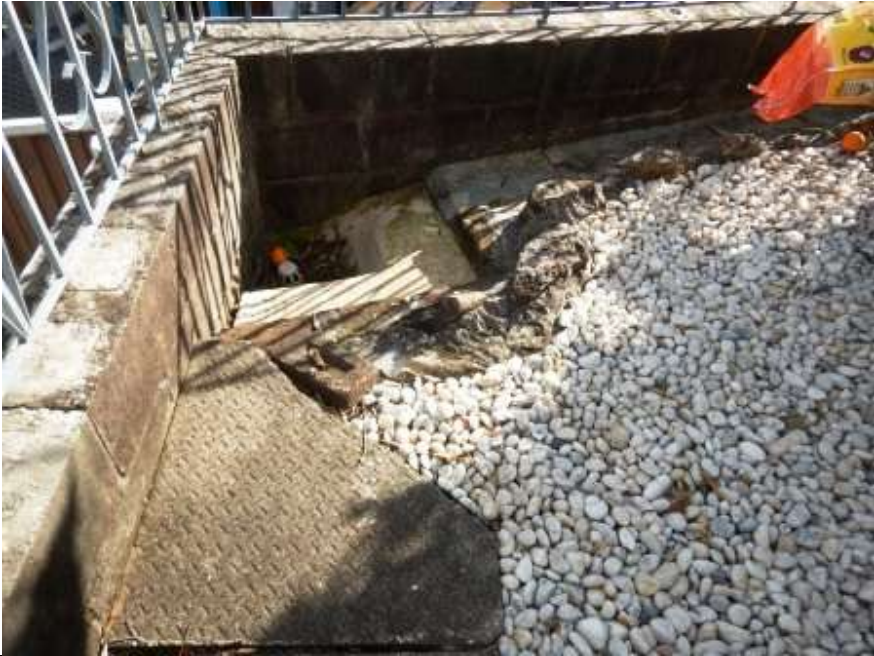
Location	Defect
Exterior upper rear tennis court level.	<div>Subsidence of the paving tiles, existing condition and location photo.</div> <div>

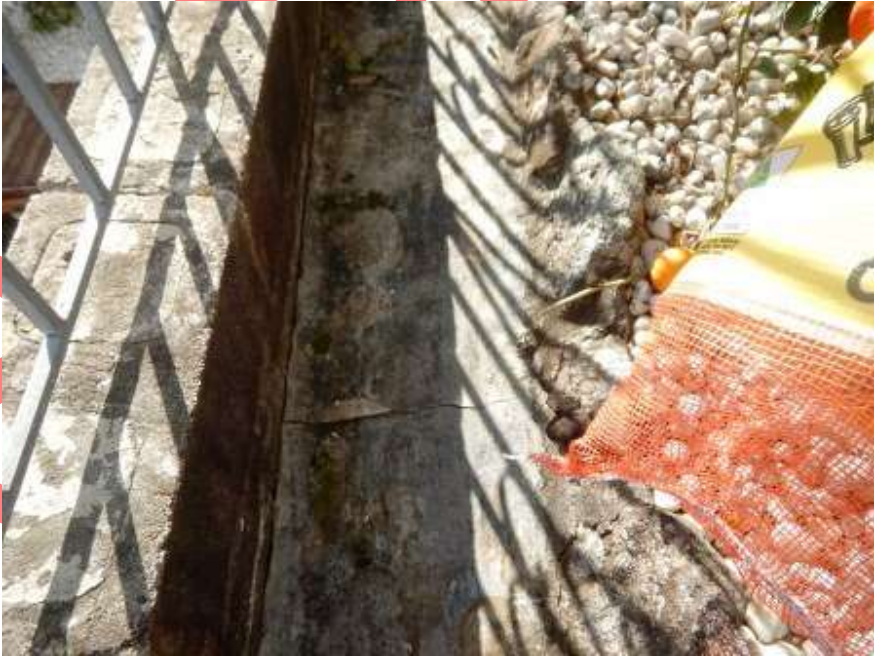
</div>
Exterior upper rear tennis court level.	<div>Category 1: Fine cracks that do not need repair &lt; 1mm in width.</div> <div>

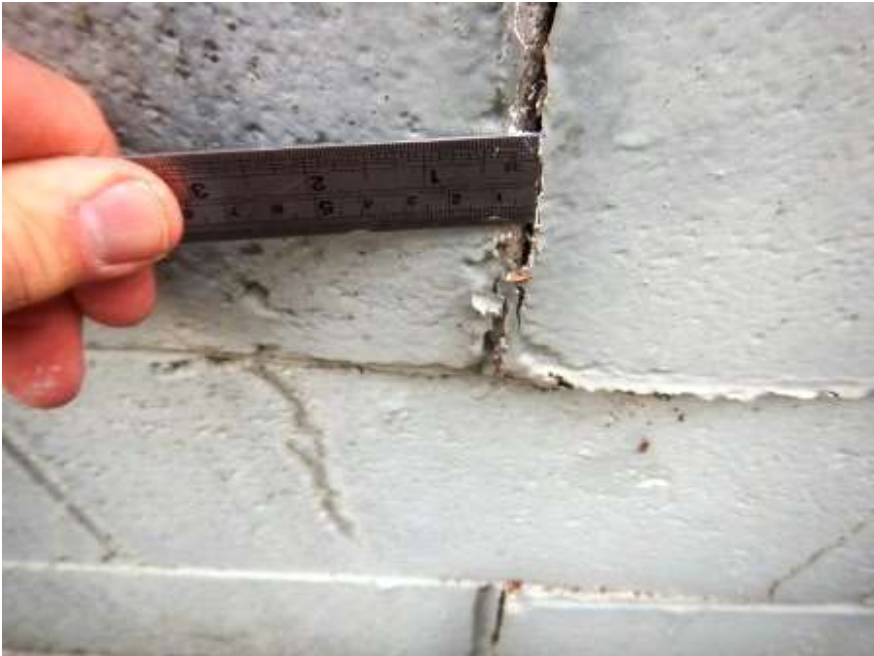
Location	Defect
Exterior upper rear tennis court level.	<div>Category 2: Cracks noticeable but easily filled &lt; 5 mm in width.</div> <div>

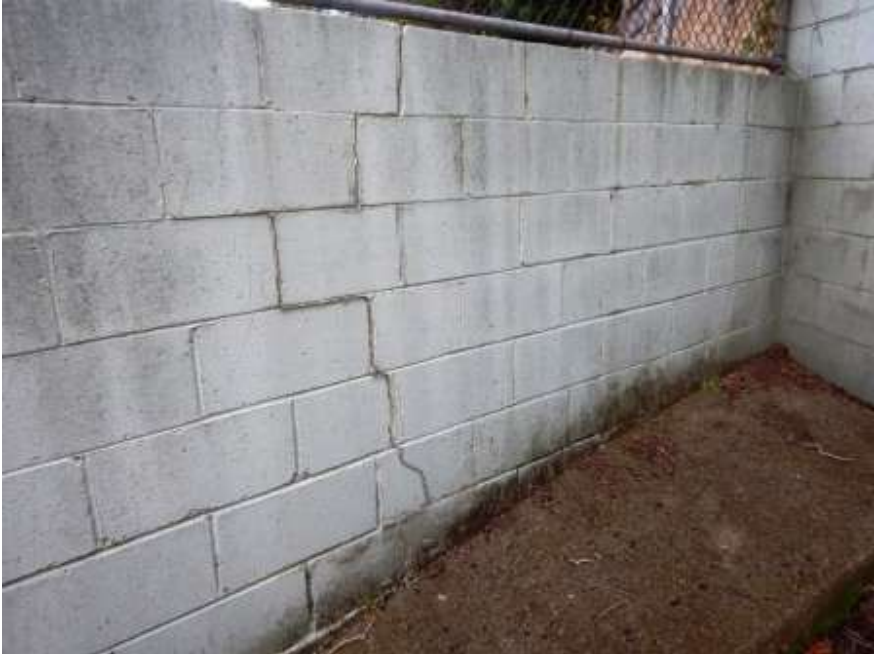
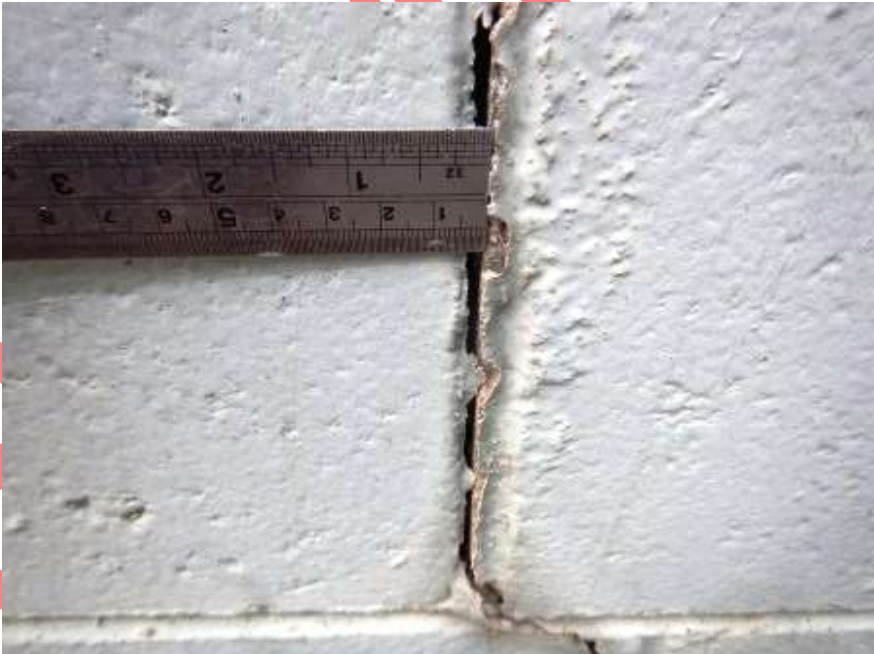
Location	Defect
Exterior upper rear tennis court level.	<div>Category 2: Cracks noticeable but easily filled &lt; 5 mm in width.</div> <div>

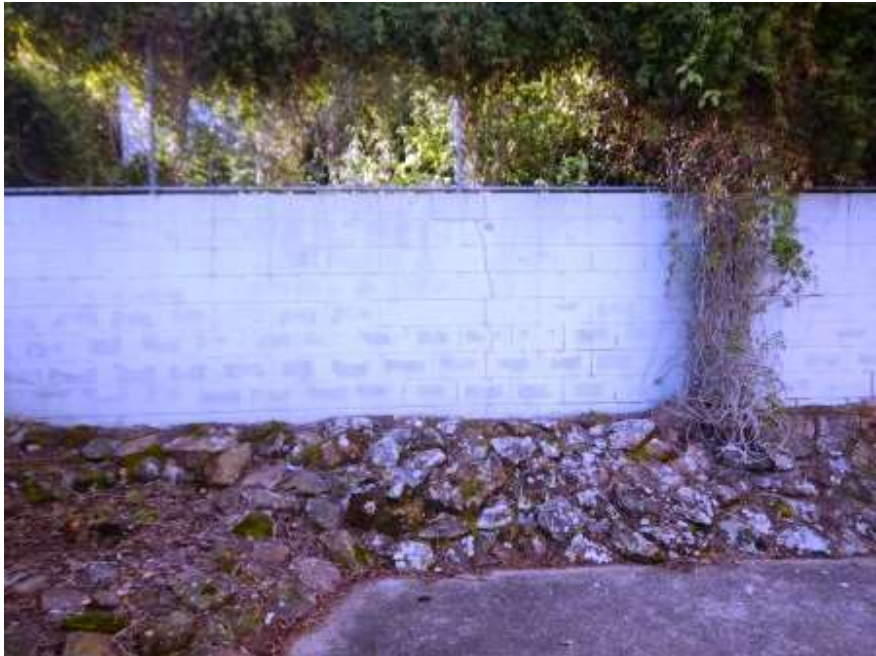
Location	Defect
Exterior upper rear tennis court level.	Existing condition and location photo. <div>

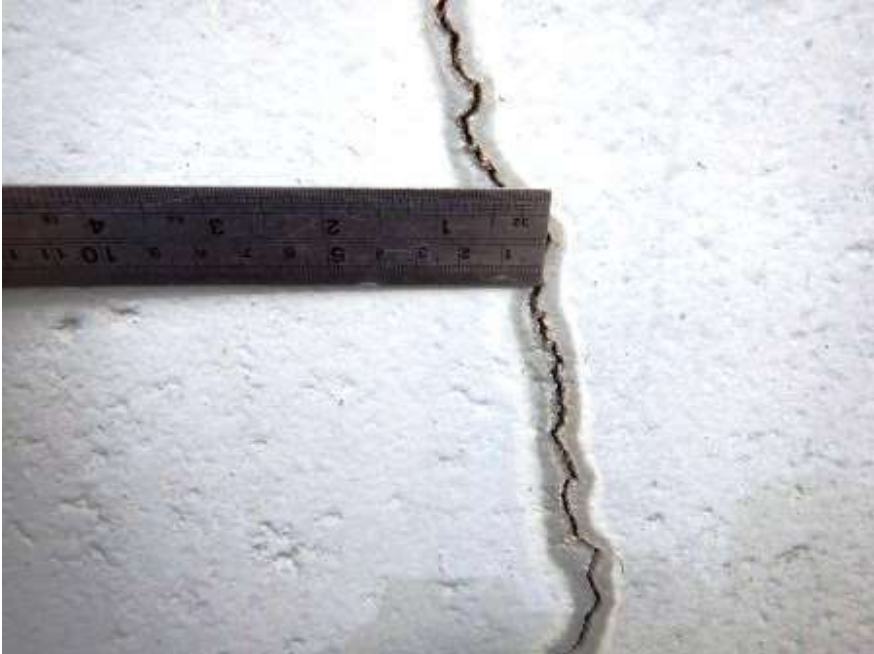
Location	Defect
Exterior upper rear tennis court level.	<div>Category 2: Cracks noticeable but easily filled &lt; 5 mm in width.</div> <div>

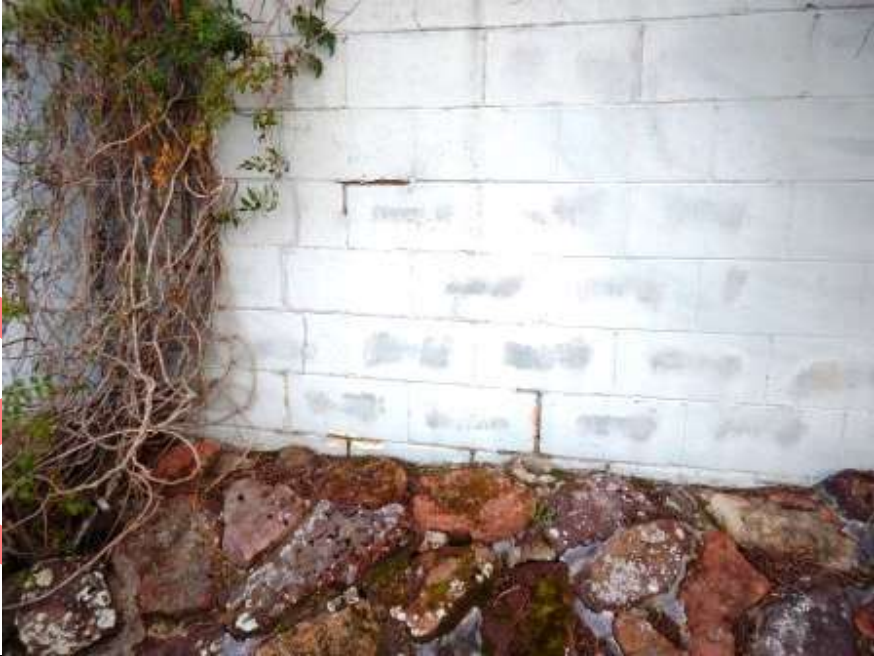
</div>
Exterior upper rear tennis court level.	<div>Category 2: Cracks noticeable but easily filled &lt; 5 mm in width.</div> <div>

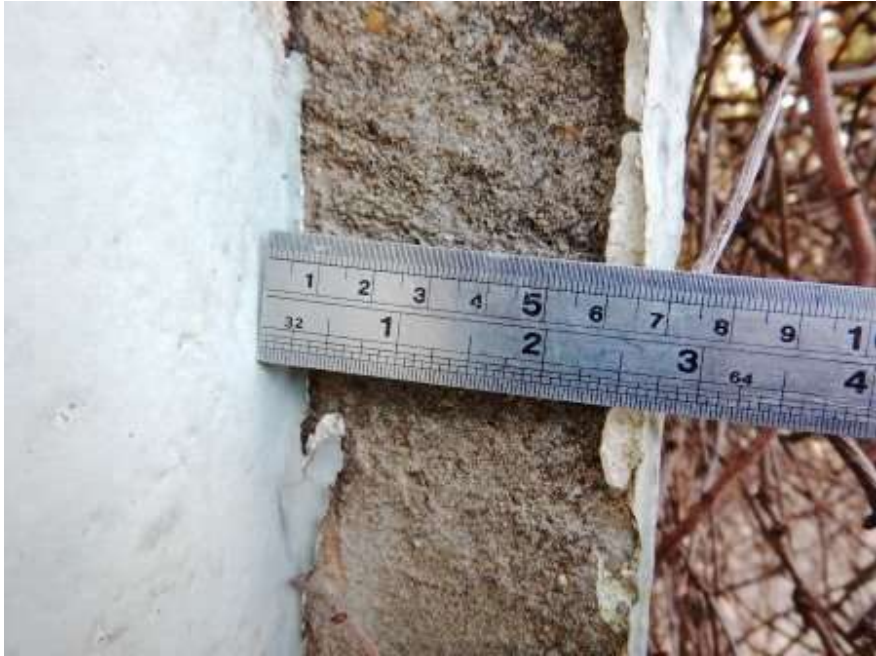
Location	Defect
Exterior upper rear tennis court level.	<div>Existing condition, location photo, subsidence and structural failure to the wall.</div> <div>

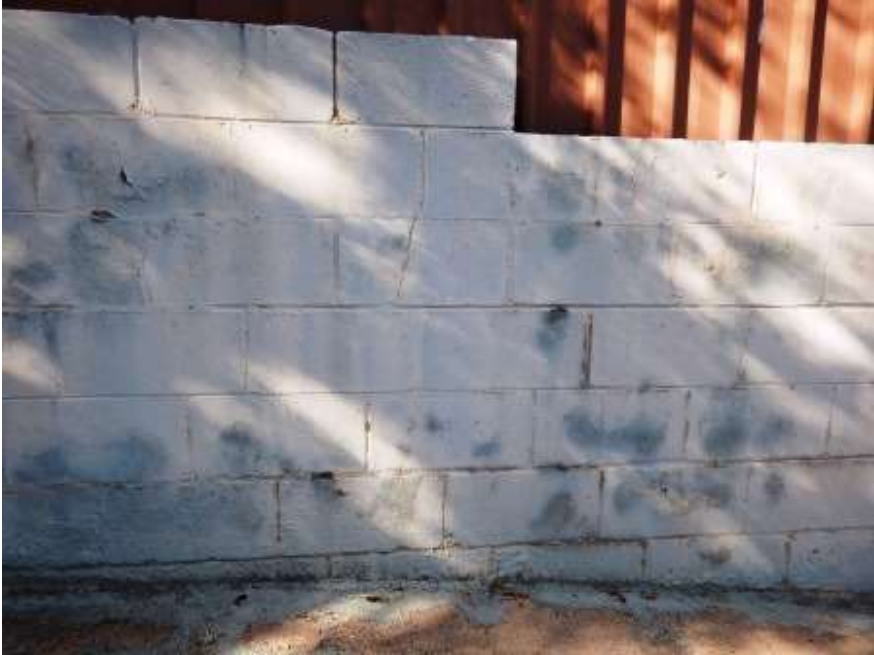
Location	Defect
Exterior upper rear tennis court level.	<div>Category 1: Fine cracks that do not need repair &lt; 1mm in width.</div> <div>
