# Dilapidation Report

## **Building Dilapidation Report (Except ACT)**

Building Dilapidation Report in accordance with Australian Standard AS 4349.0—2007. Inspection of Buildings – General Requirements for the purpose of assessing the general condition of the structure.

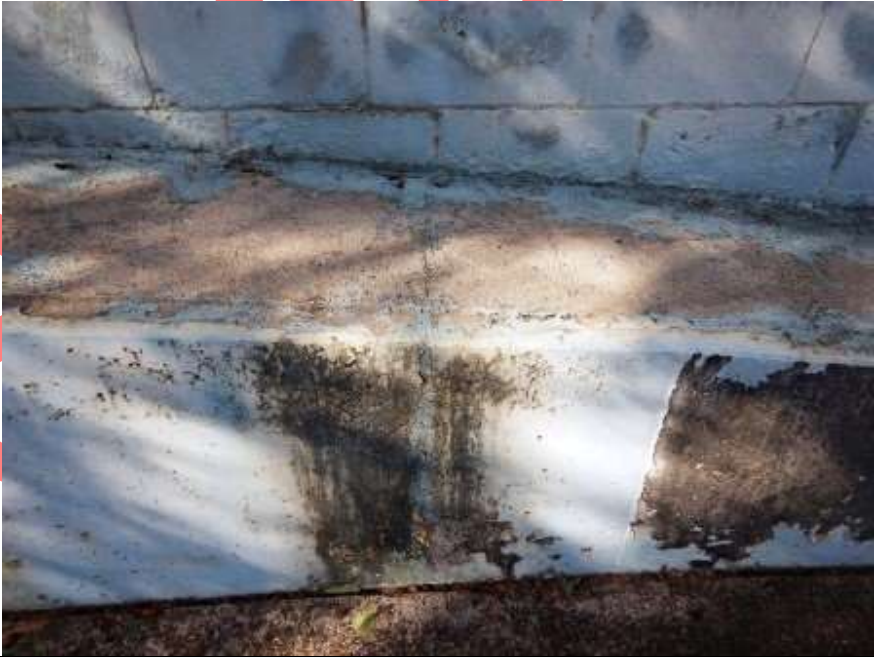
</div>
Exterior upper rear tennis court level.	<div>Category 1: Fine but noticeable cracks, Slab reasonably level, &lt; 1.0 mm in width and &lt; 10 mm change in offset from a 3 m straight edge placed over the crack.</div> <div>

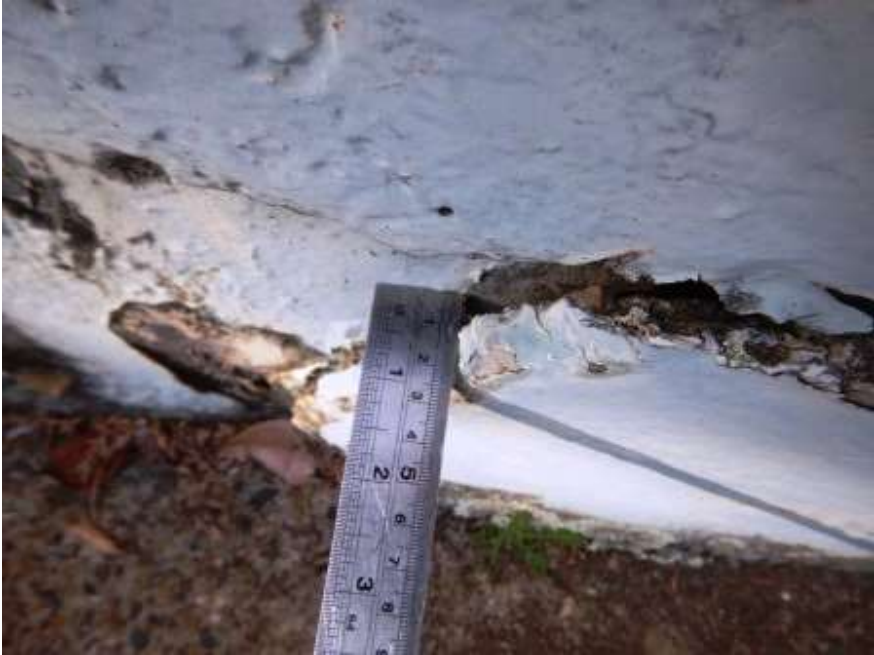
Location	Defect
Exterior upper rear tennis court level.	<div>Category 3: Cracks 5 mm to 15 mm in width.</div> <div>

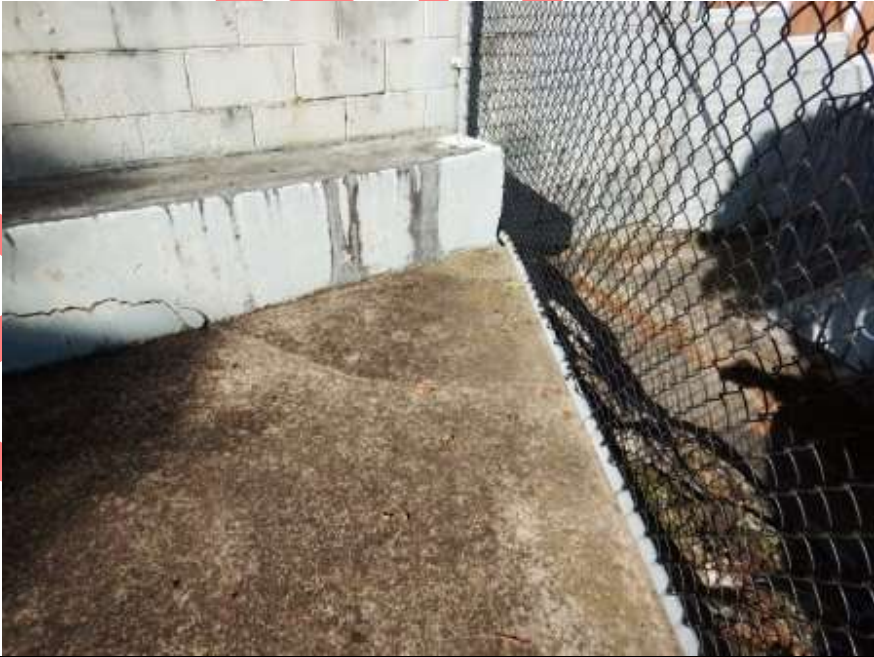
</div>
Exterior upper rear tennis court level.	<div>Category 4: Gaps in slab, Disturbing curvature or change in level, 4 mm to 10 mm in width and &gt; 25 mm change in offset from a 3 m straight edge placed over the crack.</div> <div>

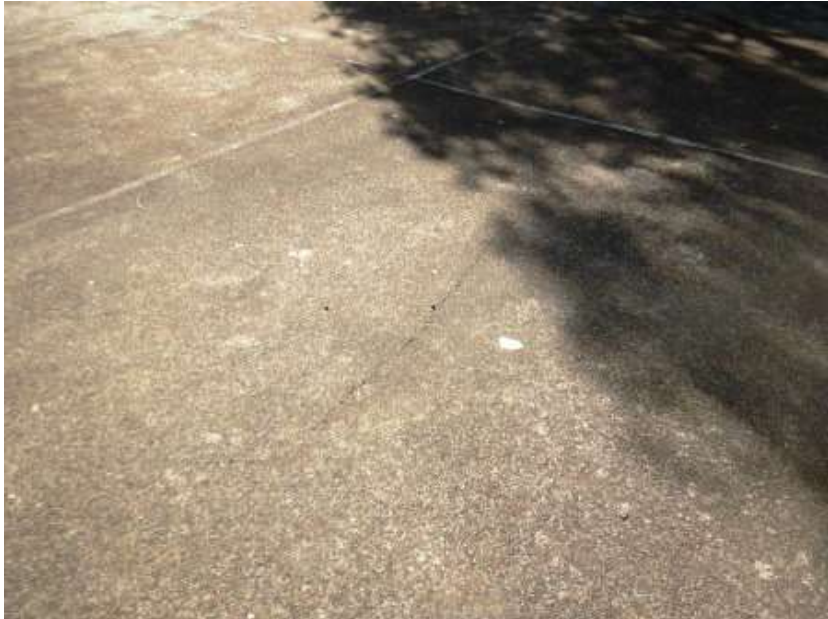
Location	Defect
Exterior upper rear tennis court level.	<div>Category 2: Distinct cracks, Slab noticeably curved or changed in level, &lt; 2.0 mm in width and &lt; 15 mm change in offset from a 3 m straight edge placed over the crack.</div> <div>

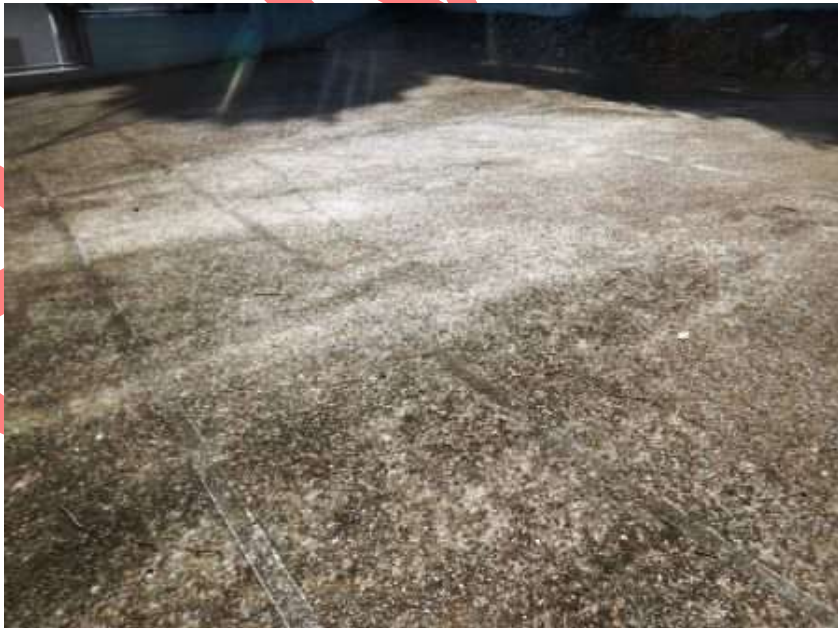
</div>
Exterior upper rear tennis court level.	<div>Category 2: Distinct cracks, Slab noticeably curved or changed in level, &lt; 2.0 mm in width and &lt; 15 mm change in offset from a 3 m straight edge placed over the crack.</div> <div>

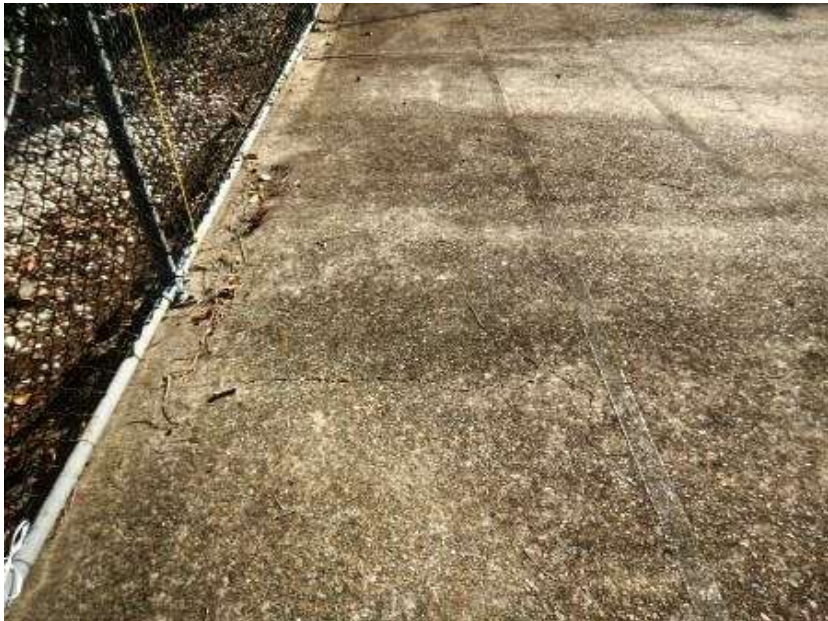
Location	Defect
Exterior upper rear tennis court level.	<div>Category 2: Distinct cracks, Slab noticeably curved or changed in level, &lt; 2.0 mm in width and &lt; 15 mm change in offset from a 3 m straight edge placed over the crack.</div> <div>

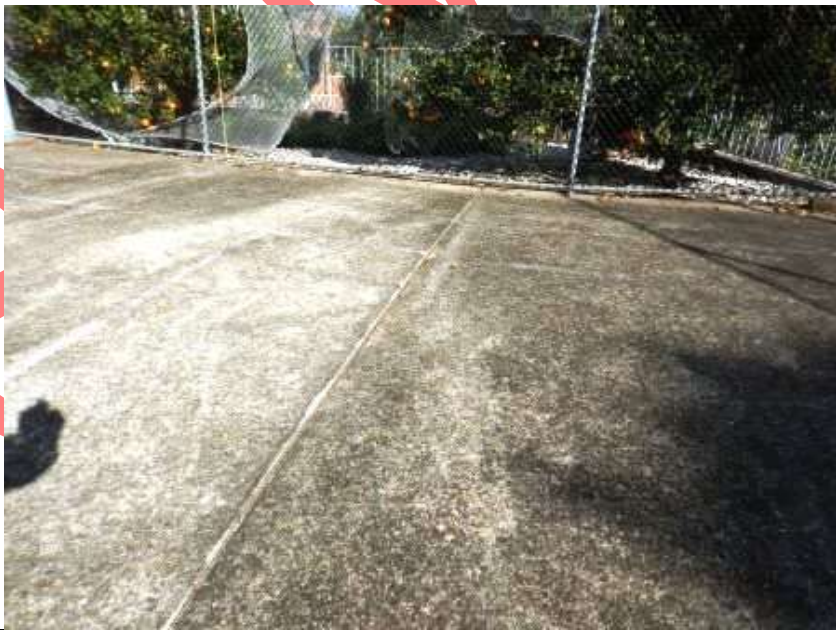
</div>
Exterior upper rear tennis court level.	<div>Category 2: Distinct cracks, Slab noticeably curved or changed in level, &lt; 2.0 mm in width and &lt; 15 mm change in offset from a 3 m straight edge placed over the crack.</div> <div>

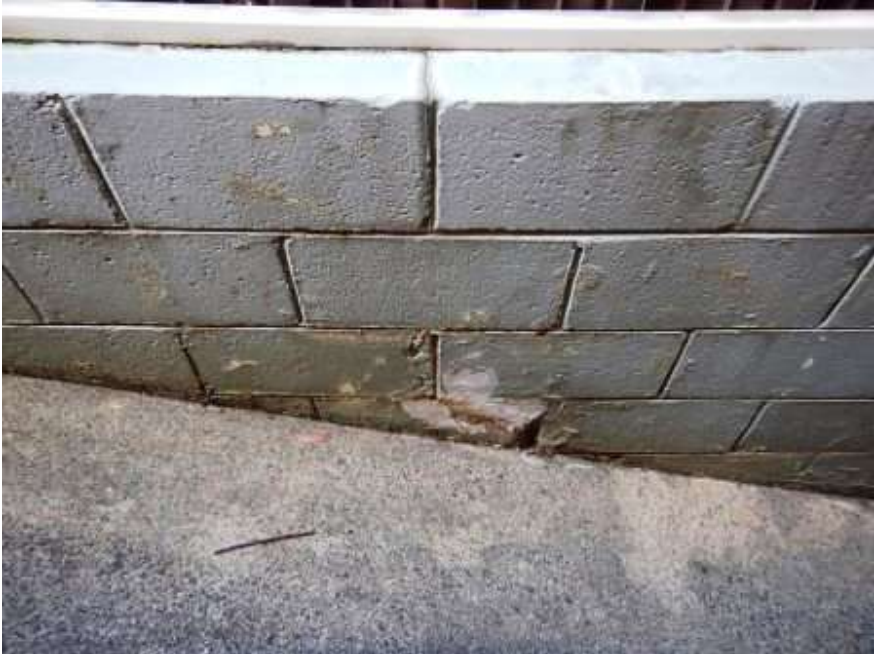
Location	Defect
Exterior right side.	<div>Category 2: Cracks noticeable but easily filled &lt; 5 mm in width.</div> <div>

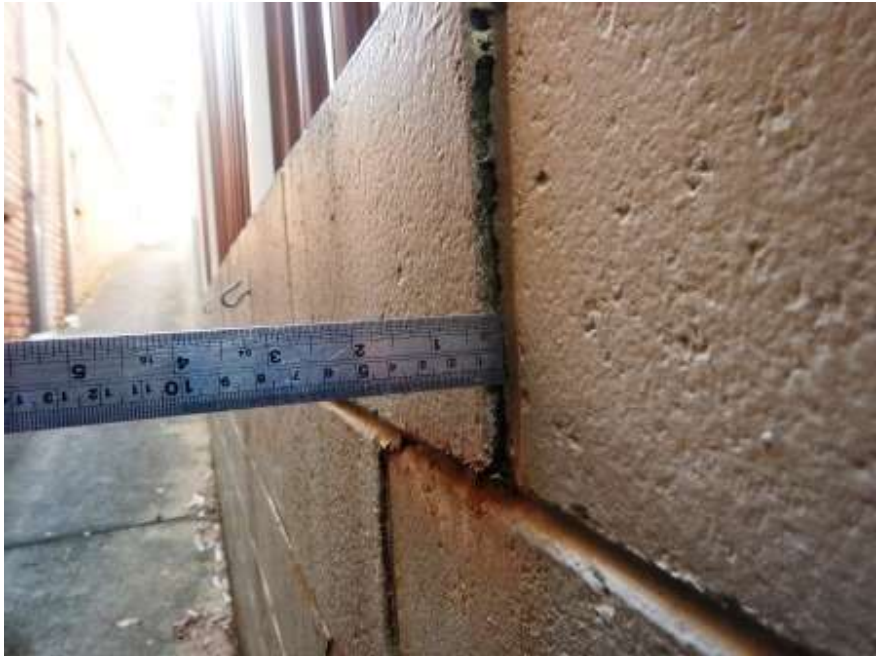
Location	Defect
Exterior right side.	Category 3: Cracks 5 mm to 15 mm in width. <div>

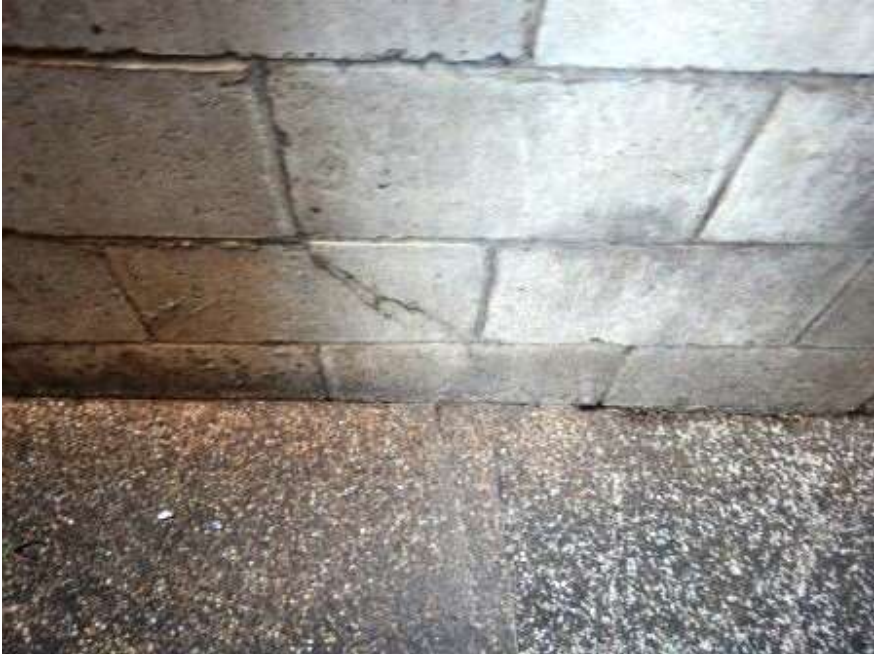
Location	Defect
Exterior right side.	<div>Category 2: Cracks noticeable but easily filled &lt; 5 mm in width.</div> <div>

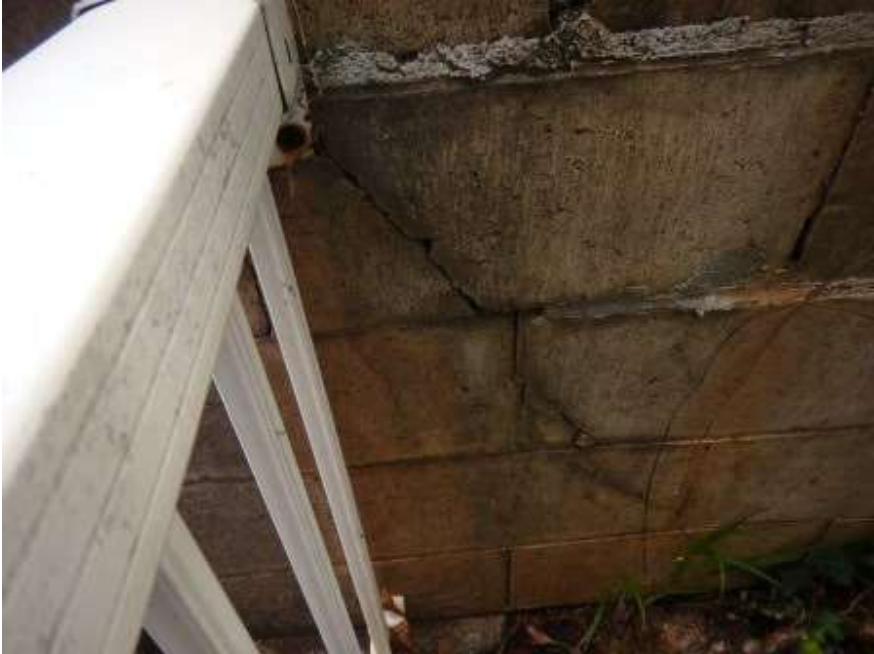
Location	Defect
Exterior right side.	Category 3: Cracks 5 mm to 15 mm in width.

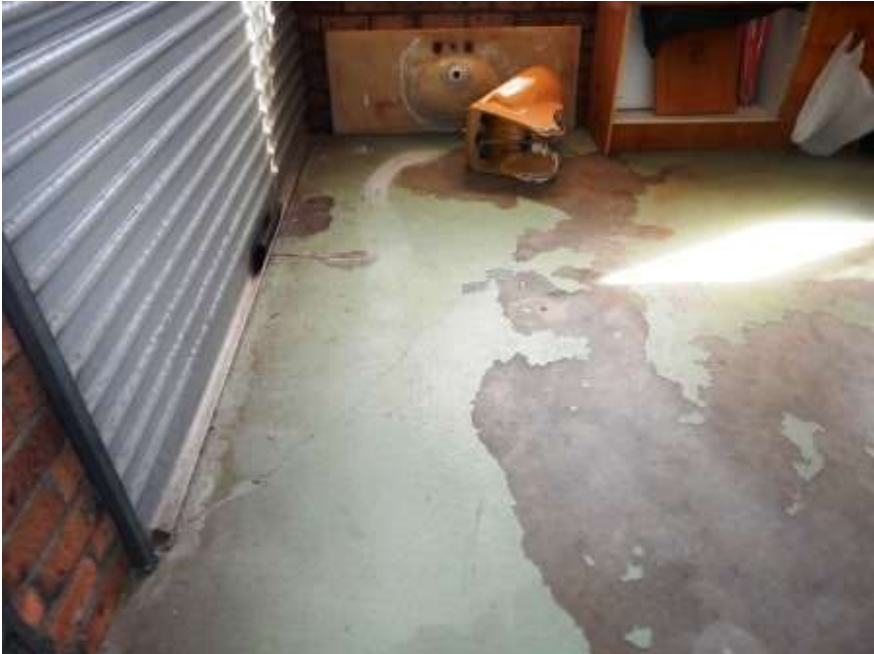
Location	Defect
Interior garage.	<div>Category 1: Fine but noticeable cracks, Slab reasonably level, &lt; 1.0 mm in width and &lt; 10 mm change in offset from a 3 m straight edge placed over the crack.</div> <div>

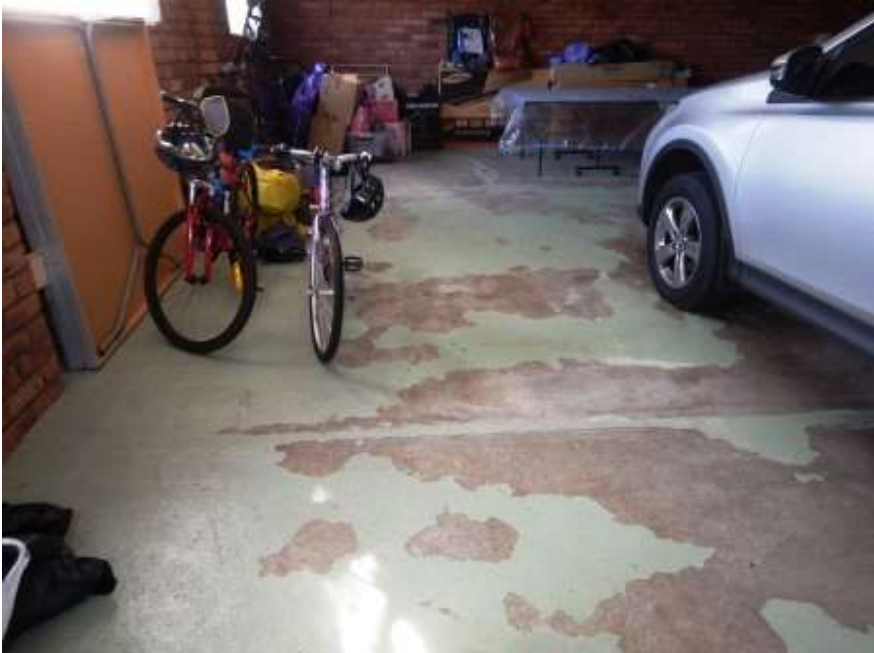
Location	Defect
Interior garage.	<div>Existing condition and location photo.</div> <div>

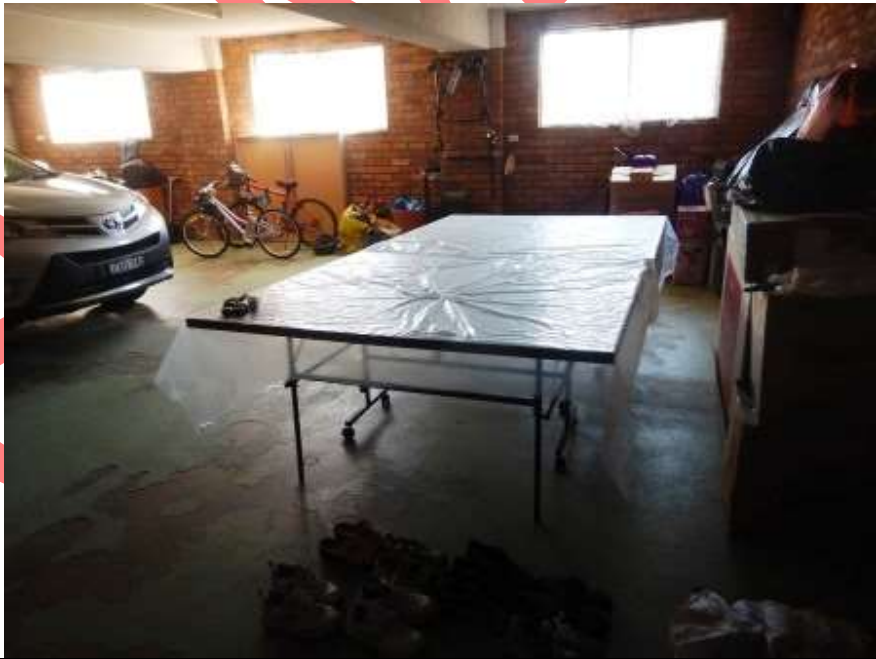
Interior garage.	<p>Existing condition and location photo.</p>

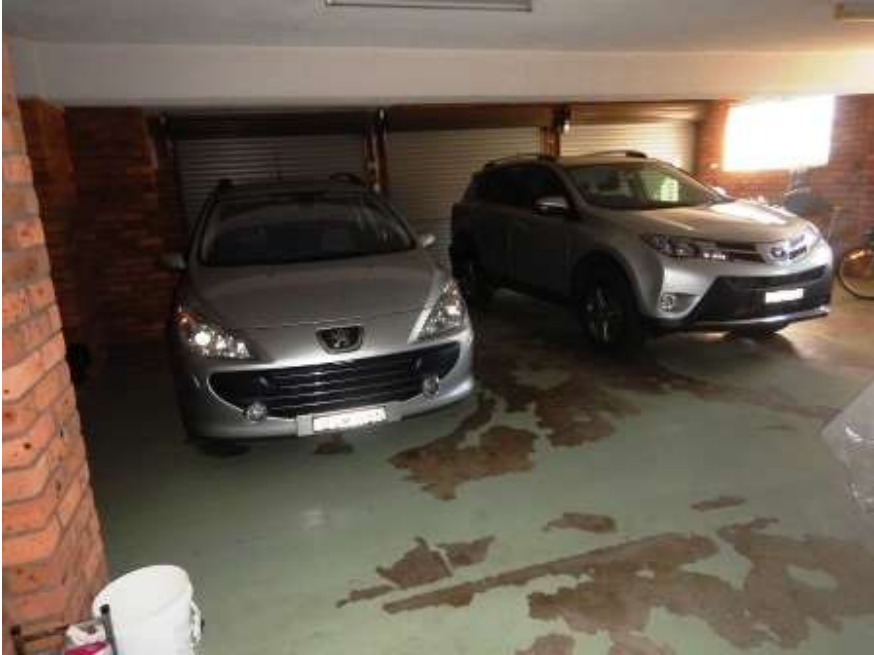
Location	Defect
Interior garage.	<div>Existing condition and location photo.</div> <div>

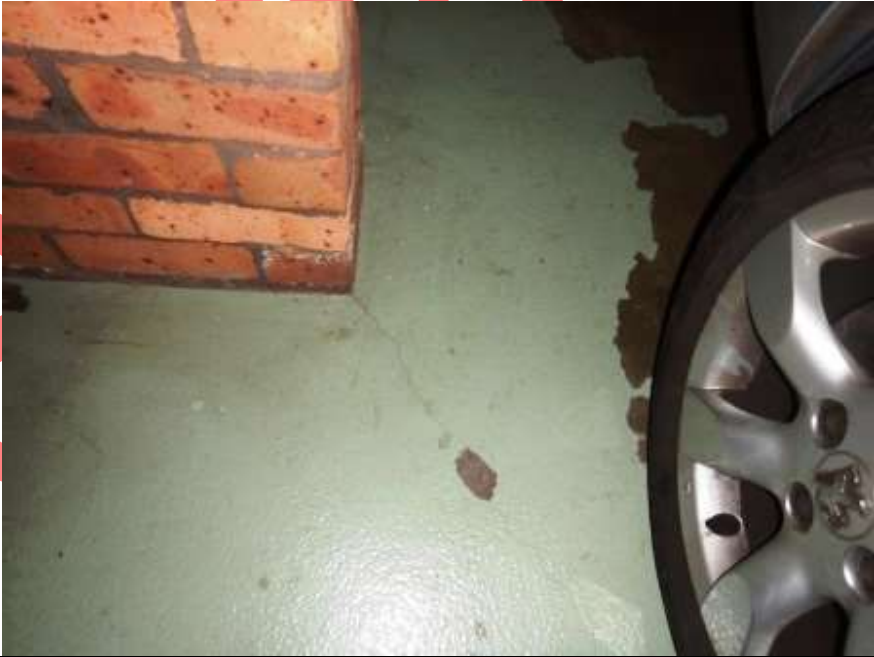
</div>
Interior garage.	<div>Category 1: Fine but noticeable cracks, Slab reasonably level, &lt; 1.0 mm in width and &lt; 10 mm change in offset from a 3 m straight edge placed over the crack.</div> <div>

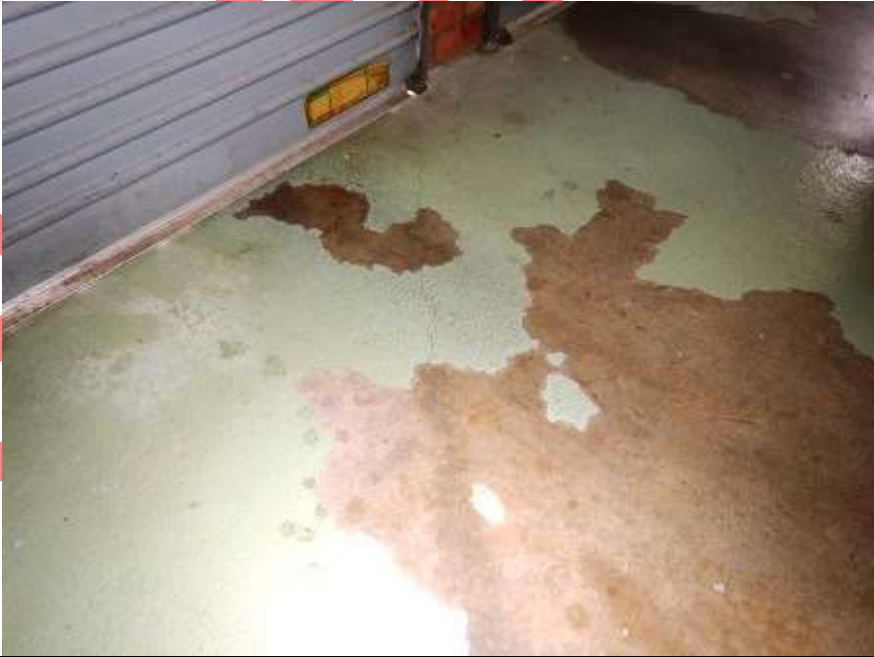
Location	Defect
Interior garage.	<div>Existing condition and location photo.</div> <div> </div>
Interior garage.	<div>Category 1: Fine but noticeable cracks, Slab reasonably level, &lt; 1.0 mm in width and &lt; 10 mm change in offset from a 3 m straight edge placed over the crack.</div> <div>

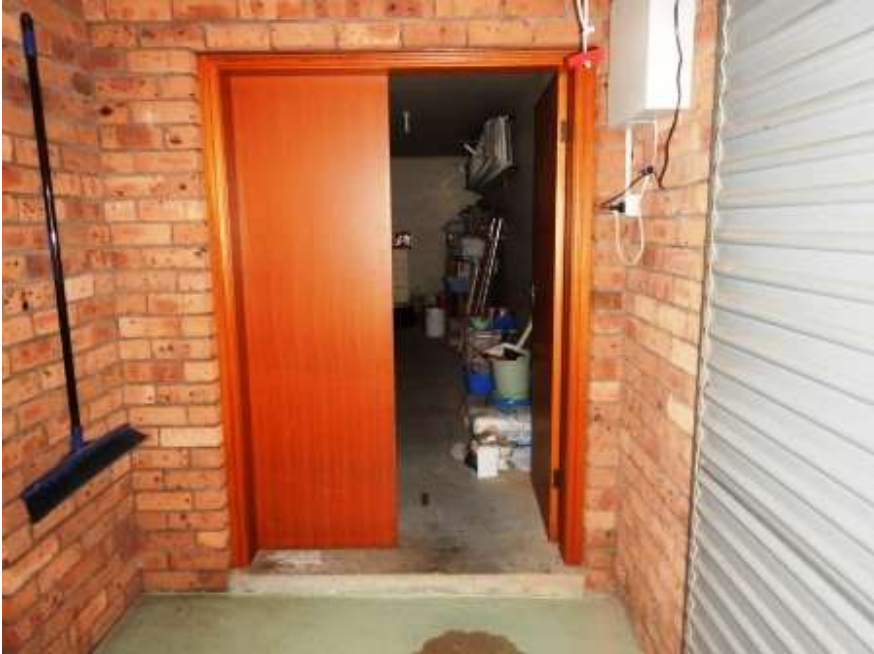
Location	Defect
Interior garage storeroom.	Existing condition and location photo. <div>

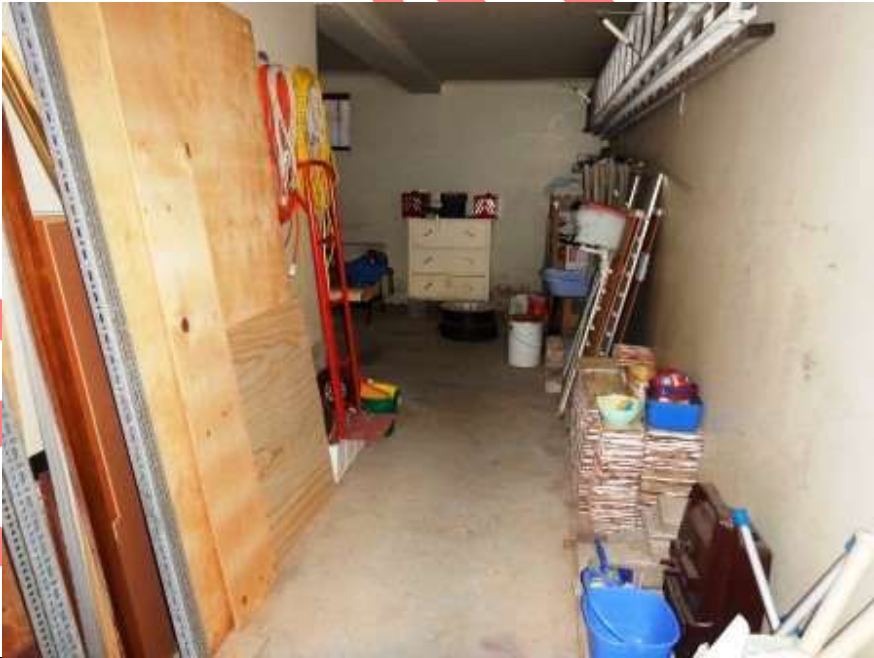
</div>
Interior garage storeroom.	Existing condition and location photo. <div>

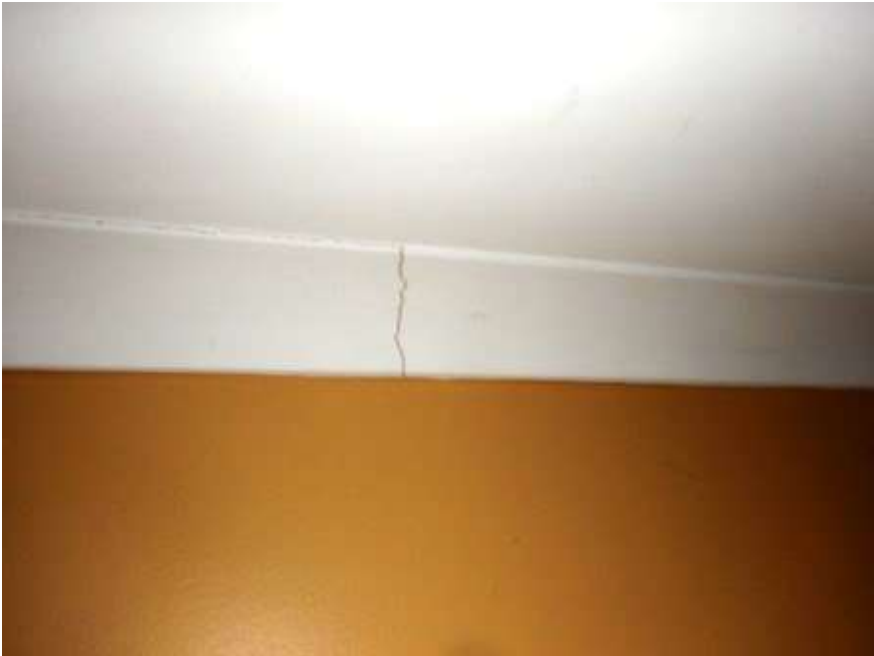
Location	Defect
Interior lower level study.	2mm crack to the ceiling cornice.

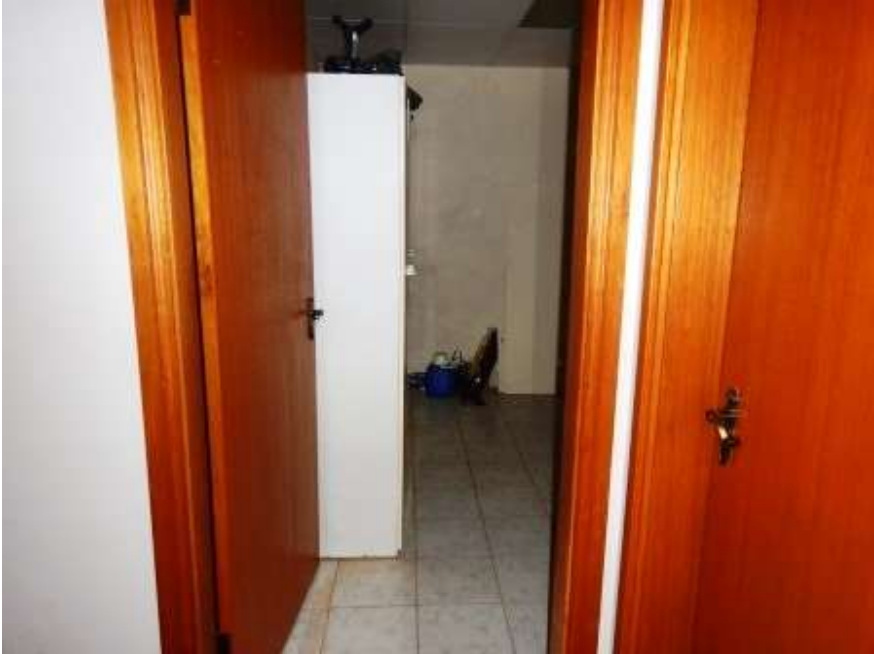
Location	Defect
Interior lower level vacant room.	Existing condition and location photo.

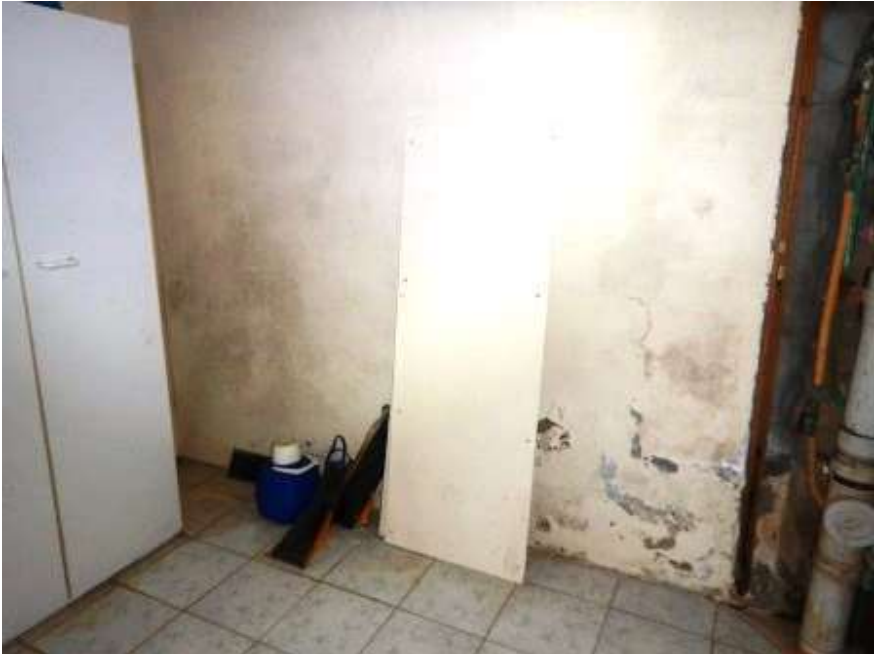
Location	Defect
Interior lower level vacant room.	<div>Water damaged and category 1: Fine cracks that do not need repair &lt; 1mm in width.</div> <div>

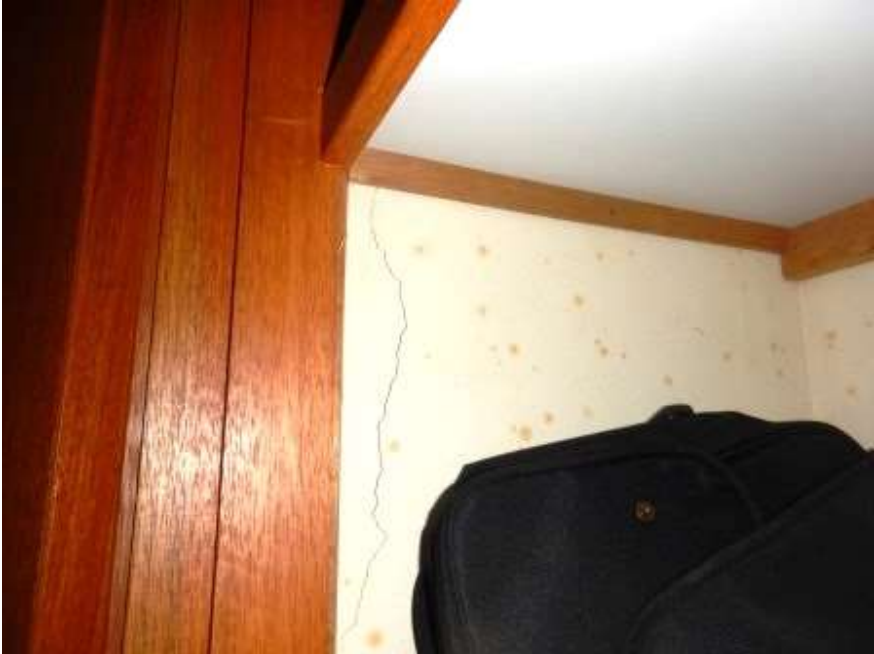
Location	Defect
Interior lower level hallway cupboard.	<div>Category 2: Cracks noticeable but easily filled &lt; 5 mm in width.</div> <div>

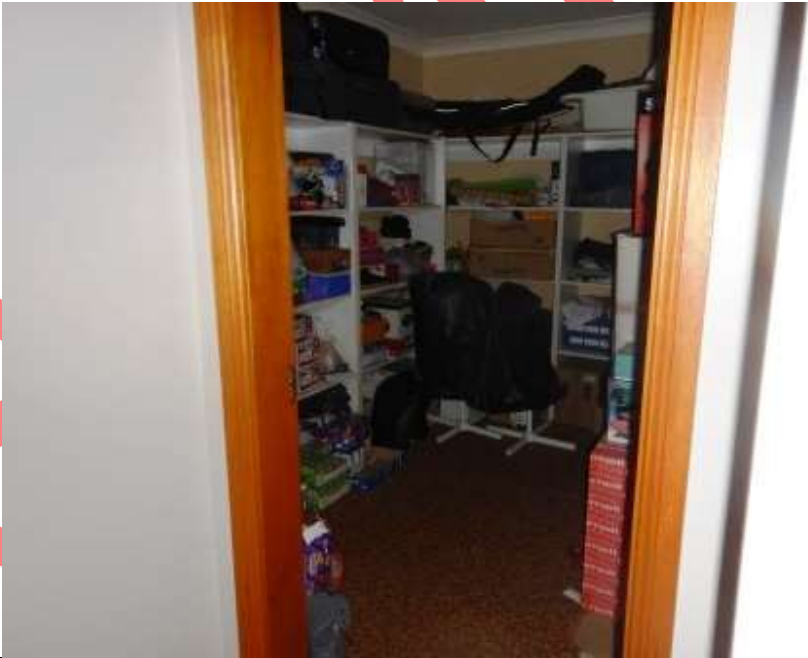
</div>
Interior lower level hallway storeroom.	<div>Existing condition and location photo.</div> <div>

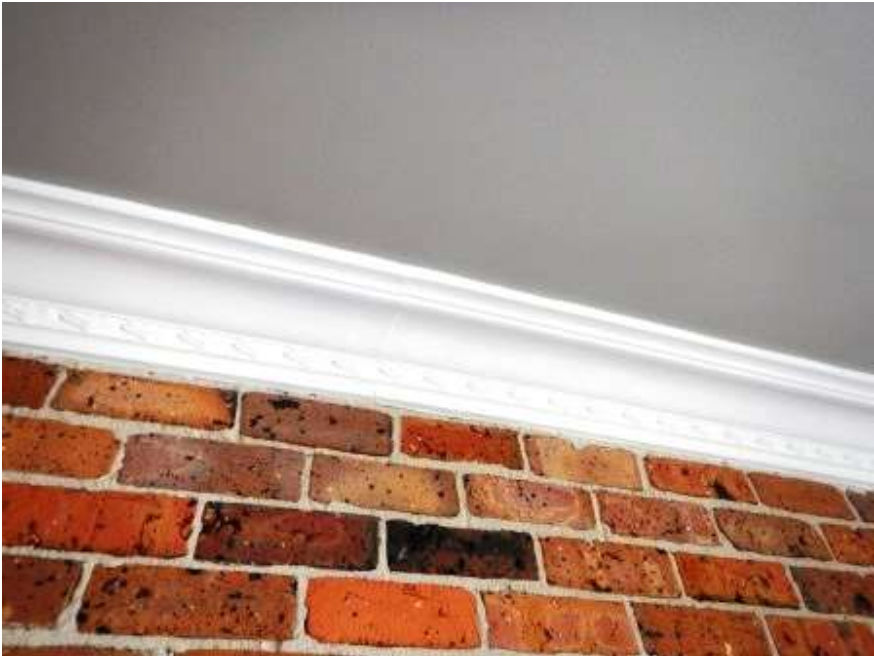
Location	Defect
Interior middle level front lounge room.	<div>Hairline cracking to the ceiling cornice.</div> <div>

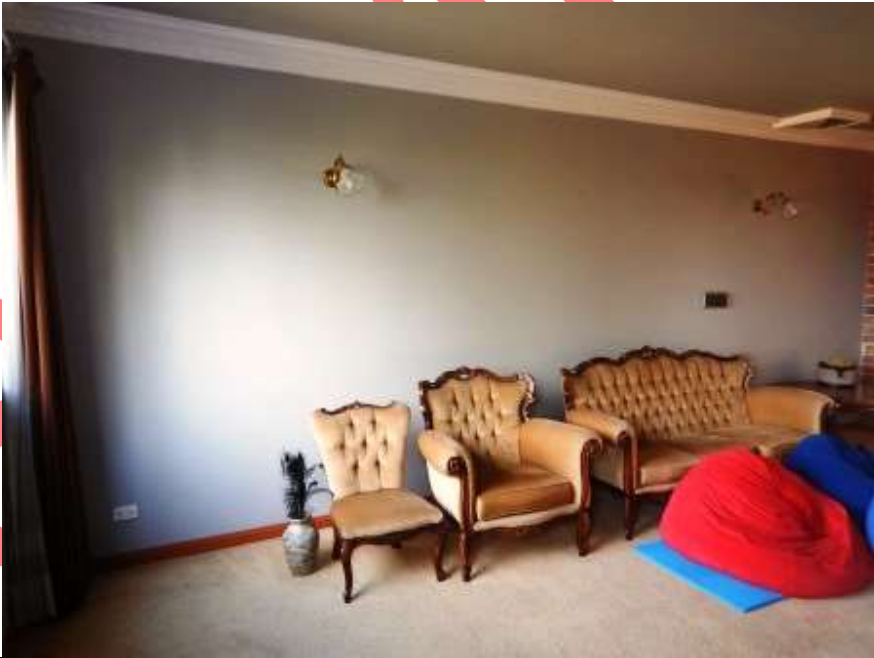
</div>
Interior middle level front lounge room.	<div>Existing condition and location photo.</div> <div>

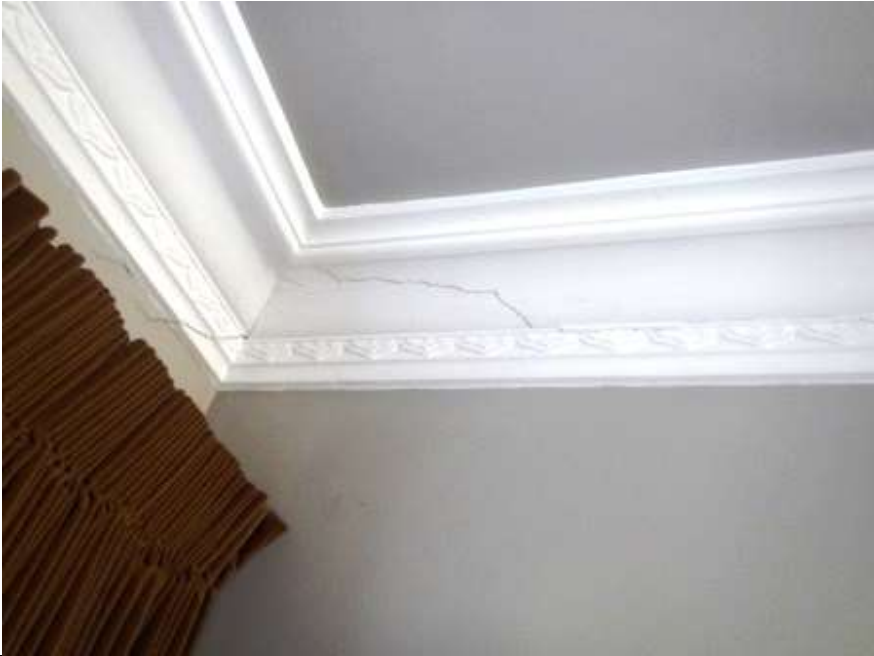
Location	Defect
Interior middle level front lounge room.	<div>Hairline cracking to the ceiling cornice and Category 1: Fine cracks that do not need repair &lt; 1mm in width.</div> <div>

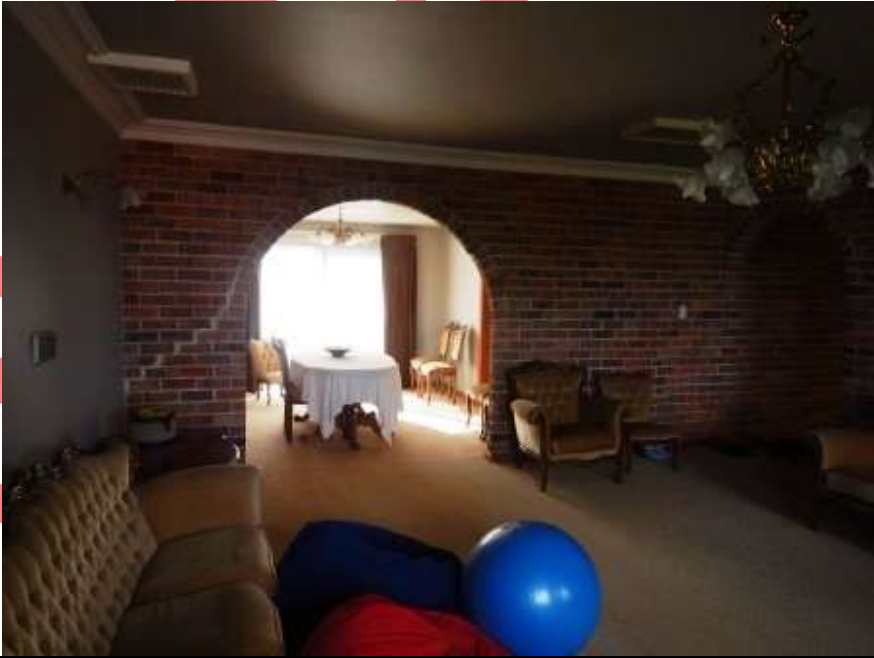
</div>
Interior middle level front lounge room.	<div>Existing condition and location photo.</div> <div>

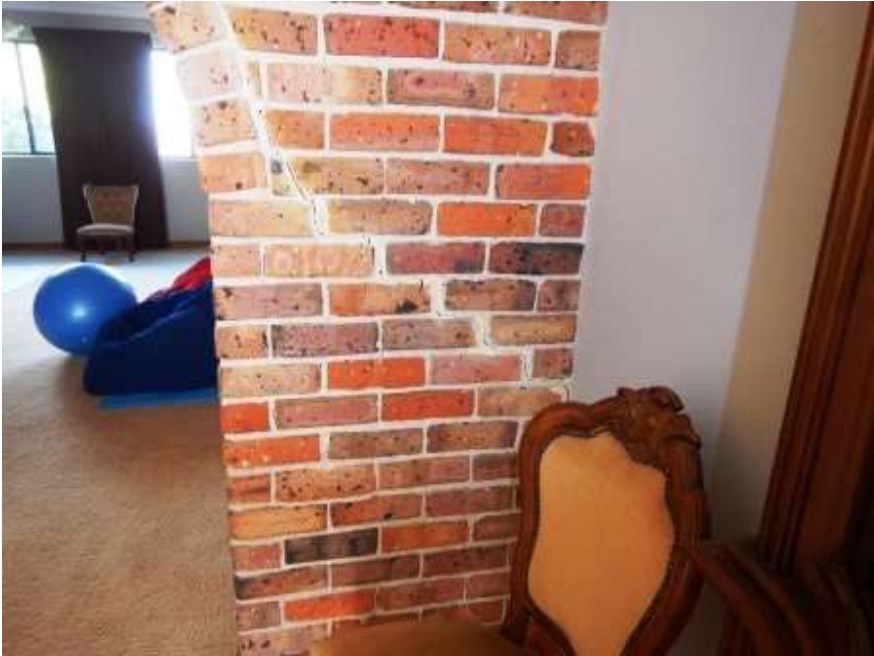
Location	Defect
Interior middle level front lounge room.	<div>Category 4: Cracks 15 mm to 25 mm in width which have been repaired in the past.</div> <div>

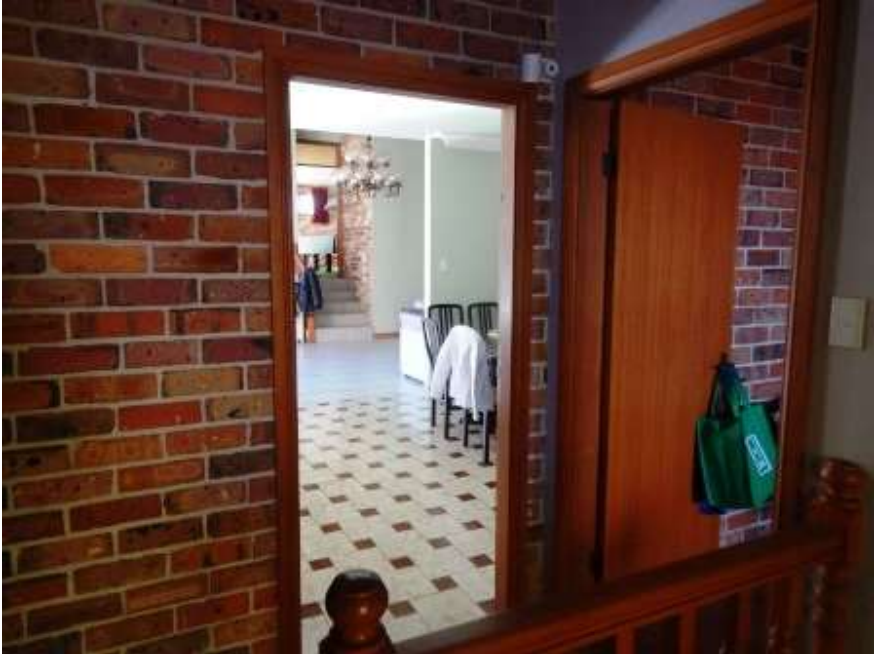
Location	Defect
Interior middle level front door entry area.	<div>Existing condition and location photo.</div> <div>

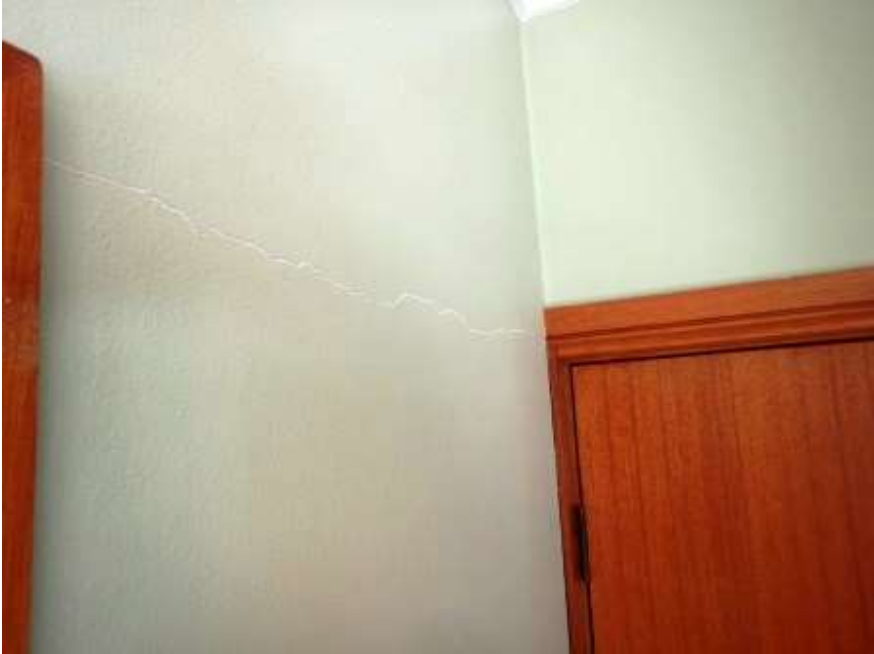
Location	Defect
Interior middle level kitchen area.	<div>Category 2: Cracks noticeable but easily filled &lt; 5 mm in width.</div> <div>

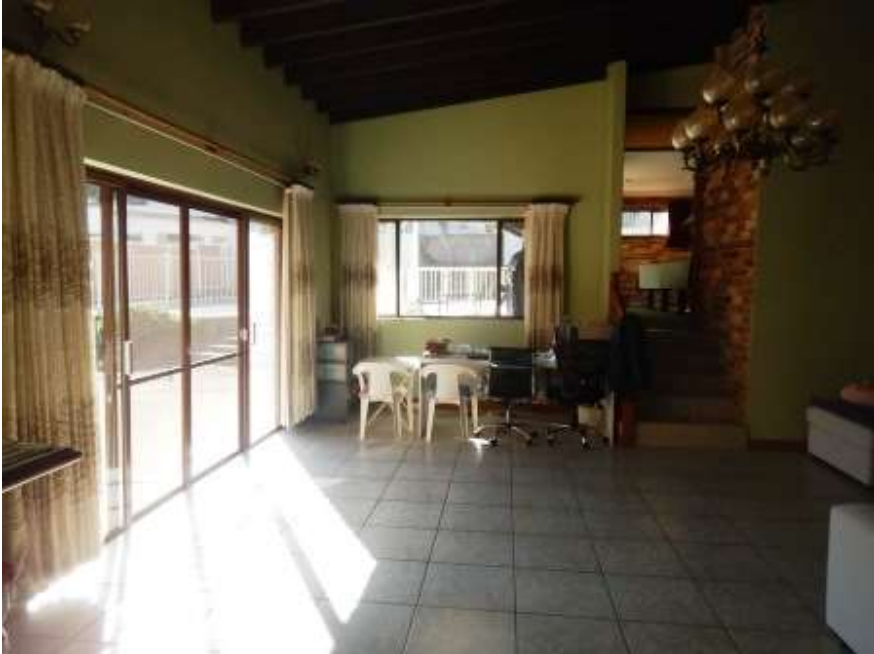
Location	Defect
Interior middle level rear lounge room.	<div>Existing condition and location photo.</div> <div>

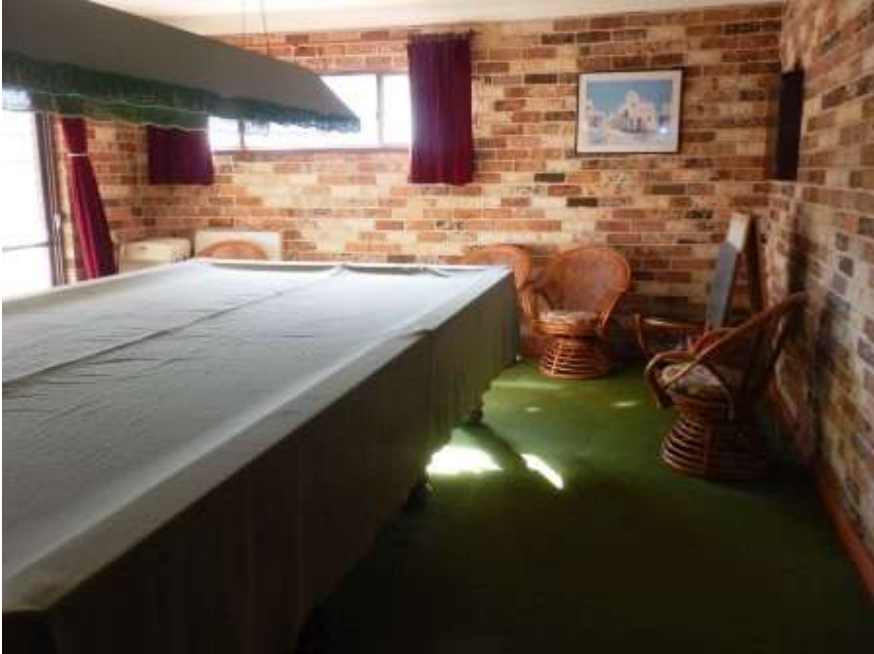
Location	Defect
Interior middle level rear games room.	Existing condition and location photo. <div>

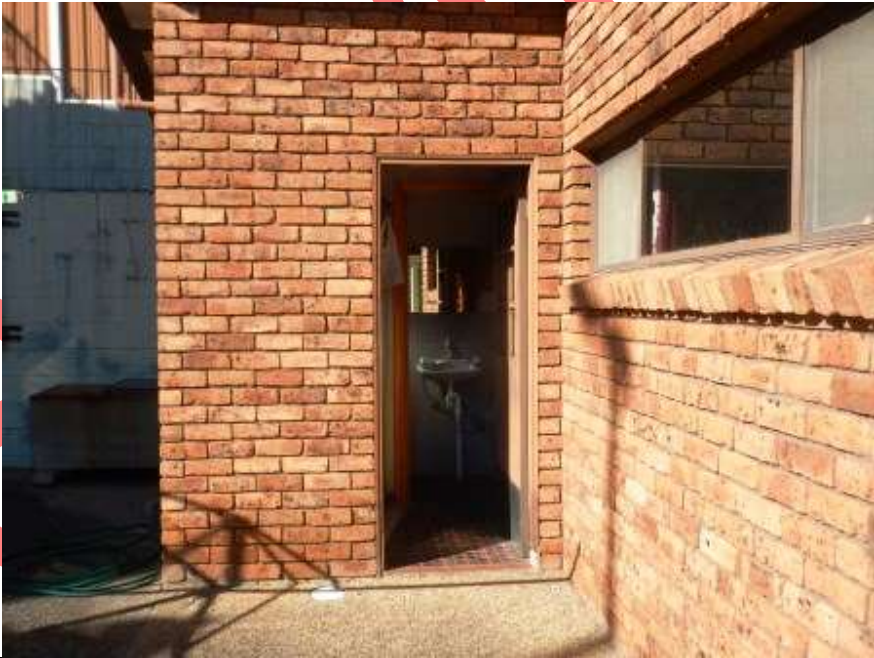
A photograph of the interior of a games room. The room features brick walls, a green carpet, and a long table covered with a white cloth. There are wicker chairs and a window with red curtains in the background. A large red checkmark is overlaid on the right side of the image.</div>
Exterior rear bathroom area.	Existing condition and location photo. <div>

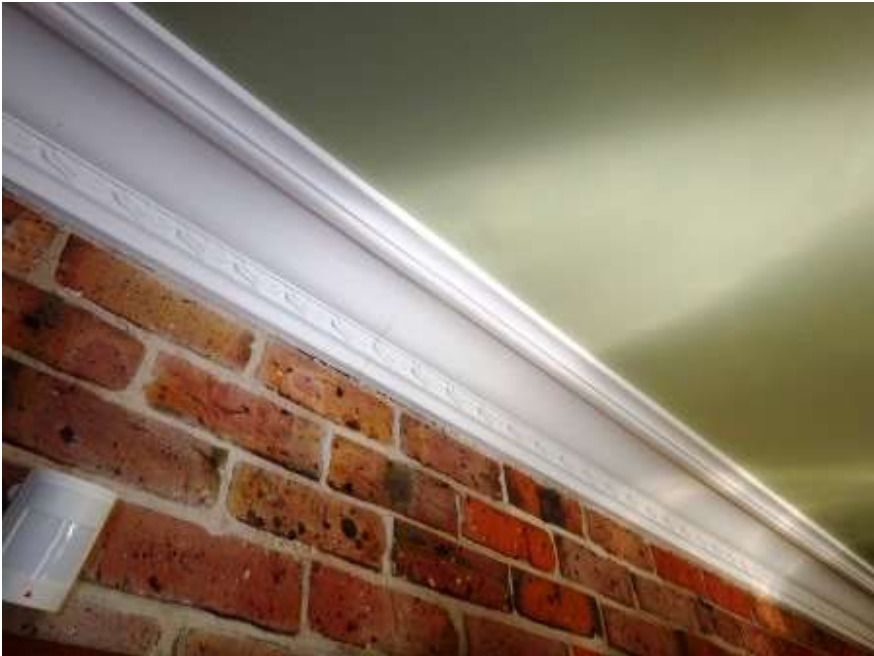
Location	Defect
Interior middle kitchen doorway area.	<div>Hairline cracking to the ceiling cornice.</div> <div>

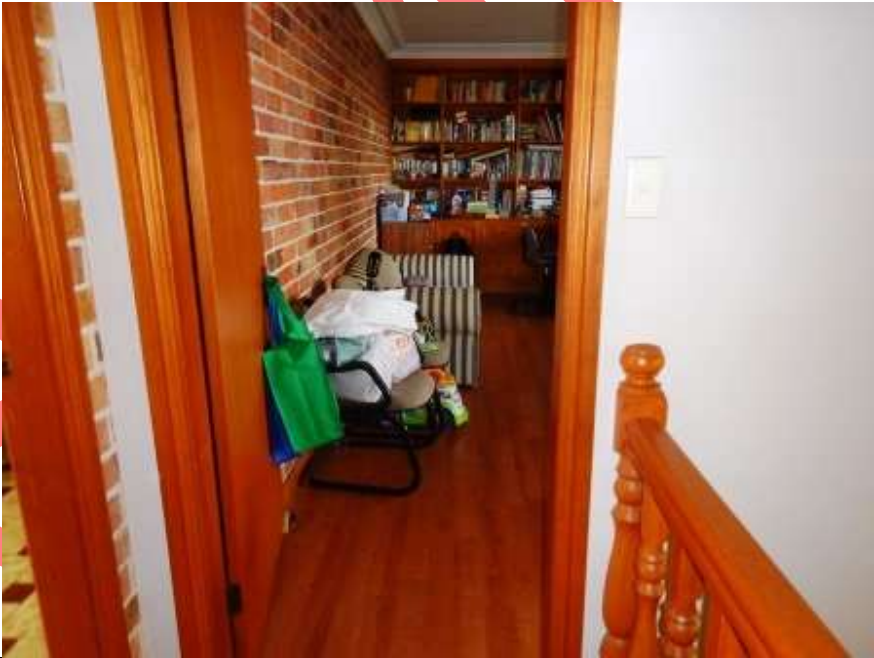
</div>
Interior middle level from right side room.	<div>Existing condition and location photo.</div> <div>

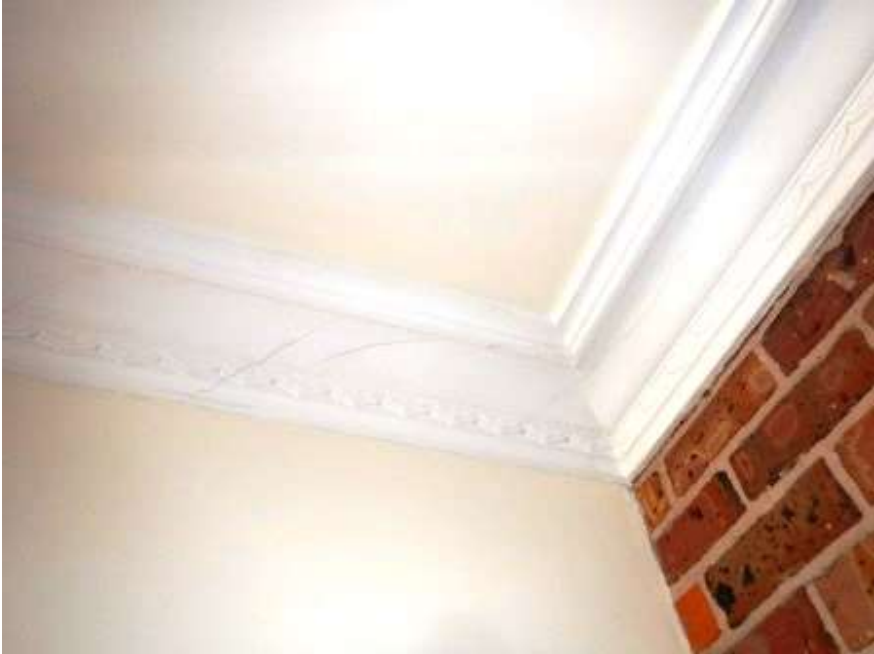
Location	Defect
Interior middle level from right side room.	<div>Hairline cracking to the ceiling cornice.</div> <div>

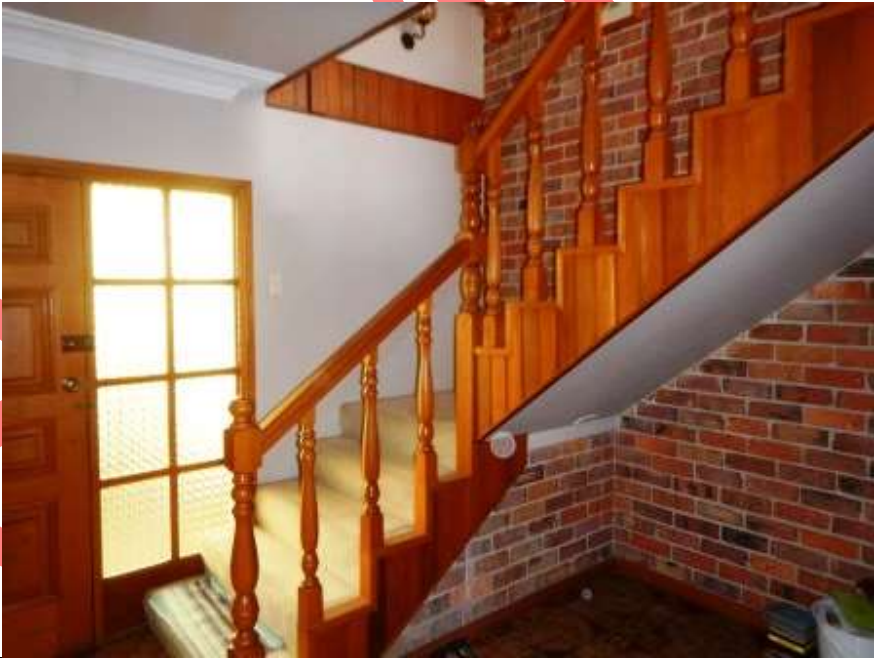
</div>
Interior staircase rear leading to the top floor.	<div>Existing condition and location photo.</div> <div>
