# Dilapidation Report

## **Building Dilapidation Report (Except ACT)**

Building Dilapidation Report in accordance with Australian Standard AS 4349.0—2007. Inspection of Buildings – General Requirements for the purpose of assessing the general condition of the structure.

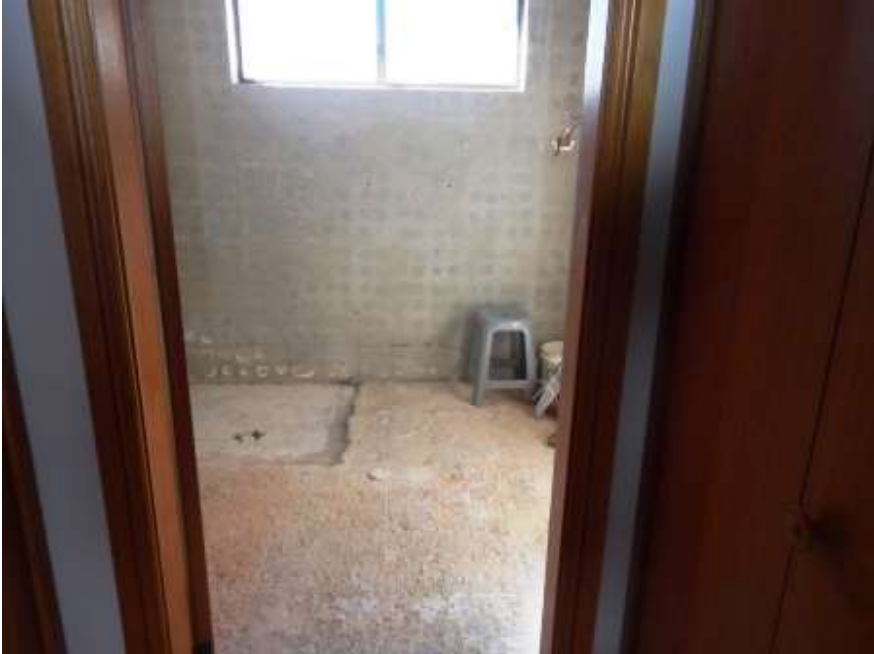
Location	Defect
Interior bedroom 1 ensuite.	Existing condition and location photo. <div>

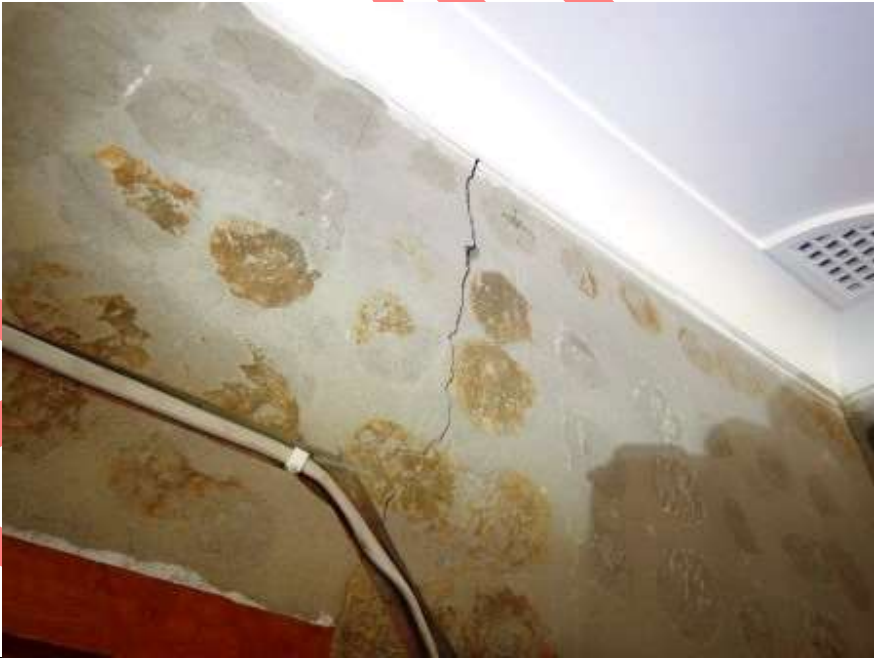
</div>
Interior bedroom 1 ensuite.	Category 2: Cracks noticeable but easily filled < 5 mm in width. <div>

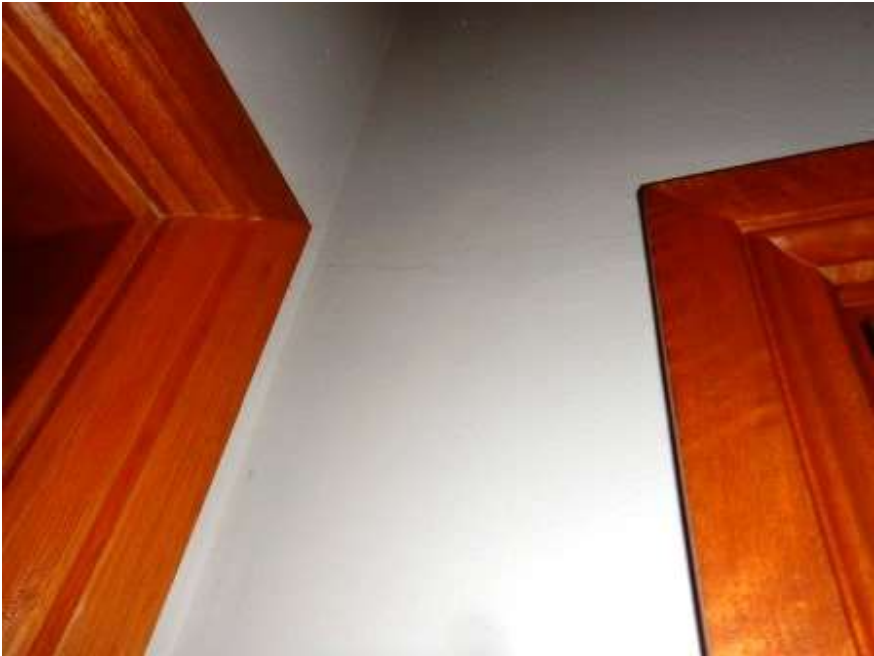
Location	Defect
Interior top floor hallway area.	<div>Category 1: Fine cracks that do not need repair &lt; 1mm in width.</div> <div>

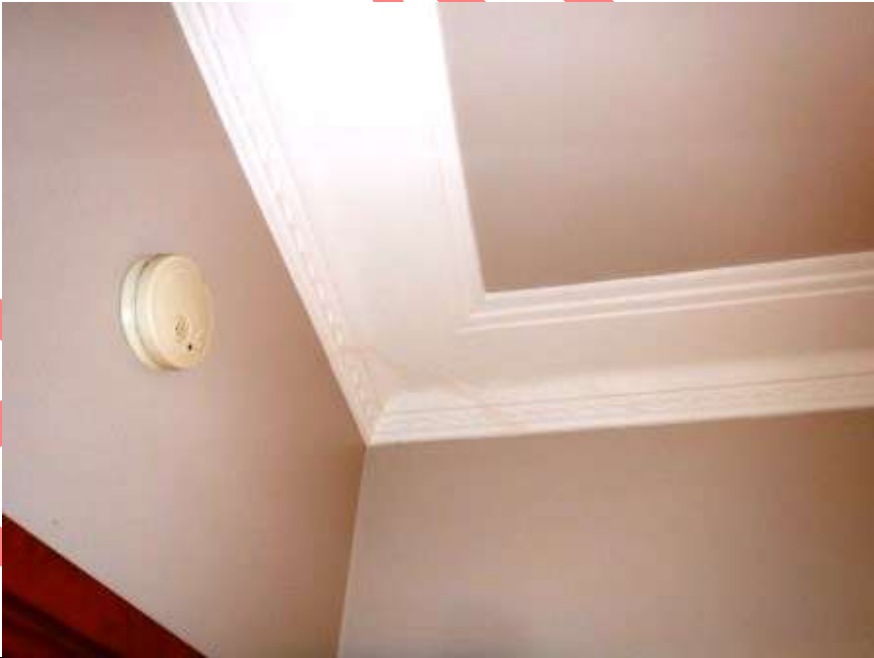
</div>
Interior top floor hallway area.	<div>Cracking to the ceiling cornice which has been repaired in the past.</div> <div>

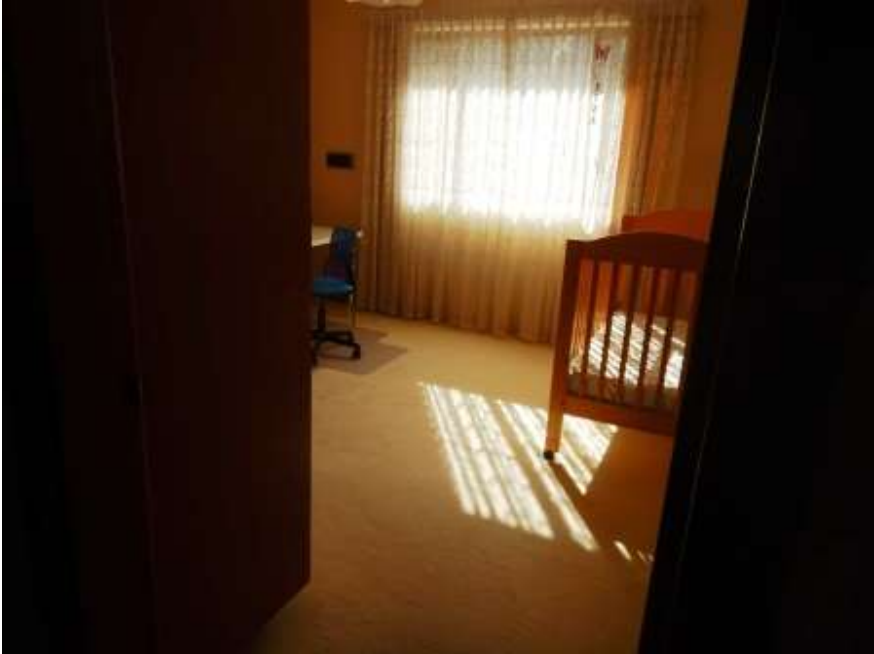
Location	Defect
Interior top floor rear bedroom 2.	Existing condition and location photo. <div>

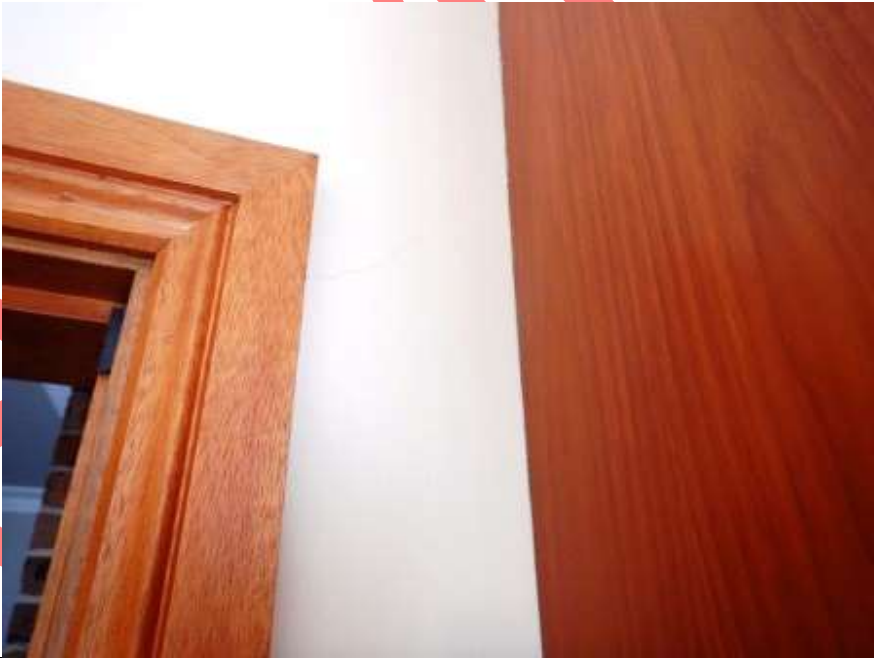
</div>
Interior top floor rear bedroom 2.	Category 0: Hairline cracks < 0.1 mm in width. <div>

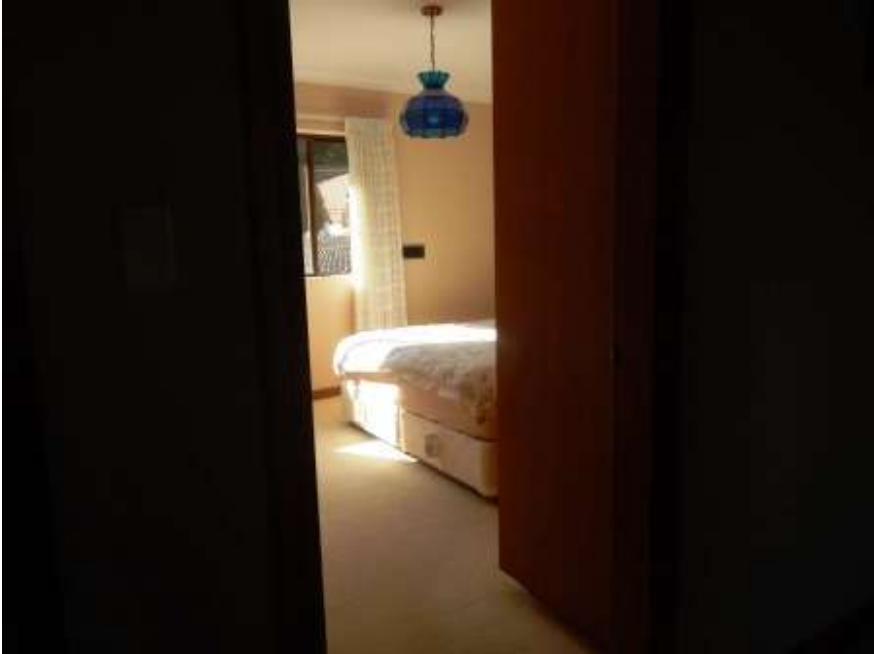
Location	Defect
Interior top floor rear bedroom 3.	Existing condition and location photo. <div>

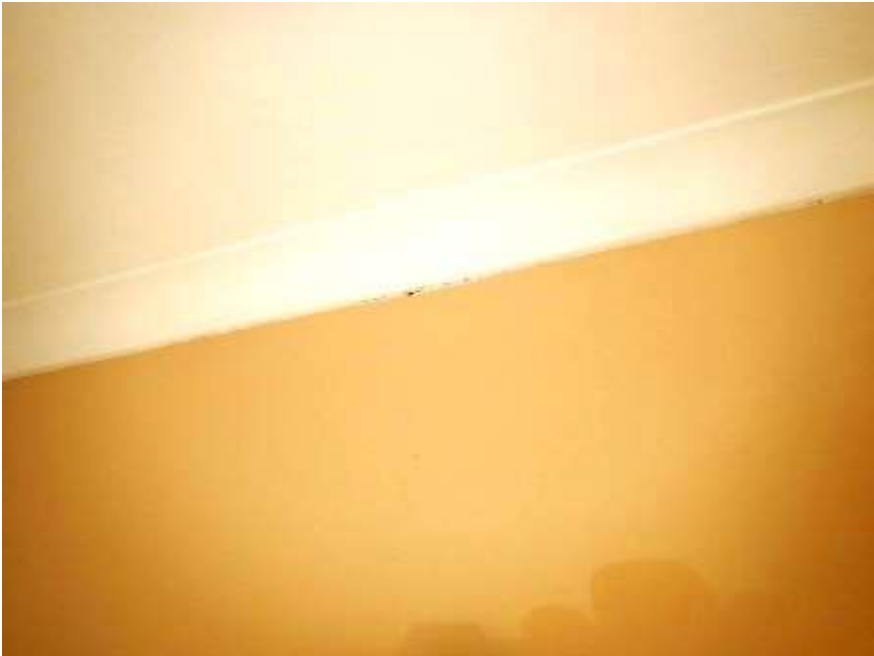
Location	Defect
Interior top floor rear bedroom 3.	<div>Cracking between the ceiling cornice and wall lining.</div> <div>

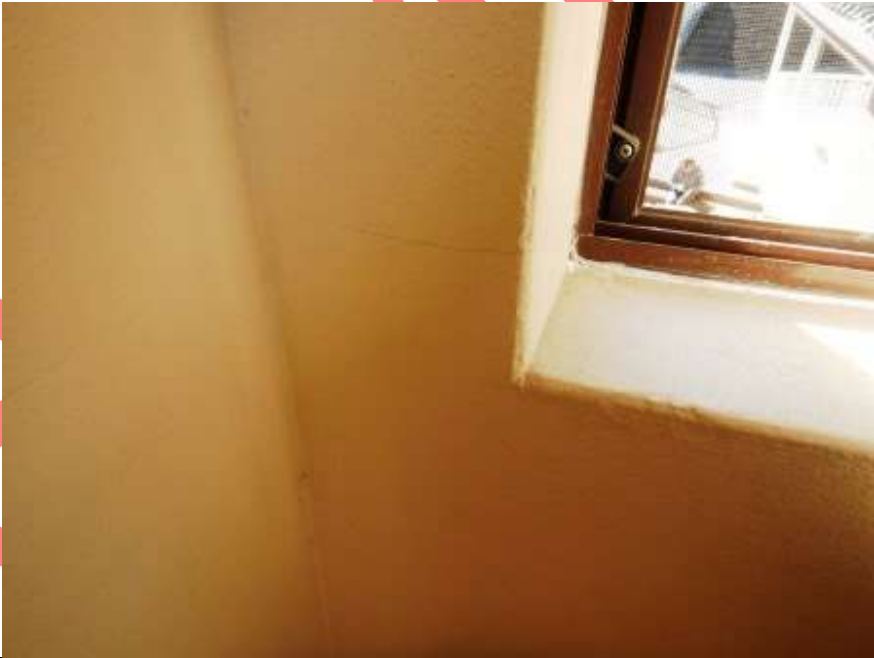
</div>
Interior top floor rear bedroom 3.	<div>Category 0: Hairline cracks &lt; 0.1 mm in width.</div> <div>

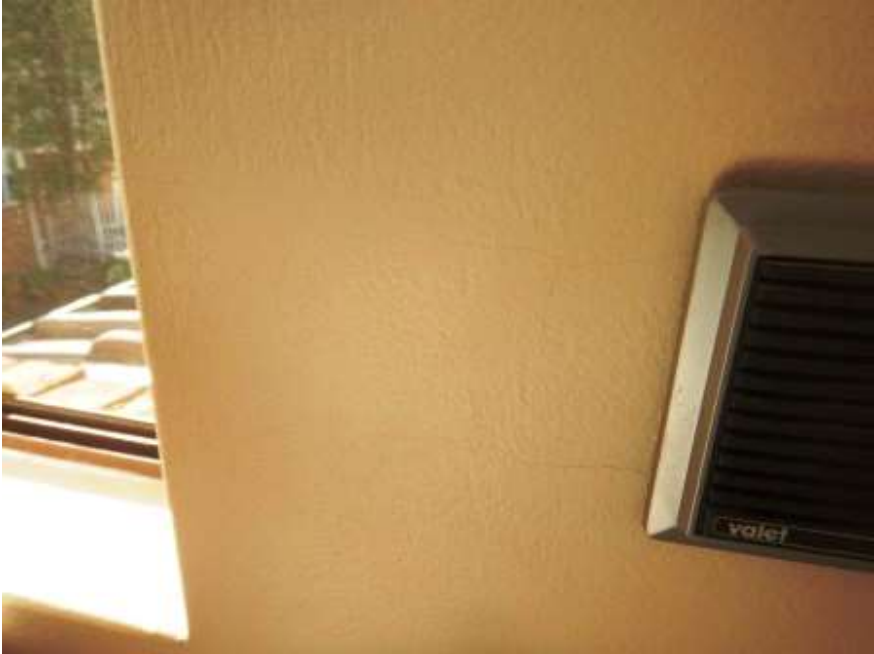
Location	Defect
Interior top floor rear bedroom 3.	<div>Category 0: Hairline cracks &lt; 0.1 mm in width.</div> <div>

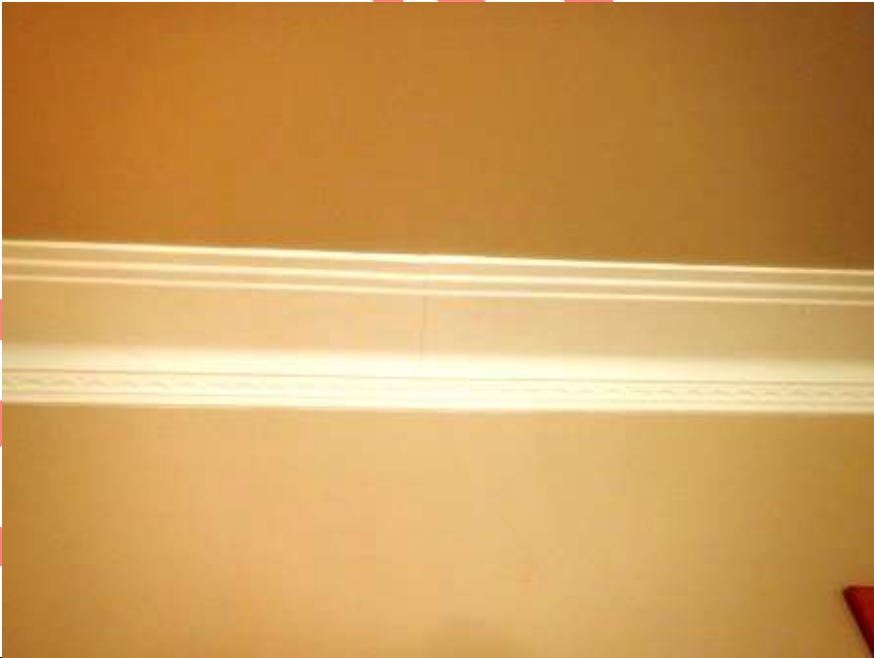
</div>
Interior top floor rear bedroom 3.	<div>Cracking to the ceiling cornice and lining.</div> <div>

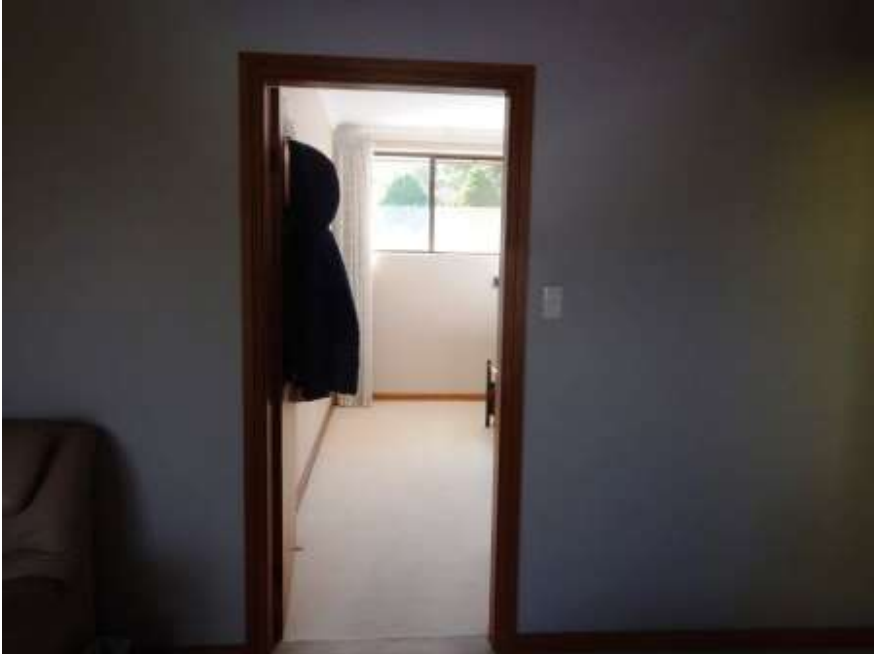
Location	Defect
Interior top floor rear bedroom 4.	Existing condition and location photo. <div>

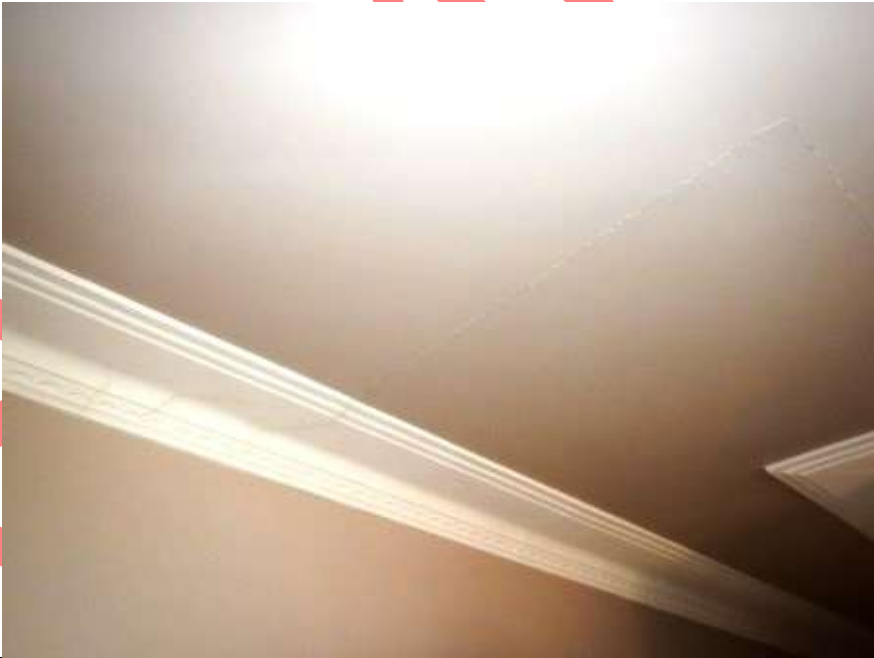
A photograph showing the interior of a bedroom. A doorway in the center leads to a hallway with a window at the end. A dark jacket is hanging on the left wall, and a portion of a brown sofa is visible in the bottom left corner.</div>
Interior top floor hallway area.	Cracking to the ceiling cornice and lining. <div>

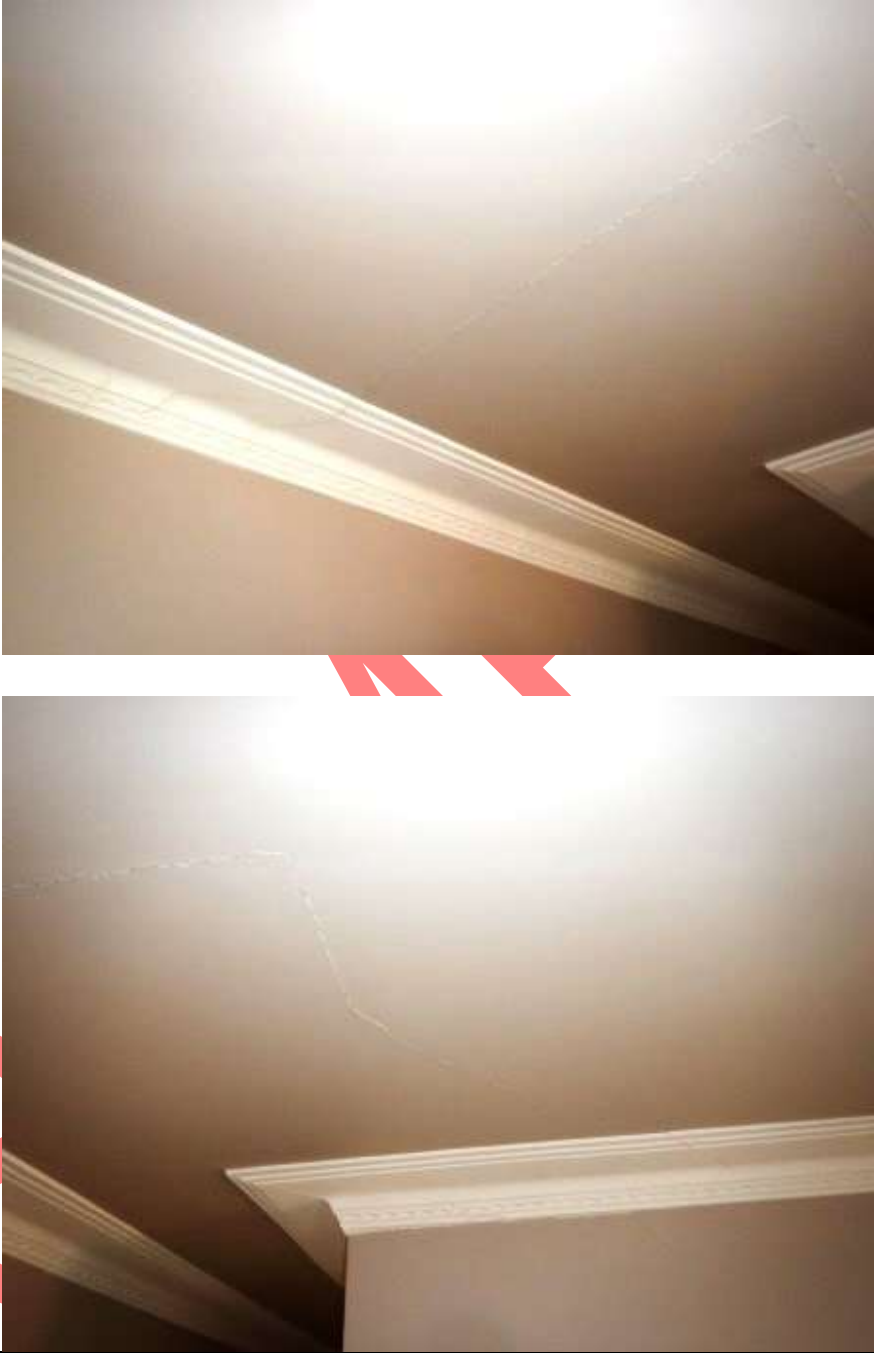
Location	Defect
Interior top floor hallway / lounge room area.	<div>Cracking to the ceiling cornice and lining.</div> <div>

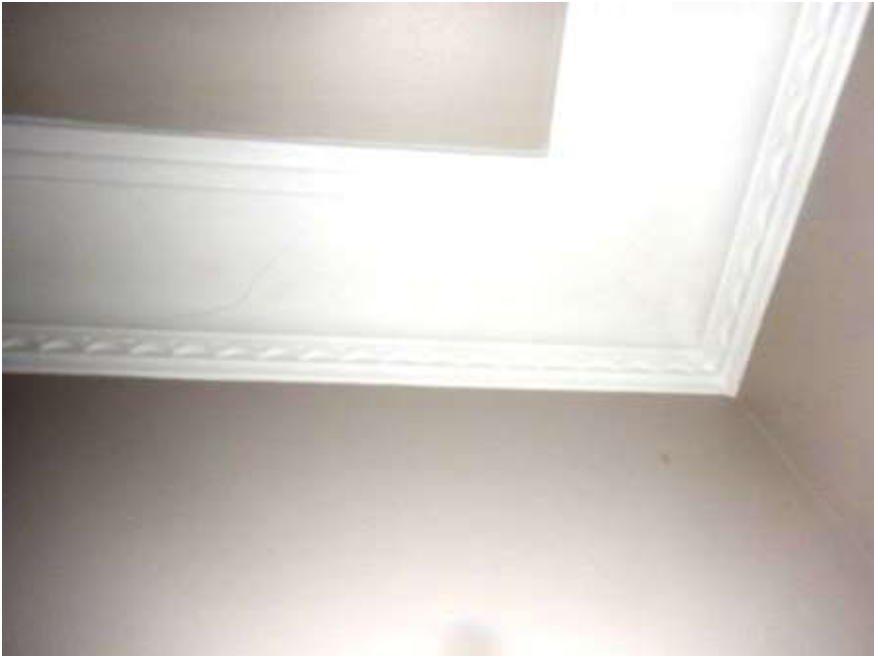
Location	Defect
Interior top floor bathroom.	<div>Hairline cracking to the ceiling cornice.</div> <div>

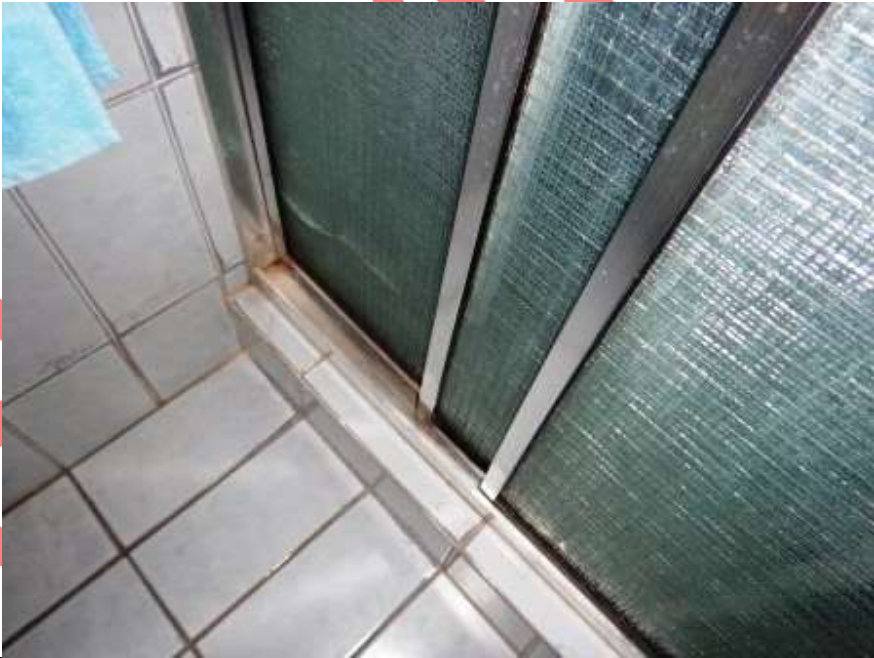
</div>
Interior top floor bathroom.	<div>Cracked glass to the shower door.</div> <div>

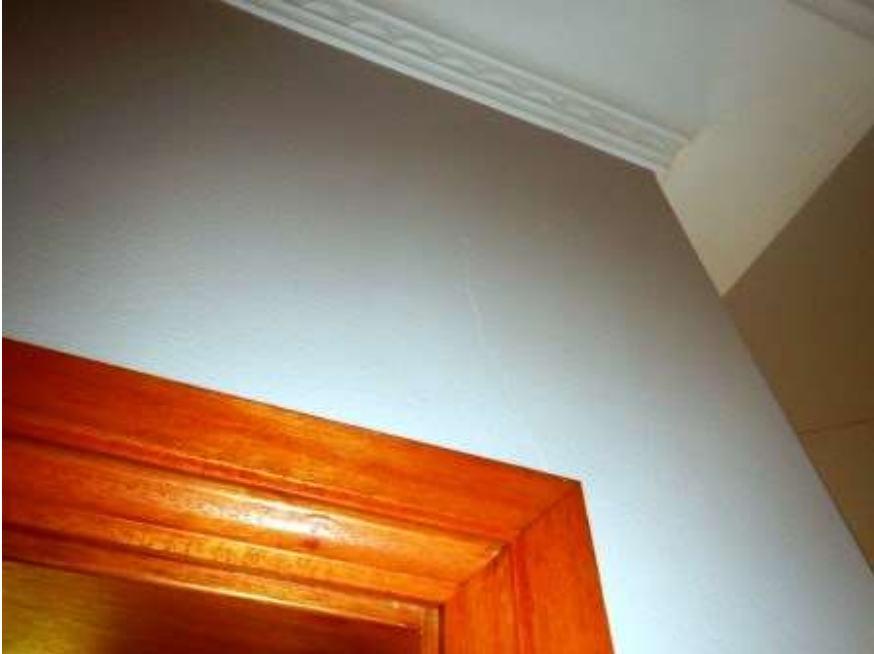
Location	Defect
Interior top floor hallway area.	<div>Category 1: Fine cracks that do not need repair &lt; 1mm in width.</div> <div>

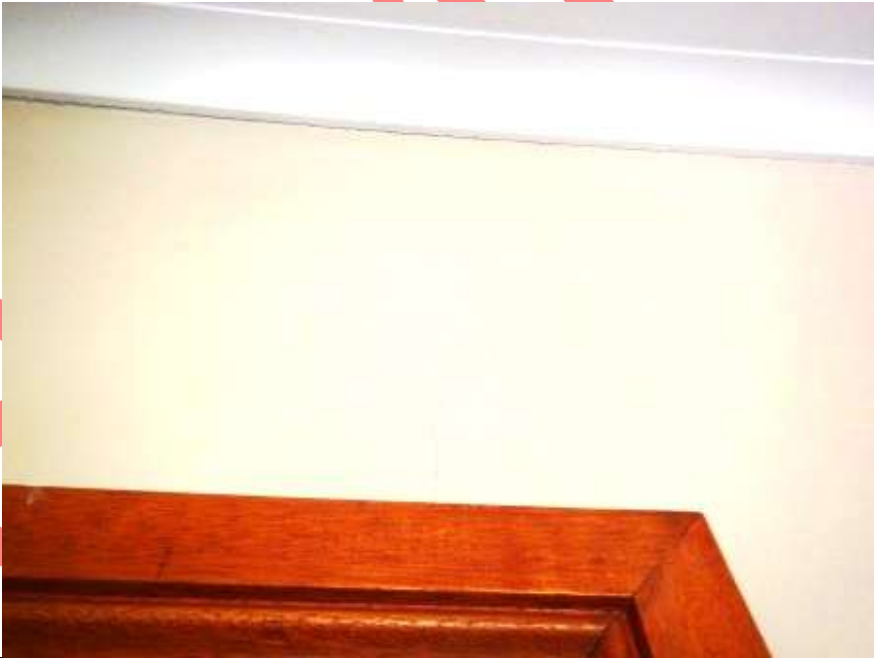
</div>
Interior top floor front bedroom 4.	<div>Category 1: Fine cracks that do not need repair &lt; 1mm in width.</div> <div>

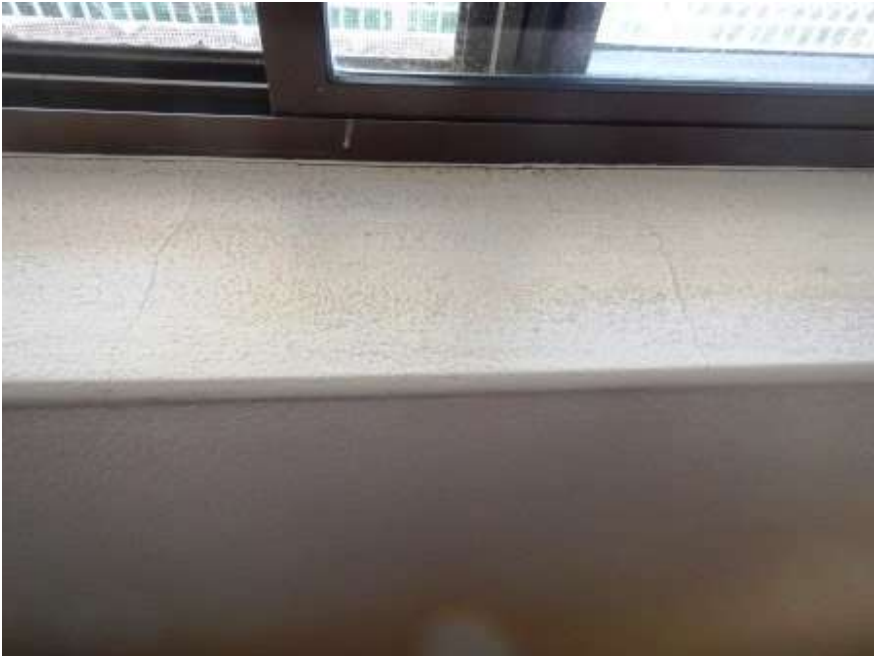
Location	Defect
Interior top floor front bedroom 4.	<div>Category 0: Hairline cracks &lt; 0.1 mm in width.</div> <div>

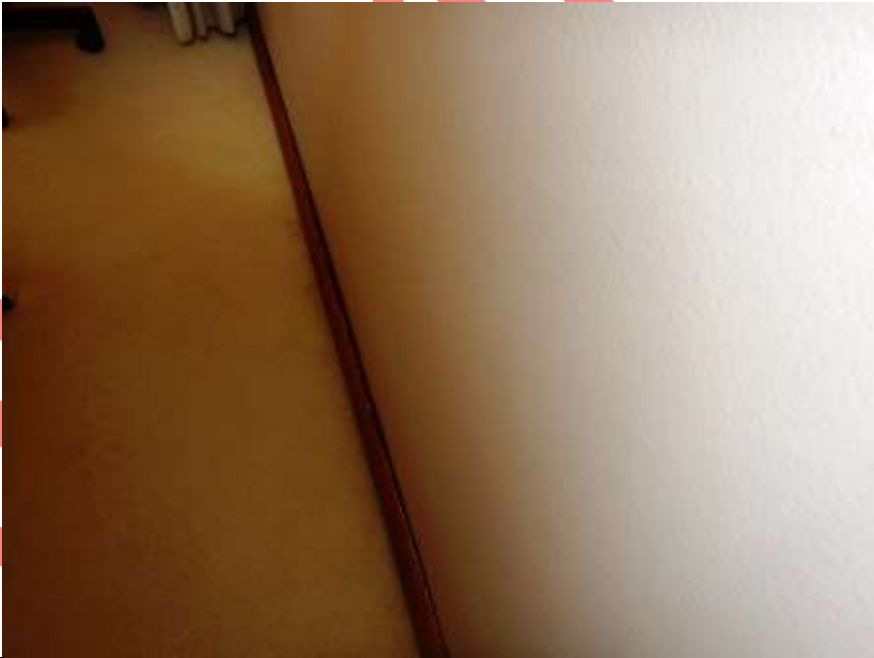
</div>
Interior top floor front bedroom 4.	<div>Loose skirting boards.</div> <div>

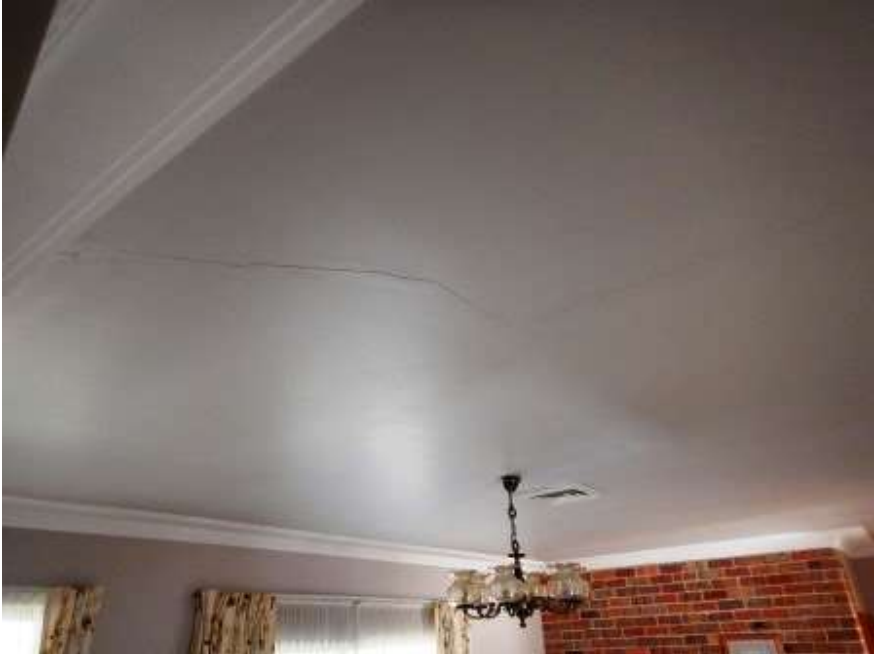
Location	Defect
Interior top floor lounge room area.	<div>Cracking to the ceiling lining.</div> <div>

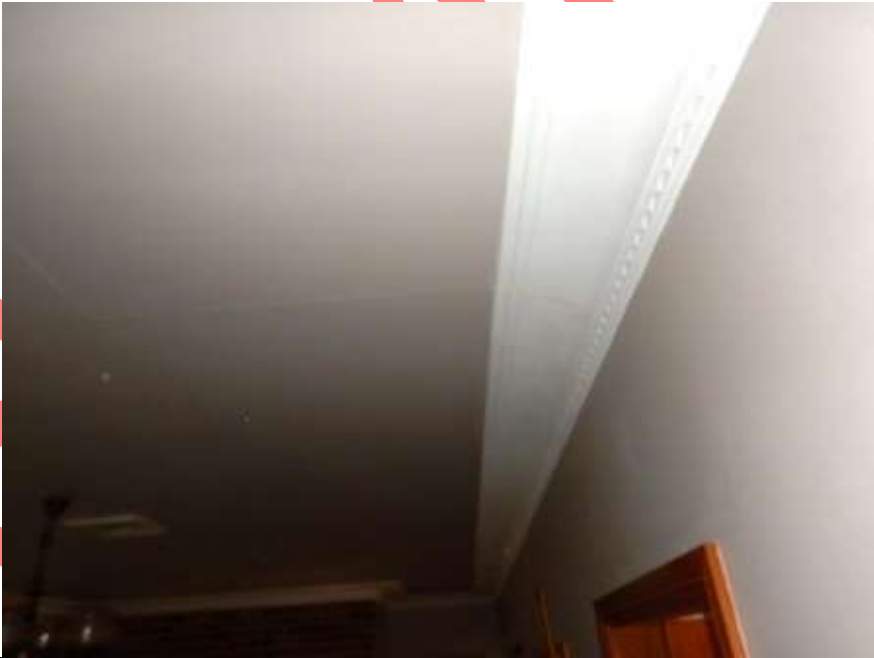
</div>
Interior top floor lounge room area.	<div>Cracking to the ceiling lining.</div> <div>

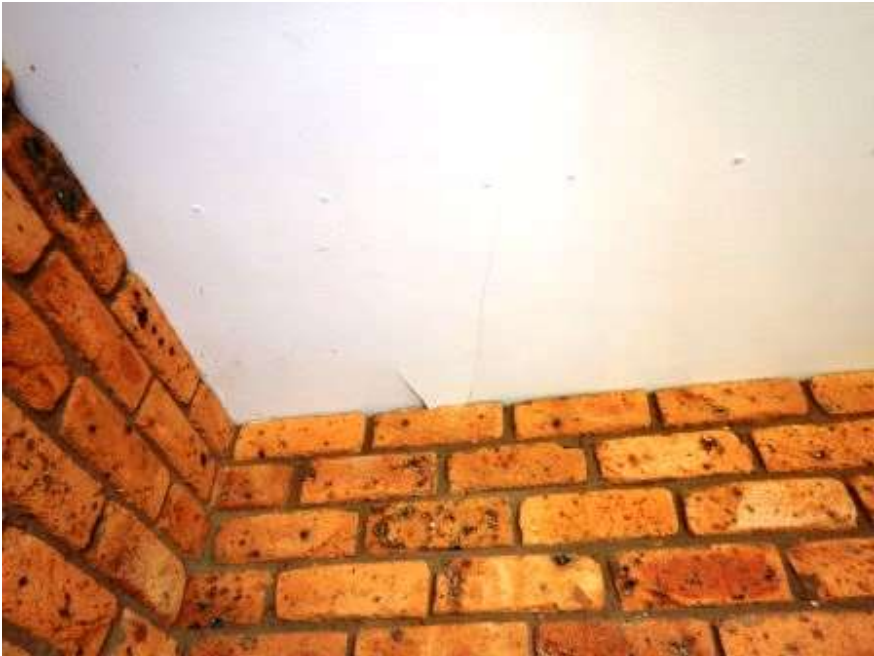
Location	Defect
Exterior upper level balcony area.	Cracked and damaged soffit / eave lining. <div>

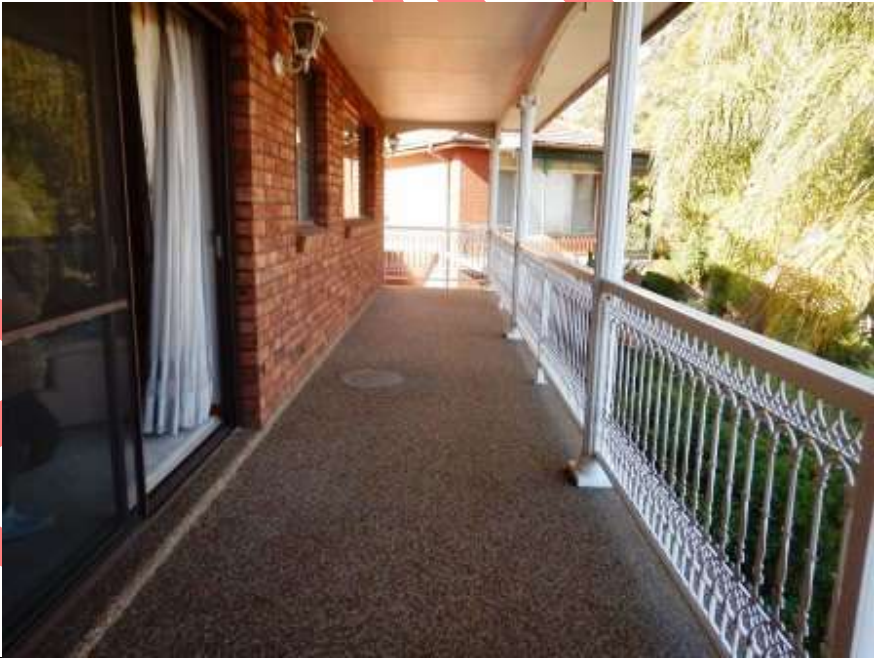
</div>
Exterior upper level balcony area.	Existing condition and location photo. <div>

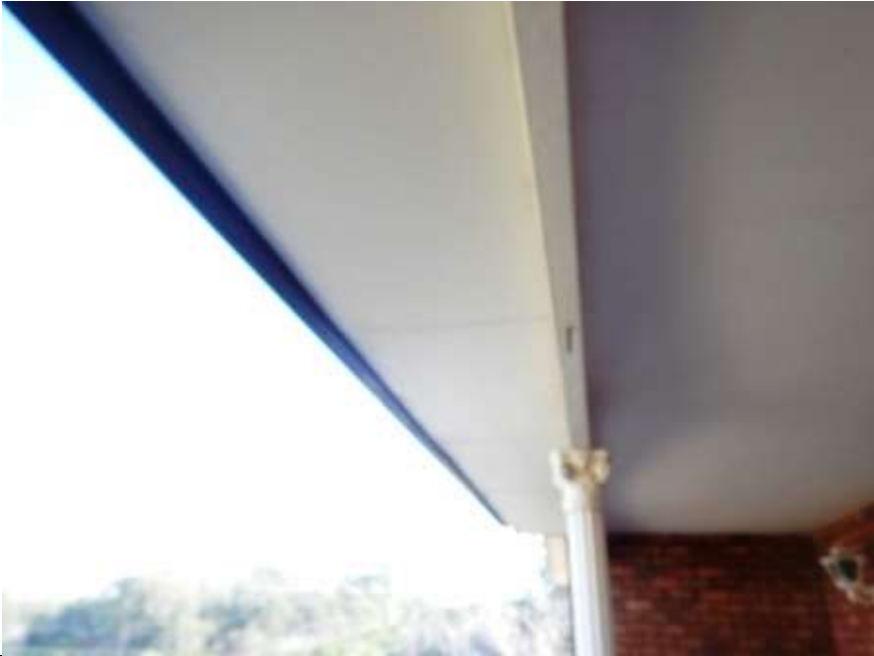
Location	Defect
Exterior upper level balcony area.	<p>The soffit / eave lining has been resecured to the ceiling joist in the past.</p>

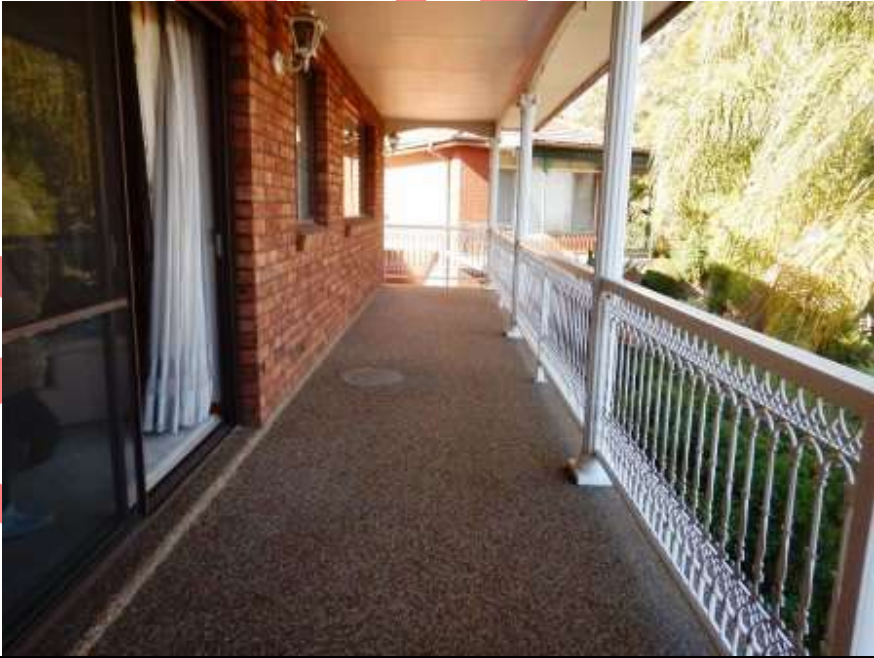
Exterior upper level balcony area.	<p>Existing condition and location photo.</p>
